LEAD -BASED PAINT INSPECTION REPORT

SUBJECT PROPERTY:
Santa Fe Station
413 E. 7th Street
Lawrence, KS 66044

Hernly Associates, Inc.
State of Kansas Lead Activity License #KS00-1030
Michelle Nelson, Assessor #KS05-4153
920 Massachusetts, Suite #2
Lawrence, Kansas 66044-2898
TEL: (785) 749-5806
FAX: (785) 749-1515
info@hernly.com
www.hernly.com
HERNLY Project No.: 090916-01M
9/18/2009

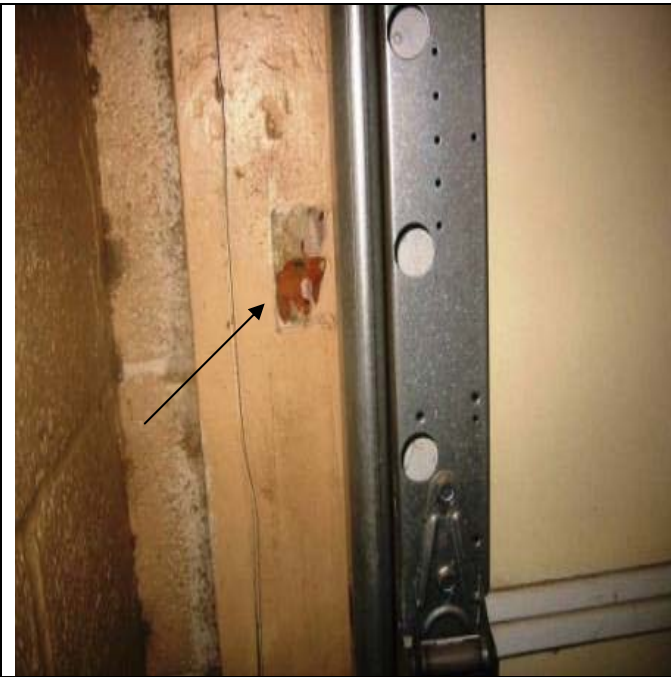
Deteriorated LBP on the Baggage room A wall garage door casing.

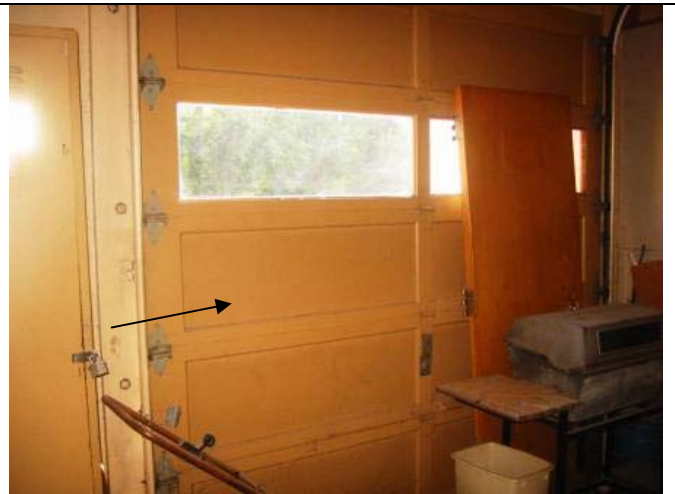
Deteriorated LBP on the Baggage room C wall garage door face

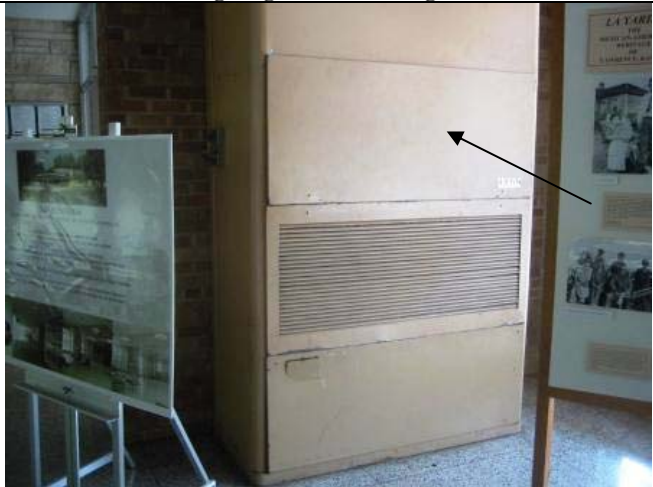
Deteriorated LBP on Waiting lounge air handling unit

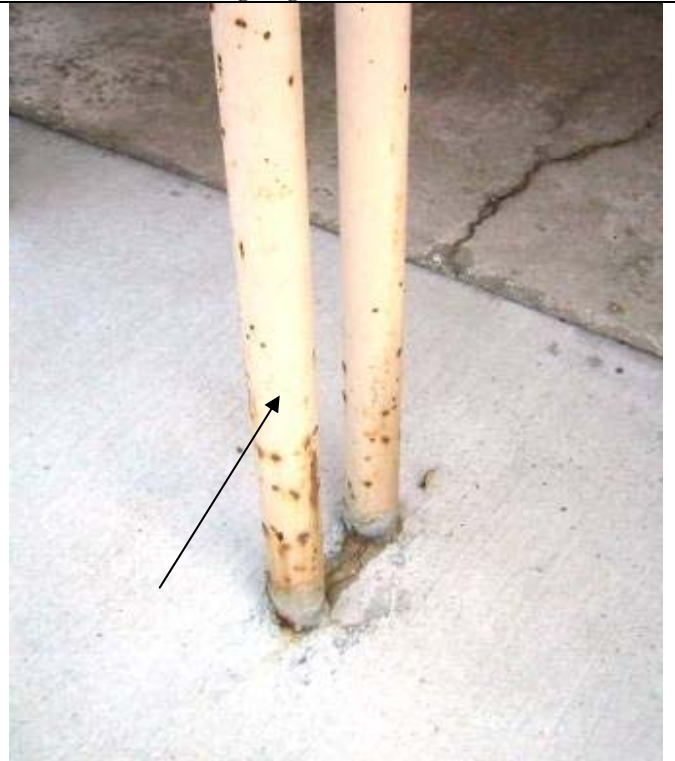
Deteriorated LBP on the exterior columns

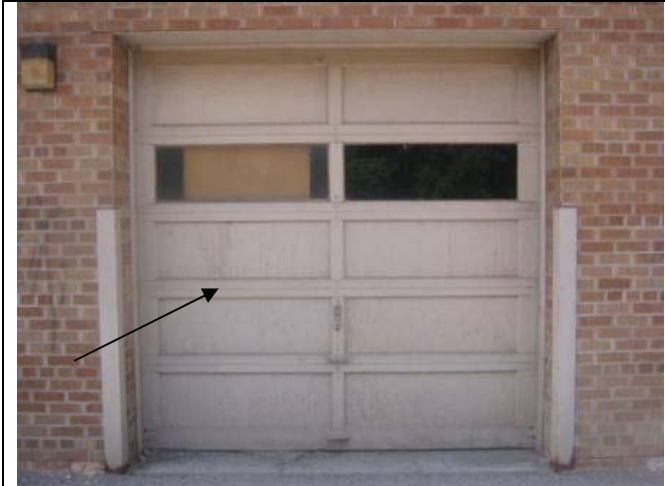
Deteriorated LBP on the exterior C wall garage door face.

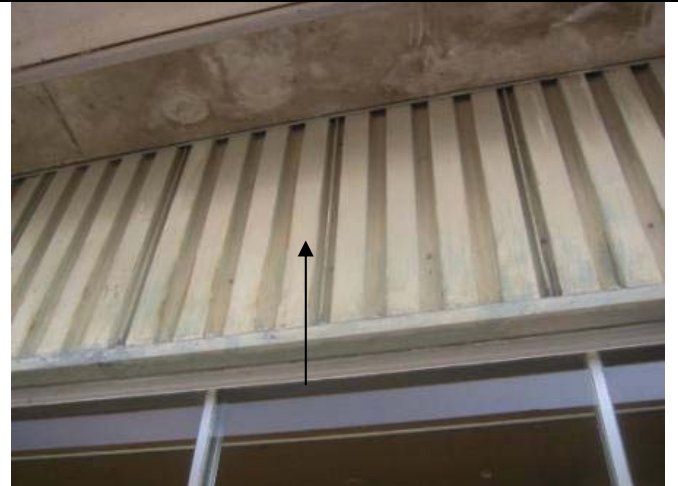
Deteriorated LBP on the exterior A wall siding
