Memorandum

To: Mayor and City Commission
CC: Karin Rexroad, Public Transit Administrator
Date: August 12, 2002
Re: Burlington Northern Santa Fe Depot Facility Evaluation/Transit Center Concept

Lawrence Amtrak Station

Building Condition Survey - July 2002

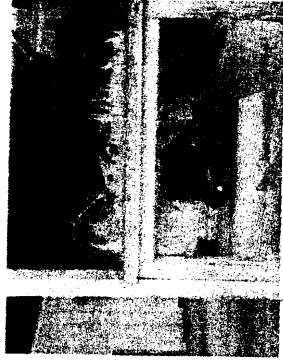
P84

- Window 1 - minor gaps between mortar and stone above and below window. Cracked glass in two panes.
- Window 2 - Wooden frame around window has peeling paint, most notably on the lower half of the window. (P84) Glass is intact, but the tinting application is peeling off in several places (5% of total glass area).
- Window 3 - frame good, cracked glass in one pane.
- Window 4 - cracked glass in one pane
- Window 5 -cracked glass in two panes.
- Window 6 (main windows on Southwest side of waiting room) - Frame in good condition, with no deterioration of brick sill. Cracked glass in one pane.

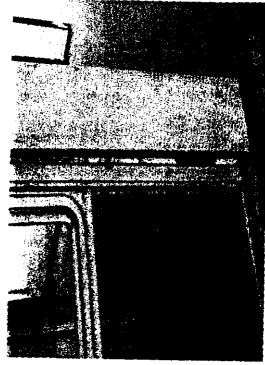
P85

- W 8 - cracked glass in two panes. Caulking has come away from corner joint along entire right side to form 1/4 in. gap at the edge of the frame. (P85)
- W 9, 10, 11, 12, and 13 - good condition of frames with no cracked or broken glass. Stonework above and below windows shows minor gaps in mortar at joints. (P86)
- W 10 - glass is missing from right half of windows, and the opening has been covered with wood. (Repaired between 6.24.2002 and 7.8.2002) (P87)

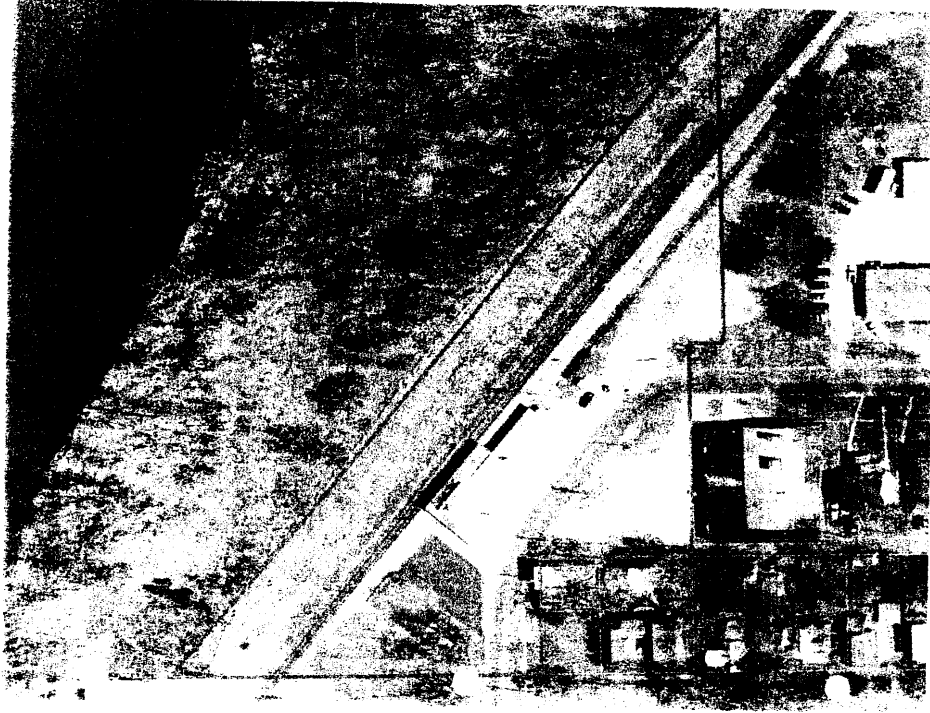
- Two parking lots on Northwest side of the building.
- The farthest from the station is asphalt with several cracks that run the length of the lot but do not show a great amount of deterioration.
- This lot has room for approximately eight cars
- The curb along the Northeastern half of the lot is deteriorated or missing
- Bordered by wooden rail on the Northeast side that shows some deterioration of the wood
- The lot bordering the station is of brick and shows significant deterioration to the surface. The majority of the brick has some sand on it, and a strip along the Southeast side of the lot varying in width from 5-10ft. is almost entirely covered in sand.

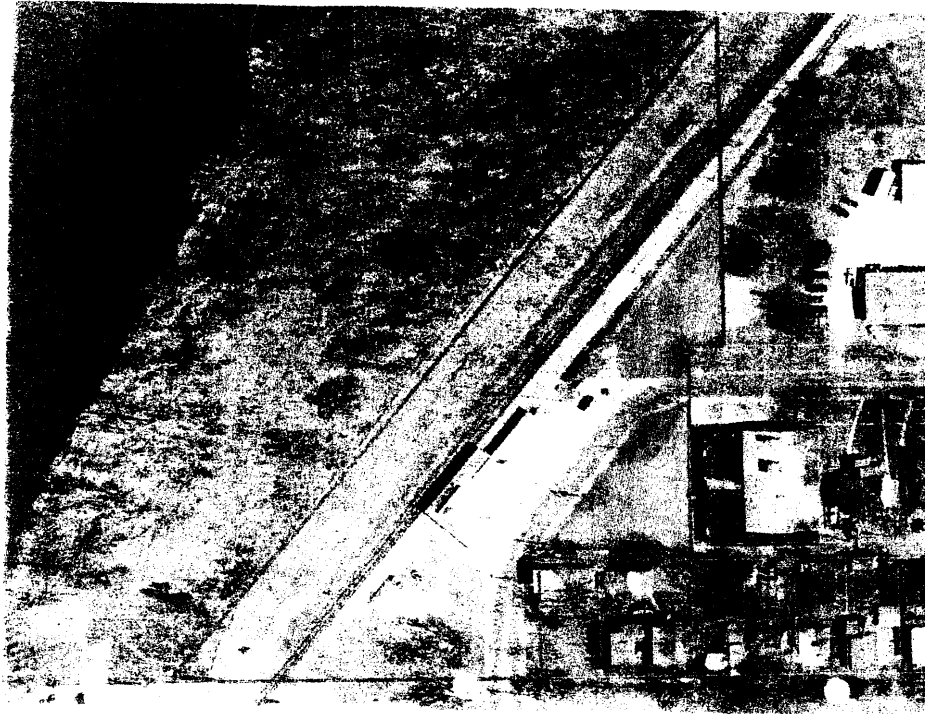
- The area to the Southeast of the station is mainly gravel and sand, with the exception of small grass areas on the South near the road and bordering the secondary tracks.
- Several large depressions where water has accumulated exist in the lot.
- Concrete drive way on the Southeast side of the station shows surface deterioration along the edges with shallow cracks.

- Gravel lot on the opposite side of 7th St., currently used by Van GO Mobile Arts. The triangular lot borders the street on the Northeast, and alley on the West, and the arts building on the South. In addition to the gravel, there are areas of weeds and grass around each telephone pole.

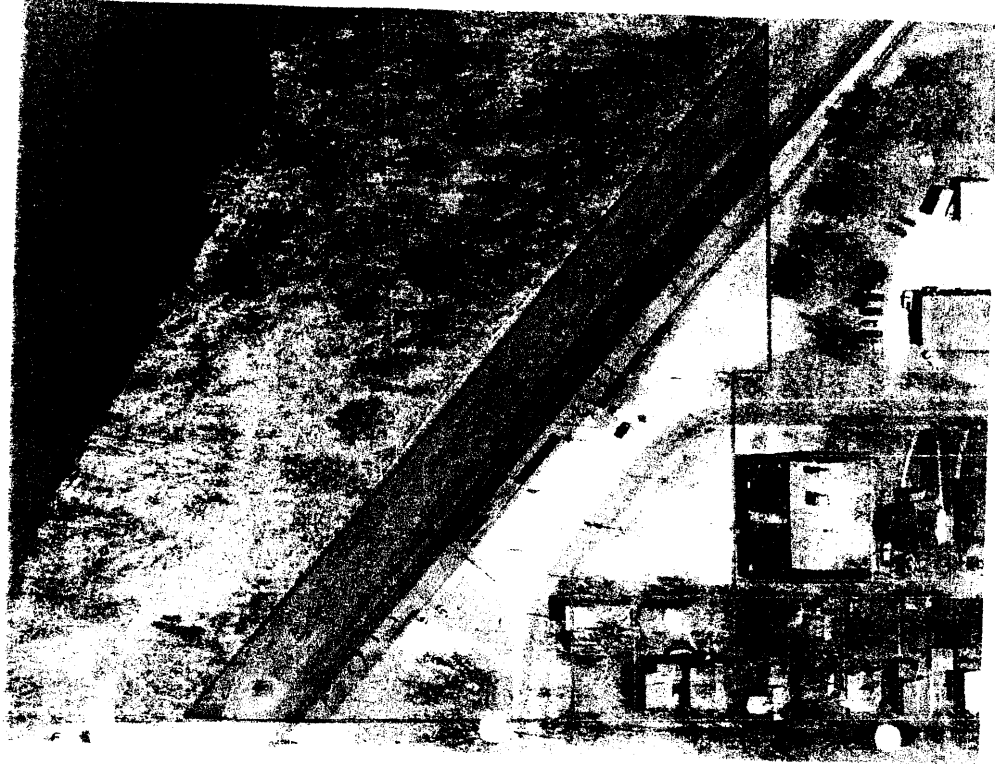
- Train platform/access sidewalk along Southwest side of the tracks shows several large cracks running perpendicular to the edge. Five sidewalk cracks exist to the Northwest of the station, all showing deterioration at edge bordering the tracks.
- Portion of the sidewalk Southeast of the station is asphalt as far as the first light pole from the station, changes to concrete, and continues as such until the property line. Asphalt has 5-10 cracks. Concrete shows deterioration along the Southwest side of the sidewalk near weed vegetation, and three major cracks, which show increasing deterioration near the tracks.
- The platform directly in front of the station is in good condition, but the remainder shows deterioration of the surface and edge.

- A private (?) gravel road runs along the Northeast side of the tracks, separated from them by a screen of weed vegetation. The road appears in fairly good condition with no potholes. The Northeast side of the road borders a Habitat Restoration Area near the river.
- Electrical box near the railroad crossing at northernmost corner of property line.

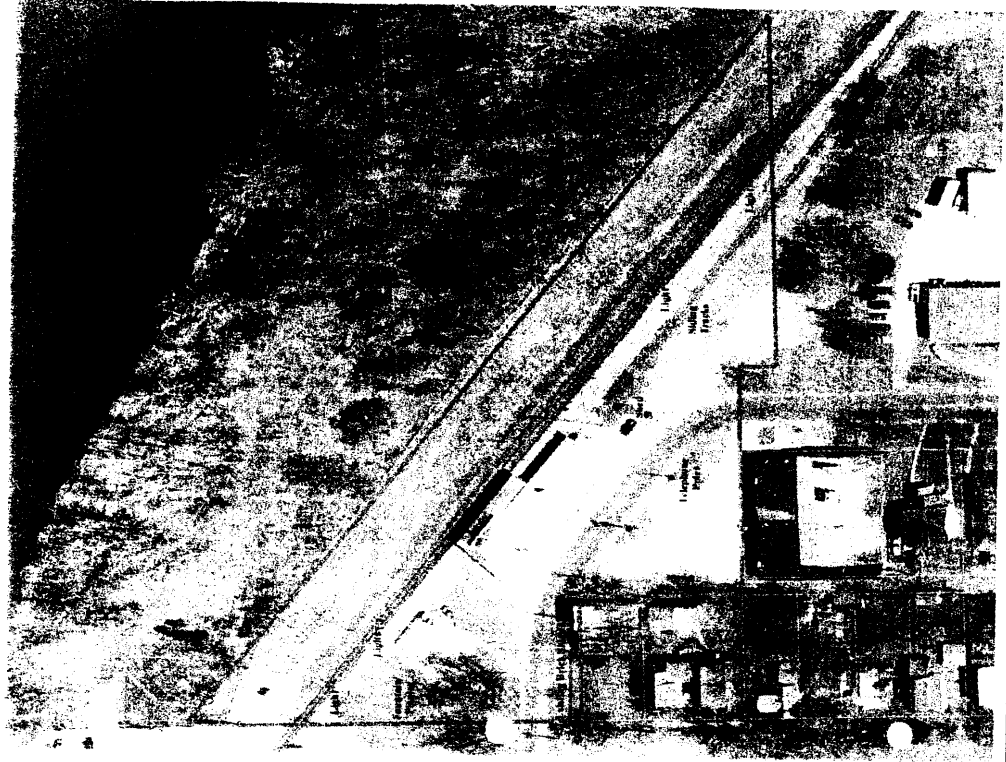
- The grass lawn to the Northwest of the station has a circular concrete structure, one foot high, possibly once a fountain or planter, and of potential historic interest.
- An existing brick sidewalk runs in front of the upholstery shop and continues to the end of the block. It is in good condition in front of the shop and almost entirely covered in grass on the other half.
- A railroad crossing lies just beyond the Northernmost corner of the property.
- The edge of the concrete patio bordering the siding tracks is deteriorated to the rebar in two spots.
- All four of the platform light poles show surface corrosion.
- A shed and pit are located to the South of the intersection of the siding tracks and Southeast patio.
- There are six telephone poles located within the property line.
