DGM Consultants, P.A.

FIELD REPORT #01

Project	Carnegie Library	Date	5/15/2012 DGM Project # 2012014
Location	9 th and Vermont Lawrence, Kansas 66044	Contractor	The Garland Company, Inc
To	Mr. Lynn Applegate , Bldg & Aquatics Sup City Of Lawrence 6 East 6th Street Lawrence, Kansas 66044	Owner	City of Lawrence
FAX		Weather	Sunny, 60-84°F
		Present	Greg Leslie Lynn Applegate
		PN	PO 005556

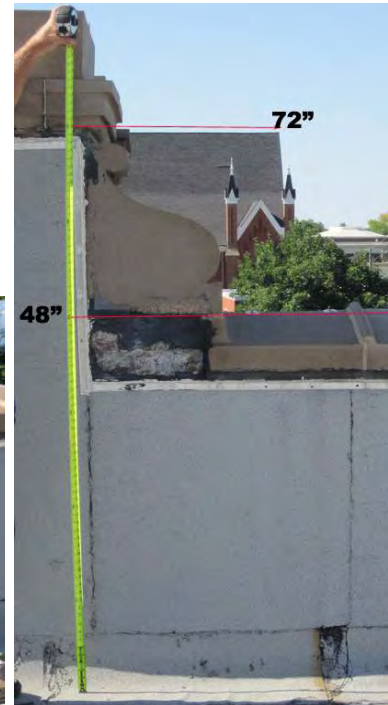
- (1) Noted lengths of wall segments "(xx'-x")" is based on length of wall at first floor from the drawings reviewed.
- (2) Parapet walls extend about 4 feet above the roofing surface (based on measurements taken along the south wall) to the top of the terra cotta caps. The higher center portion is 6 feet to the bottom of the caps.
- (3) The back side of the parapet wall is typically covered with roofing that is not fully adhered, but appears to be hung, in some locations, from the termination bar.

- (4) Lynn recalled photos from the period of the reroofing project that showed the back sides of the walls sealed with an asphalt coating prior to the present cap sheet. Some of this membrane is still exposed above the termination bar, as documented in later photographs.

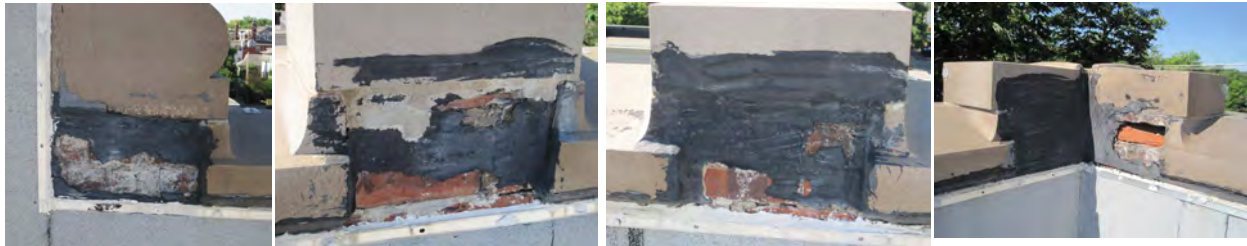
(b) The east and west sections are similar. They are constructed with a corner section and two intermediate pilasters. The pilasters are capped with a terra cotta cap stone that sets

above the rest of the cap stones. The back of the pilasters are brick between the upturned terra cotta cap stone edges. The brick is partially exposed from behind an asphalt coating that was applied over the masonry. The bricks are deteriorated to varying degrees. West parapet series of pilaster caps shown below.

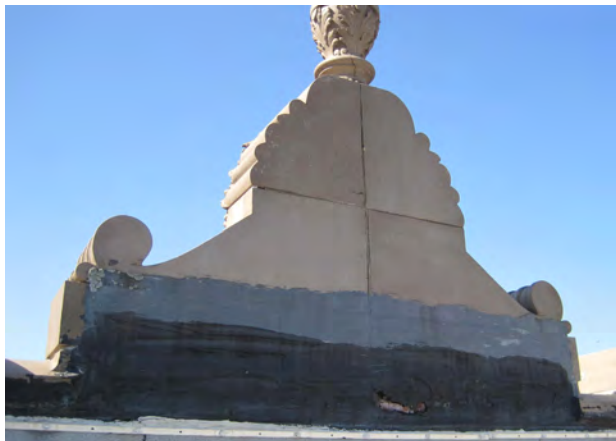
- ii) The south wall was looked at next. Back side is covered with a weathered asphalt coating above the termination bar to “seal” the exposed brick. The joints above in the back of the terra cotta finial are displaced and open. One crack was noted along the vertical joint.

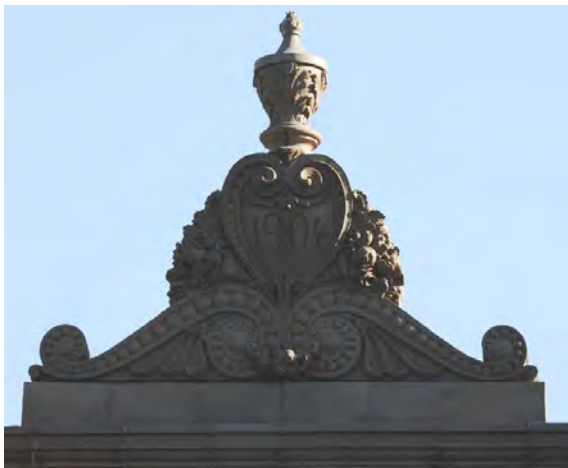
- iv) From the south face, the terra cotta finial on top of the wall looks to be in good condition, except for numerous open joint lines and a few cracks (highlighted in red).

3. Repairs
 - a. All terra cotta units: Carefully removed, cleaned, and salvaged for reinstallation. This included the finial pieces above the south entrance.

1. Remove unstable decorative finial units at the top of the south entrance wall and reinstall when wall below is repaired.
2. Prior to reroofing
 - a. Repair leaning walls.
 - b. Rebuild tops of all walls and reinstall terra cotta copings units and new cast units.
 - c. Coordinate flashing with flashing work proposed in roofing project.
3. Repair cracked lintels and cracked masonry walls.
4. Address foundation waterproofing exposure/termination concerns at north wall of 2011 Addition.

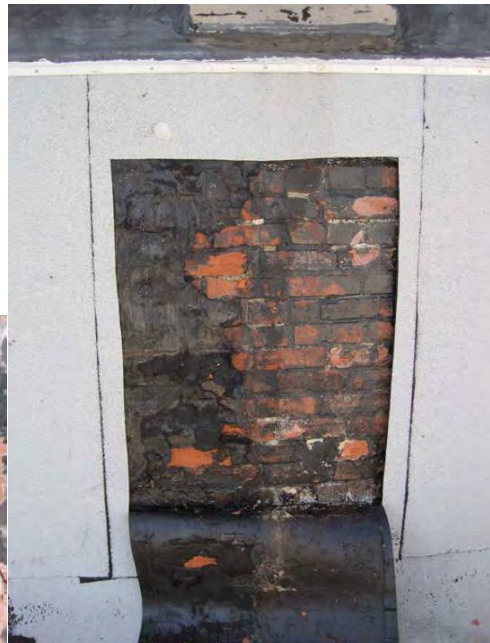
- e. South parapet wall investigation: We opened up two sections of roofing that had been applied to the back of the parapet wall (with the assistance of Greg Leslie).

- (1) The first was at the center section. After folding the roofing down we noted the wall to be visibly wet from the glistening surface moisture. The brick backup wall had been coated with an asphalt coating subsequent to some pointing and the bricks were spalling.

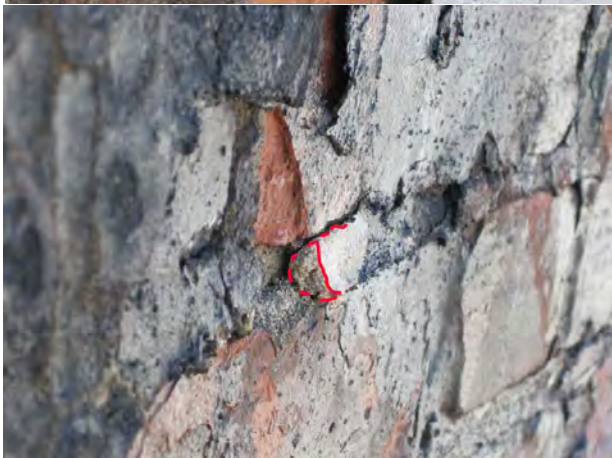
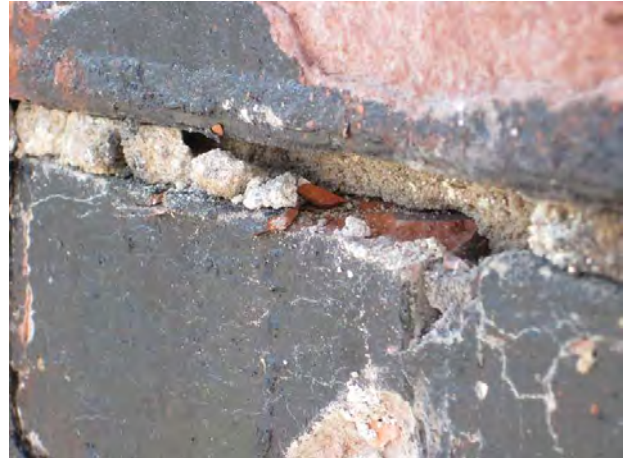
- (2) The second was the east parapet section.
- (3) The mortar original mortar joints were wider than the exterior joints and they were severely deteriorated. Previous pointing attempts appeared to be just shallow joint fills that were not

bonded to the brick well or deep enough.

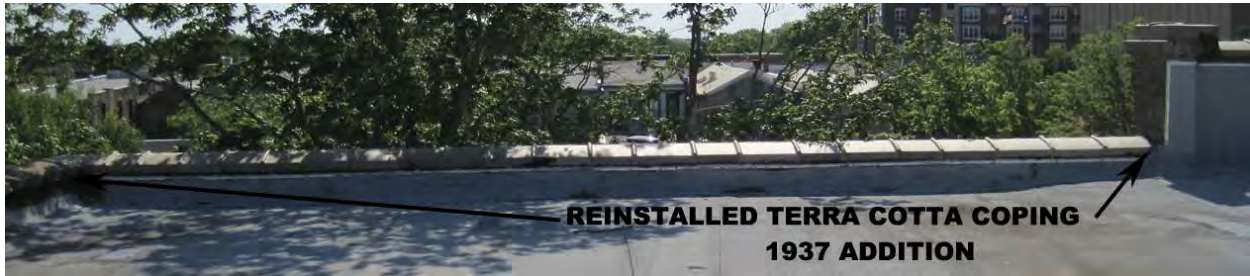
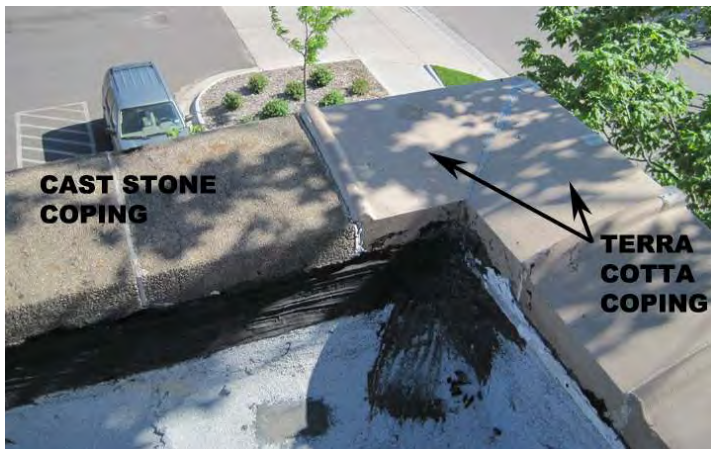
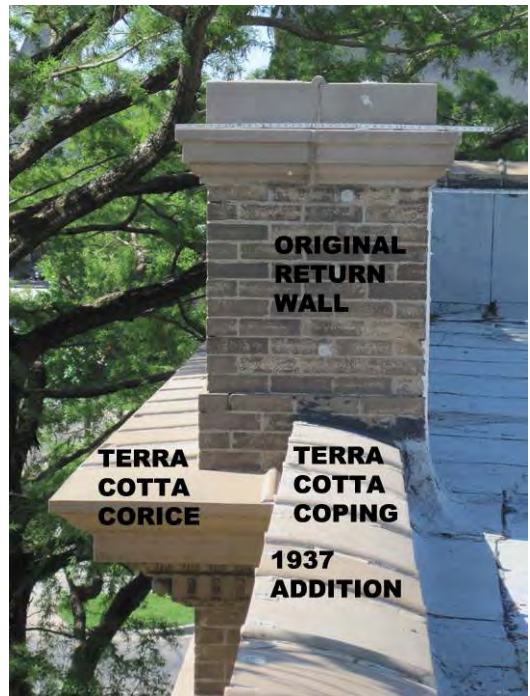
3. 1937 Addition's parapet walls (from north roof)
 - a. This addition has three sides and is centered along the north remaining portion of the original building. The parapet walls are much shorter than the original building.
 - b. East wall (36'-5"): Wall is capped with 24 terra cotta coping units salvaged from the original building, that was replaced by this addition. These terra cotta coping units are in good condition.

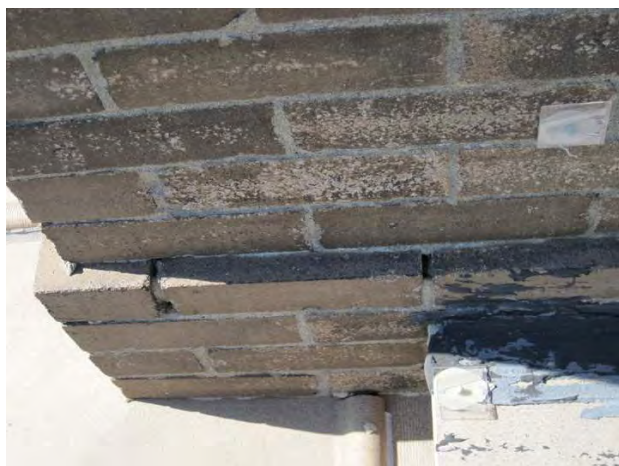
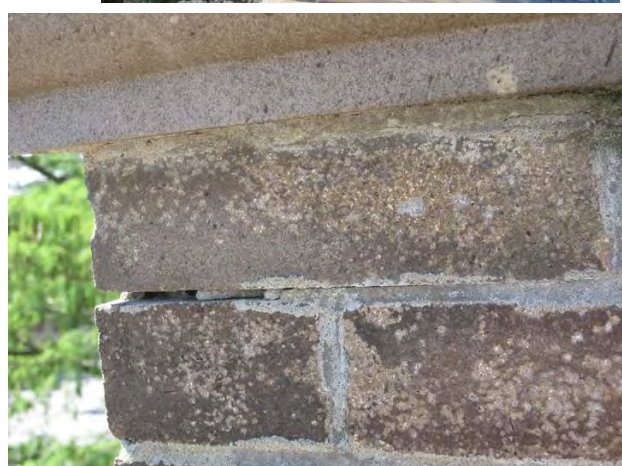
- (1) At the end of the original return wall we noted some open mortar joints in the brick.

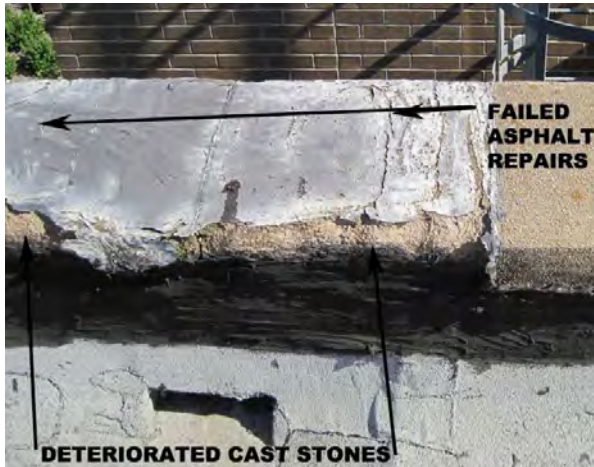
(1) The copings on the north wall are cast stone units that are of a similar cross section as the original, but 24 of the 47 units are severely deteriorated and joints are cracked.

- b. Cast stone units
 - (1) Option 1
 - (a) Replace all units with wet-cast air-entrained coping units that match the original profile. The top of the coping units should be treated with a clear breathable water-repellant every 10 years.

- (b) Install units with movement joints every 10 feet and caulk all head joints with non-staining silicone sealant.
 - (2) Option 2
 - (a) Replace all units with Indiana limestone units milled to match the original profile. The top of the coping units should be treated with a clear breathable water-repellant every 10 years.

- (b) Install units with movement joints every 10 feet and caulk all head joints with non-staining silicone sealant.
 - (3) Option 3
 - (a) Remove deteriorated units and install blocking, metal coping, and counter flashing to cover the brick wall above the adjacent 23 feet wide 2011 Addition connection roof.

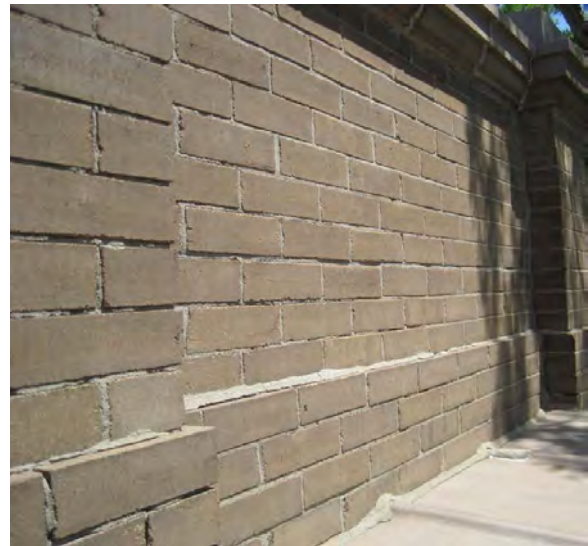
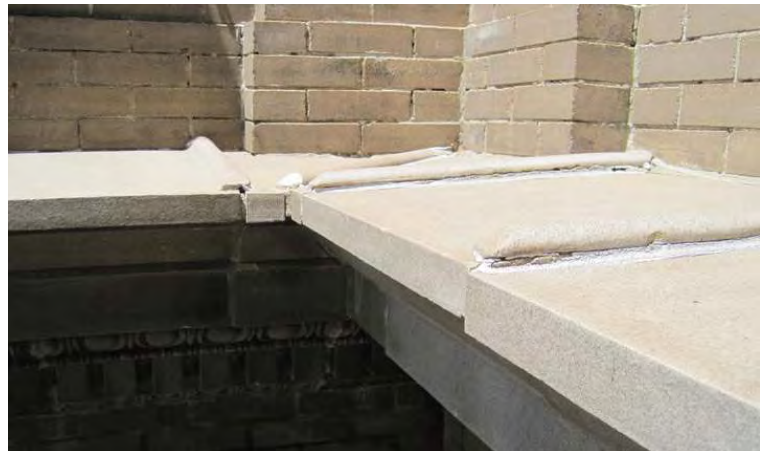
- (a) Some parapets were accessed with a ladder
- (b) Eastern
 - i) Accessed with a ladder.
 - ii) Narrow mortar joints are weathered. Some pointing has failed. Watertable is in good condition, but some open joints were noted.

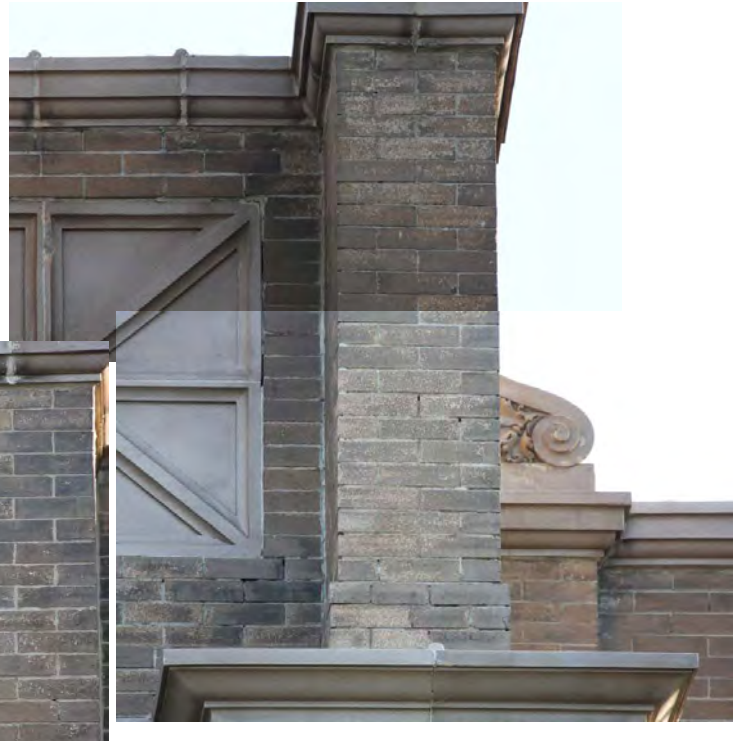
- (c) Center section: Masonry appears to be in good condition, except for some open joints between the bricks and the inlaid panels and mortar joints.

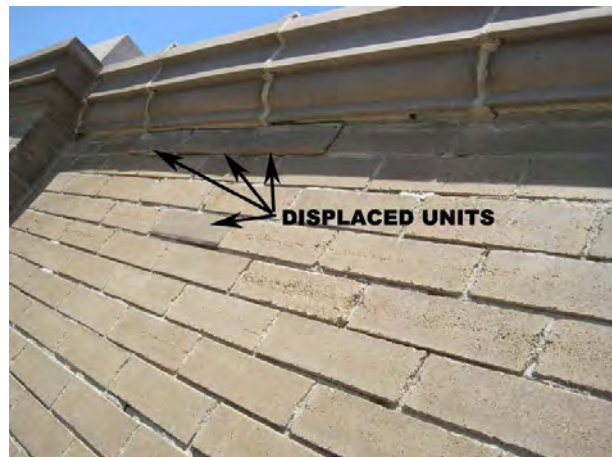
- iii) Displaced units were noted near the top of wall (photo right).

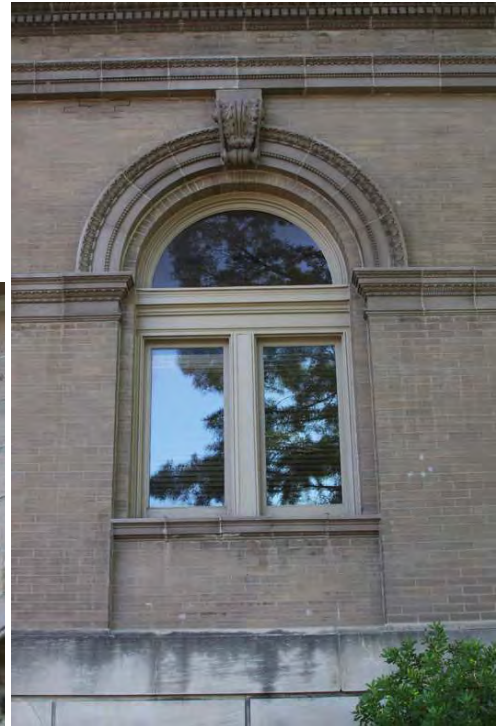
- (3) Eastern wall
 - (a) Looks relatively good, except for some biological staining below the window and along the top of the foundation wall. Some joint discoloration was

noted at upper left of window, suggesting a leak.

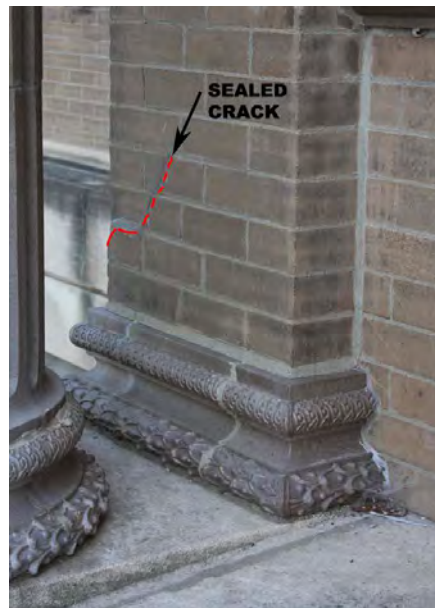
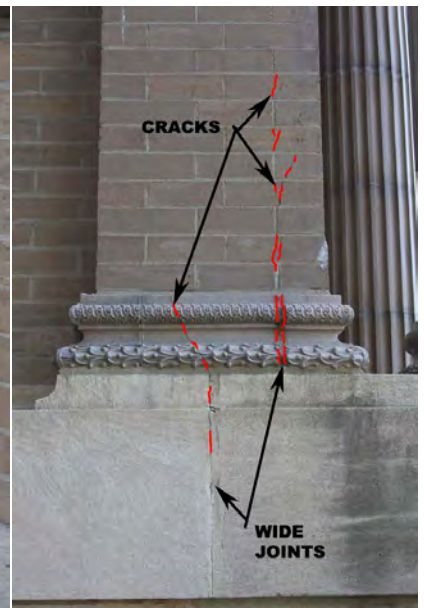
- (4) South Entrance
 - (a) The right terra cotta column capitals appear to be in excellent condition. One slightly chipped detail was noted.
 - (b) The base of the left wall corner is cracked on the west and south faces. Previous repairs have addressed the older cracks, but some cracks appear to be newer than the last repairs.

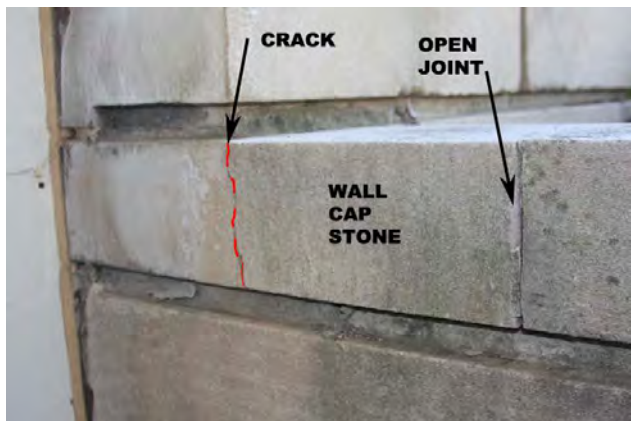
(b) Abandoned stairwell on the west side of the entrance has a bowed foundation wall. The top two courses are displaced and cracked. No guardrail at lower level stairwell.

L. Guardrails at Stairwells: The stairwells may need new guardrails to protect these three locations. The two original stair wells along the south wall have not guardrails. Another option might be to install bushes to provide some protection. The north stairwell at the 1937 Addition provides some protection, but may need to be modified to infill large openings.

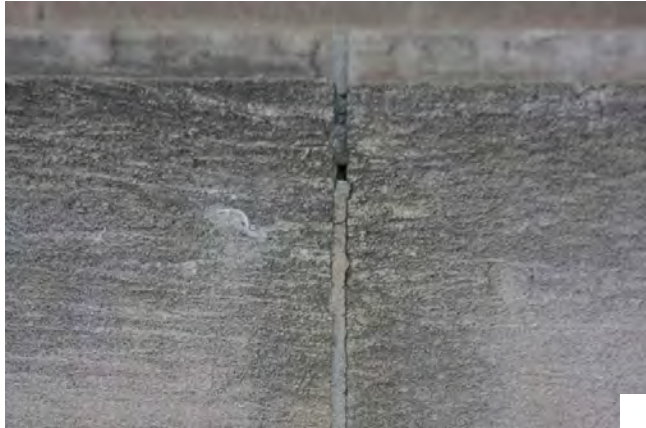
(c) Cracks and open

joints were noted at the inside corner.

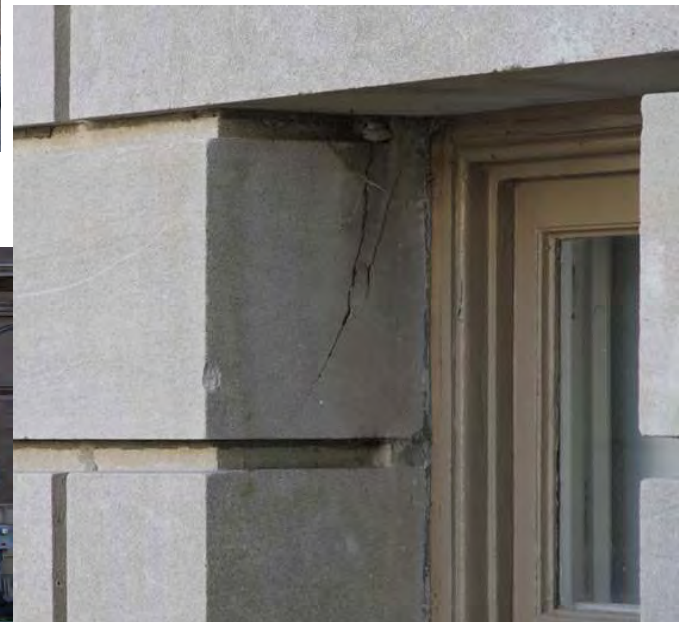
- (d) Cracks in foundation wall near corner and at basement window.

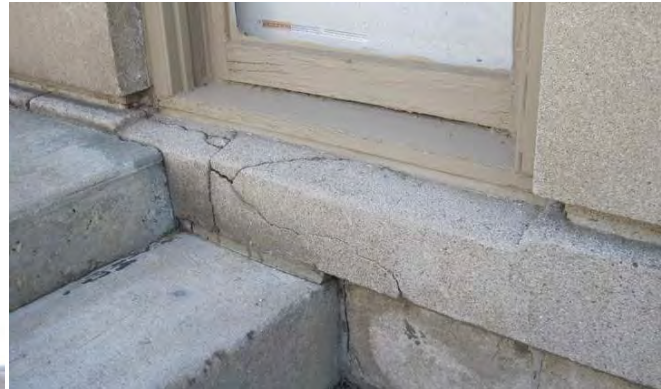
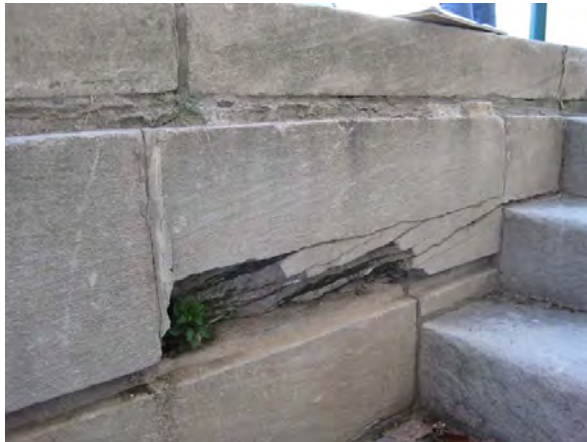
- (e) Cracked cast stone sill, at head of basement stair, is cracked
- (f) A stones in the stairwell

foundation wall is severely deteriorated.

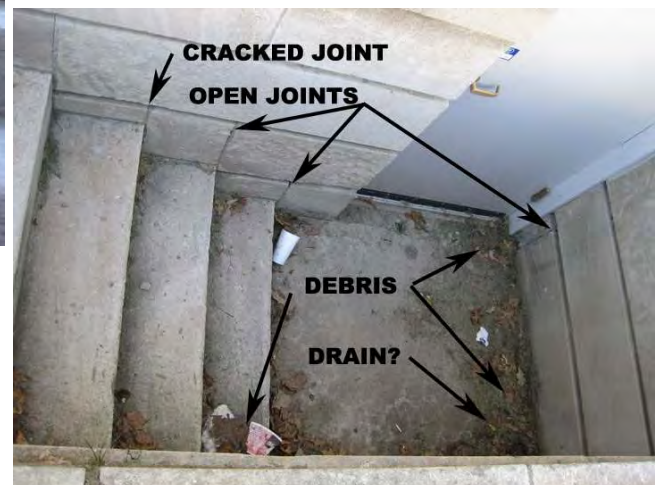
- (g) Deterioration at base of stairwell was noted.

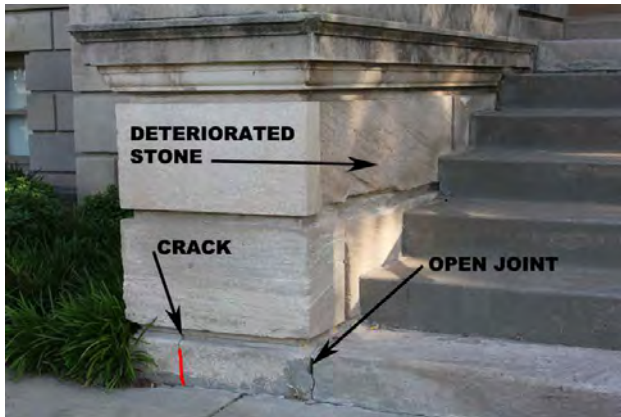
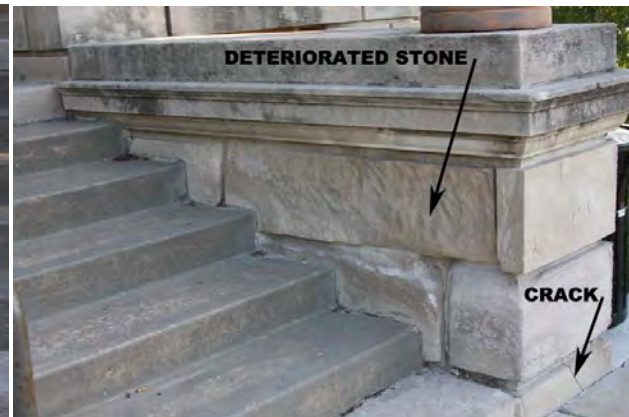
- a. Original south entrance stair walls: Some stones are cracked and deteriorated.

1. The use of deicing salts has likely caused the stone deterioration at stone walls adjacent to site steps. The lack of movement joints in the long site walls at the southeast corner force the horizontal expansion in the wall to accumulate at the corner and crack the stones.
2. Repairs:
 - a. Stairwells: Replace deteriorated stone units and minimize the usage of deicing salts during the cold months.
 - b. Site walls: Install movement joints in the site wall and replace cracked units.

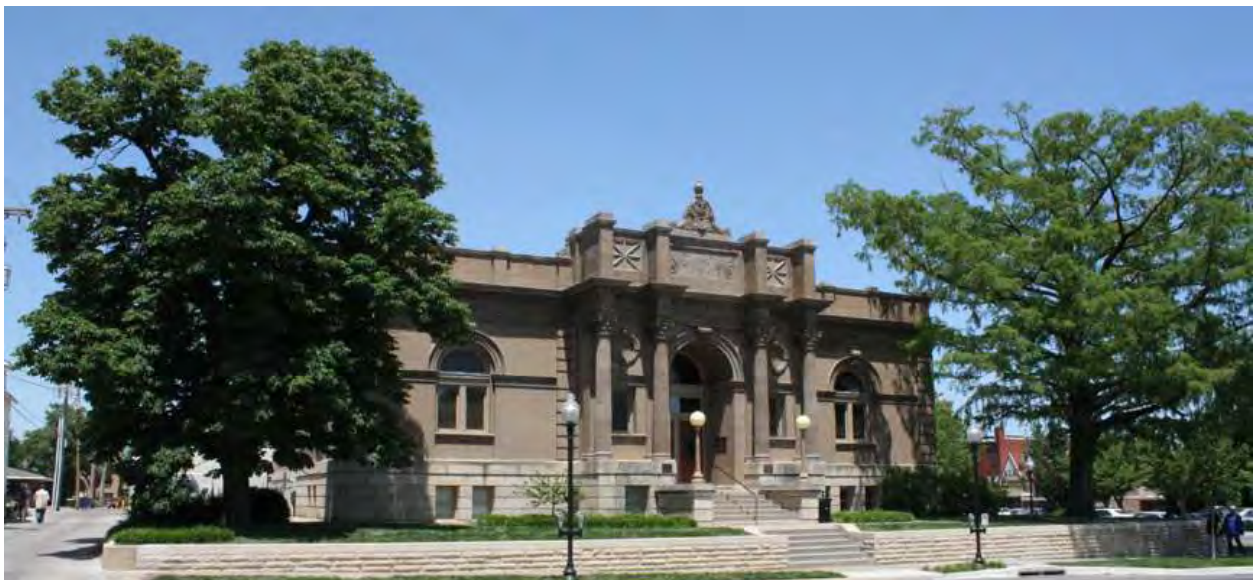
- c. Trees: The original building has two trees at the south elevation. The trees are located just off of the two corners about 16 to 17 feet (at about a 45 degree angle). The southeast tree is about 36 inches in diameter and the southwest tree is about 24 inches in diameter.

1. The two large trees on the south side of the building are likely desiccating the soil (drying it out) deep below the surface and even under the building beyond the tree's drip line. This in turn causes the soil to shrink and expand depending on the soil moisture content. The type of cracking on the west wall of the original building indicates that the corner of the building near the tree has settled enough to cause the southwest corner of the building to rotate southward, cracking the top of wall, opening the width of the window opening enough that the arch has partially failed, and cracking the wall below the window.
2. Repair
 - a. Option 1: Maintain consistent moisture content especially around trees.
 - b. Option 2: Remove trees
