DGM Consultants, P.A.

FIELD REPORT #01

Project	Carnegie Library	Date	5/15/2012 DGM Project # 2012014
Location	9 th and Vermont Lawrence, Kansas 66044	Contractor	The Garland Company, Inc
To	Mr. Lynn Applegate , Bldg & Aquatics Sup City Of Lawrence 6 East 6th Street Lawrence, Kansas 66044	Owner	City of Lawrence
FAX		Weather	Sunny, 60-84°F
		Present	Greg Leslie Lynn Applegate
		PN	PO 005556

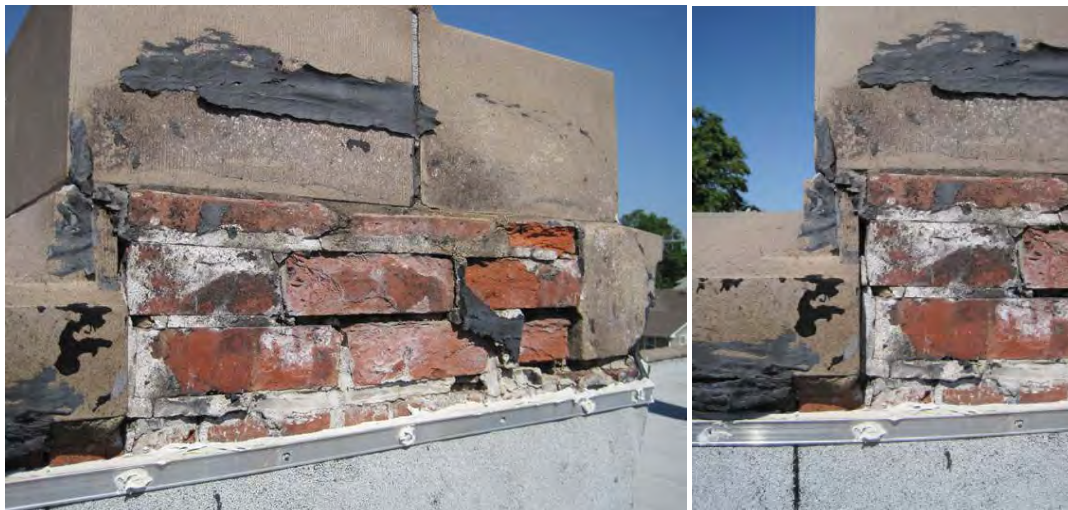
- i) The west wall was surveyed first. Most vertical joints between stones are open and the previously covered brick is deteriorated.

The original mortar joints are severely deteriorated or open and the previous pointing is failing.

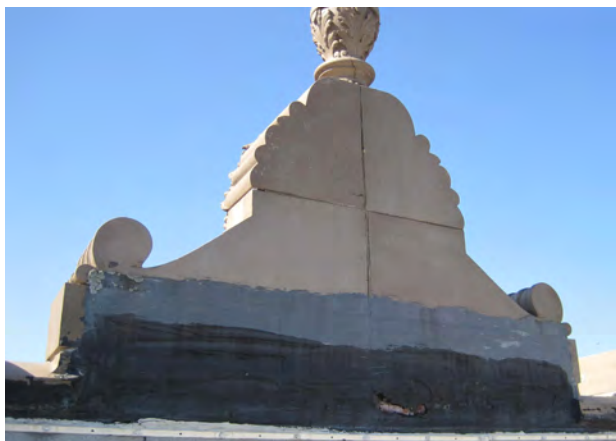
- ii) The south wall was looked at next. Back side is covered with a weathered asphalt coating above the termination bar to “seal” the exposed brick. The joints above in the back of the terra cotta finial are displaced and open. One crack was noted along the vertical joint.

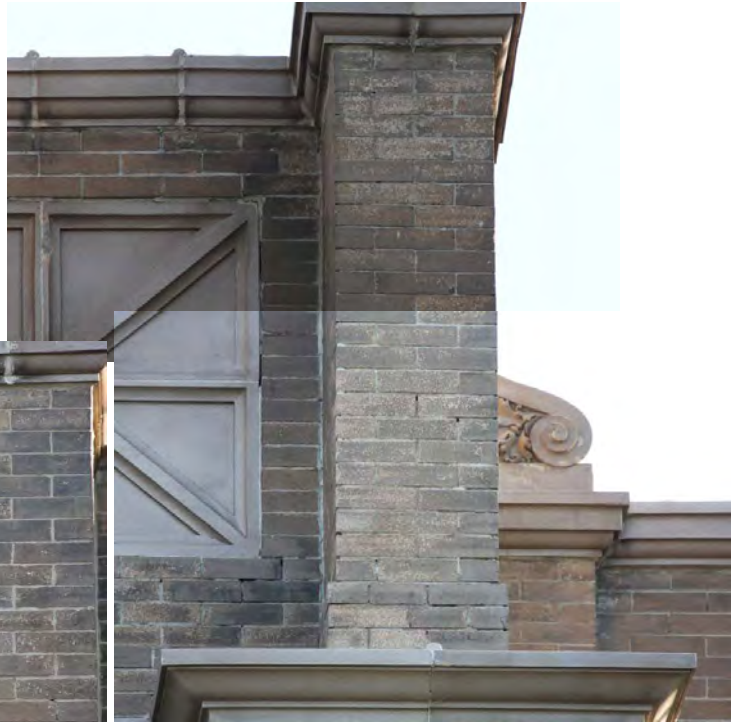
- (c) Center section: Masonry appears to be in good condition, except for some open joints between the bricks and the inlaid panels and mortar joints.

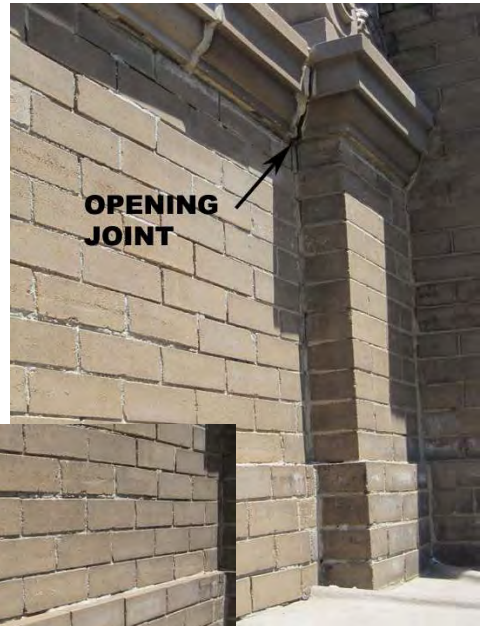
Some pointing has failed. Watertable is in good condition, but some open joints were noted. Pointing at base of parapet wall (at watertable) appears to be installed improperly and holes were noted in mortar joints.

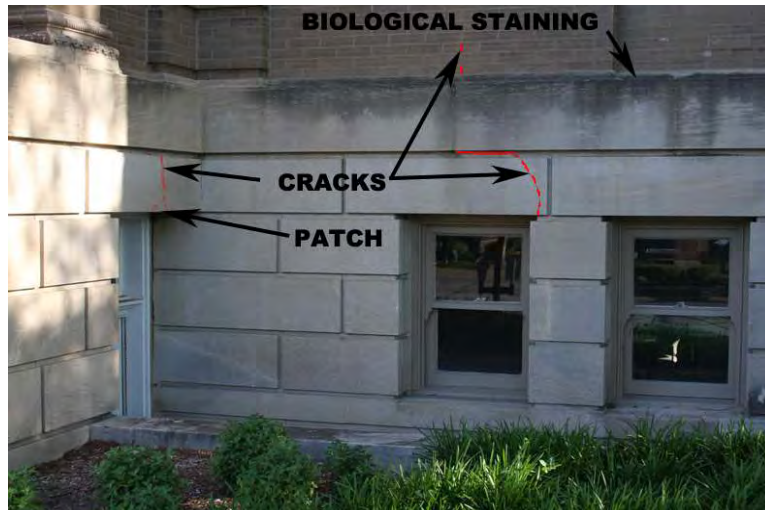
- (b) Signs of moisture coming through terra cotta joints were noted at the inside corner below the watertable.
- (c) Cracked lintels were noted at two basement openings. One crack extends up into the brick wall. Previous pointing and crack repairs,

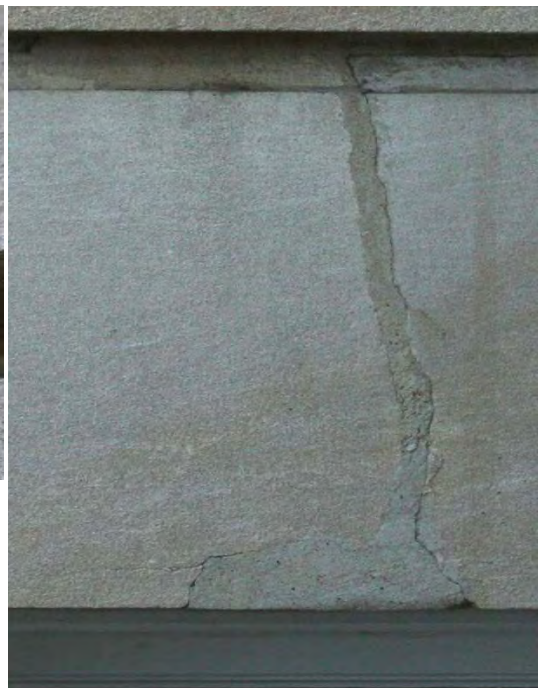
near this location, are a concern. The pointing repair seems to be too shallow and as a result the edges of the stone foundation wall are cracked and chipped. Reference photos at the top of the next page. No guardrail at lower level stairwell.

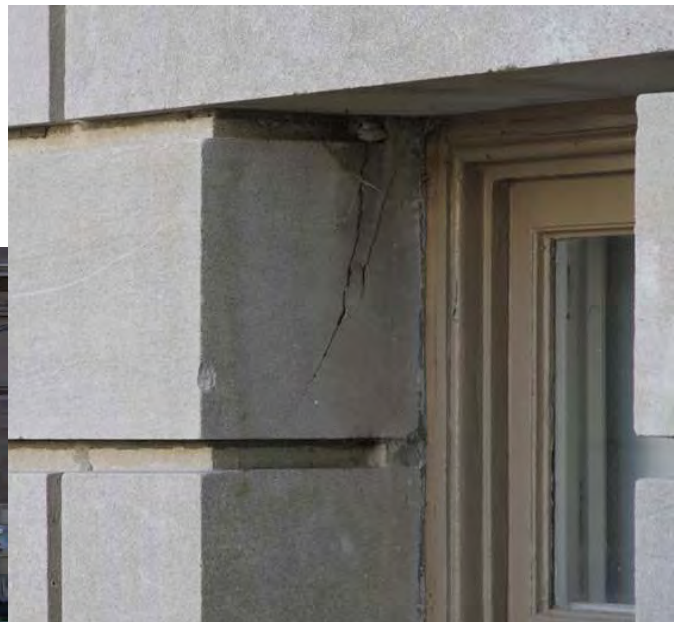
- (d) Cracks in foundation wall near corner and at basement window.

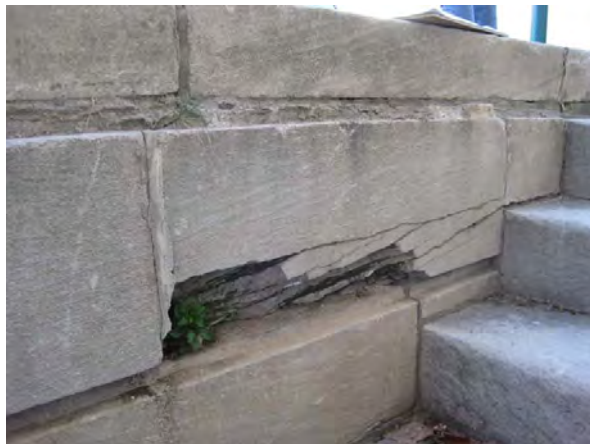
- (e) Cracked cast stone sill, at head of basement stair, is cracked
- (f) A stones in the stairwell

foundation wall is severely deteriorated.

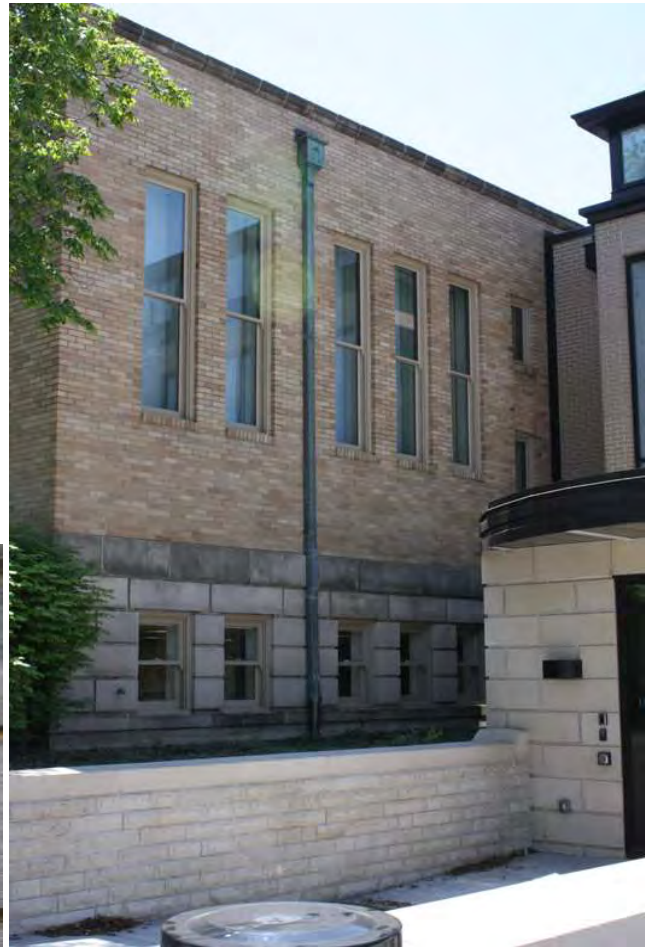
- d. North elevation
 - (1) 1937 Addition
 - (a) Western portion of elevation is partially visible from the northwest. Noted concerns were previously discussed.
 - (b) Eastern portion of north elevation is more visible from the northeast. Lintels were noted to be rusted along this elevation.

1. The rusted lintels on the 1937 Addition cannot be easily corrected without opening the wall up and replacing the lintel, which is not necessary now. The mortar at the lintel bearing conditions should be removed and the joint sealed to keep water out of the wall.
2. Repair
 - a. Remove mortar from in front of steel lintels, clean and prime steel, then caulk joint with a non-staining silicone sealant.
 - b. Clean, prime and paint all exposed portions of steel lintels.

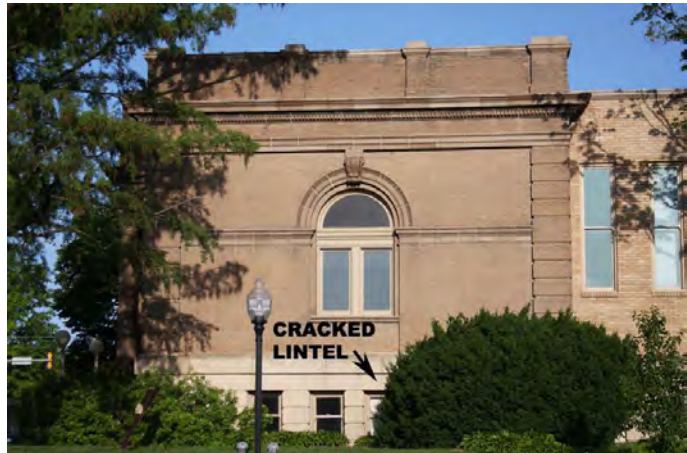
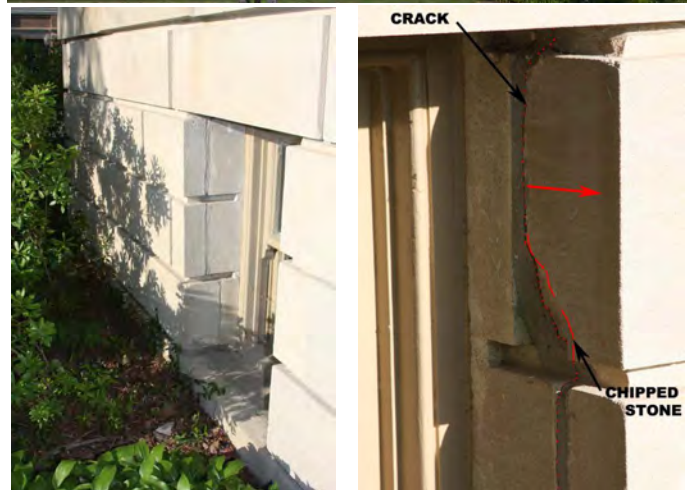
- (2) Original building
 - (a) Cracked lintel was noted in the stone foundation wall.

- (b) Repaired jamb conditions were reviewed and previous repairs are cracked.
 - (c) Parapet wall is like the others, except only open mortar joints were noted.

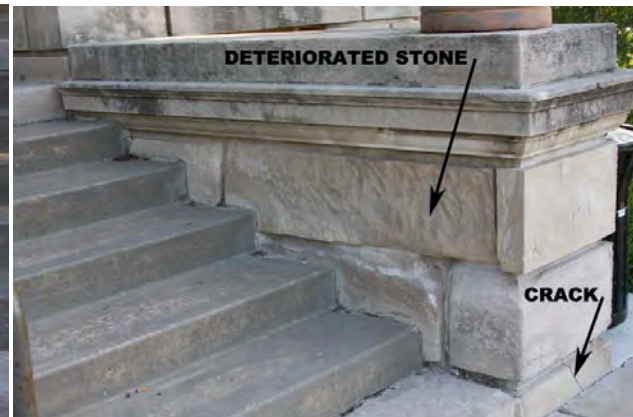
- a. Original south entrance stair walls: Some stones are cracked and deteriorated.

1. The use of deicing salts has likely caused the stone deterioration at stone walls adjacent to site steps. The lack of movement joints in the long site walls at the southeast corner force the horizontal expansion in the wall to accumulate at the corner and crack the stones.
2. Repairs:
 - a. Stairwells: Replace deteriorated stone units and minimize the usage of deicing salts during the cold months.
 - b. Site walls: Install movement joints in the site wall and replace cracked units.
