October 20, 2010

Lawrence, Kansas, 500,000 Gallon Elevated Water Tower  
Full Wash Out Inspection October 12, 2010  
by Ozark Applicators, LLC, Van Buren, MO

# City of Lawrence, Kansas, 500,000 Gallon Elevated Tower, Stratford Tank

**Built By:** Darby Corporation, Kansas City, KS  
**Year Built:** 1954  
**Location:** Lawrence, KS  
**Customer Since:** October 2010  
**Inspected:** October 12, 2010, Wash Out Inspection  
**Inspectors:** Gary Towner, NACE Coating Inspector #17370  
 Derek Hampton, NACE Coating Inspector #17358

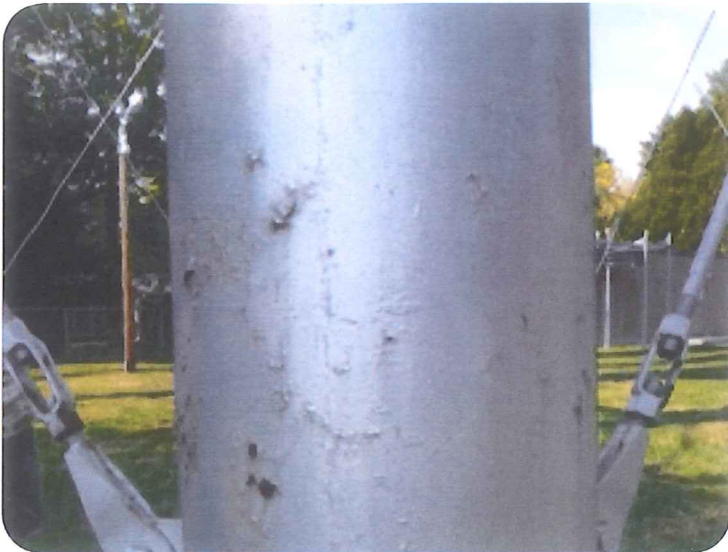
Exterior Coating Peeling off & Rust Present

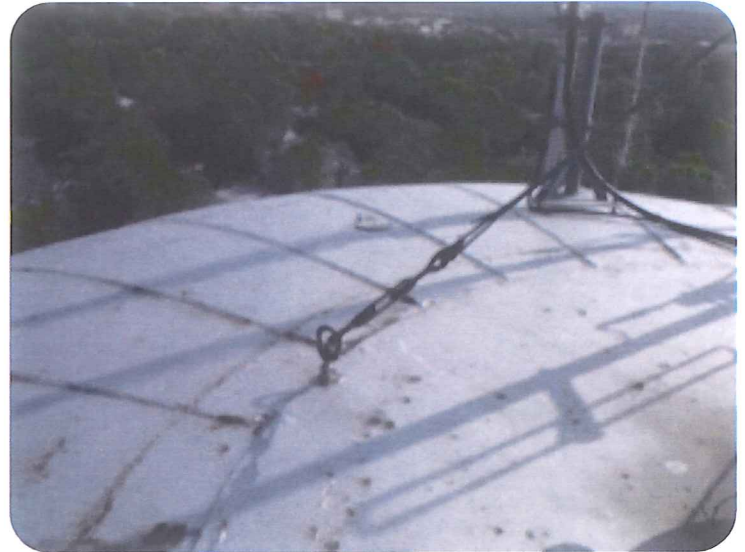
Exterior Coating on Top of Tank Peeling off & Rust Present

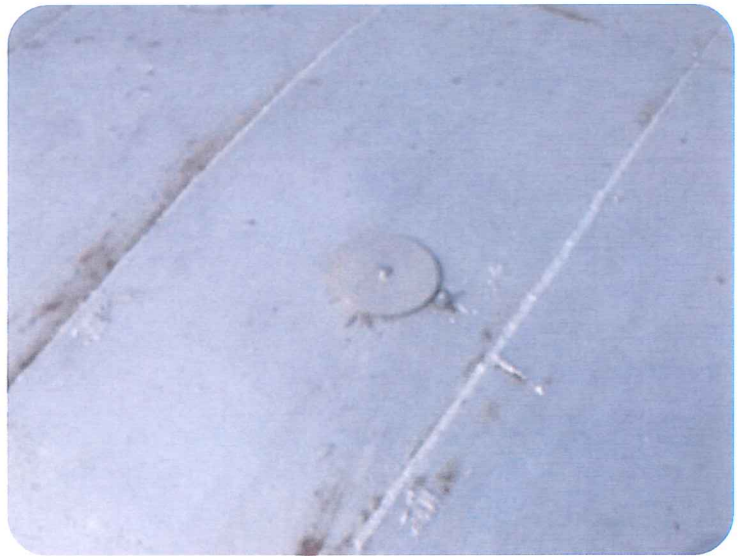
Exterior Coating on Top of Tank/Rust/Cathodic Plates that need to be Welded Shut due to Gaps

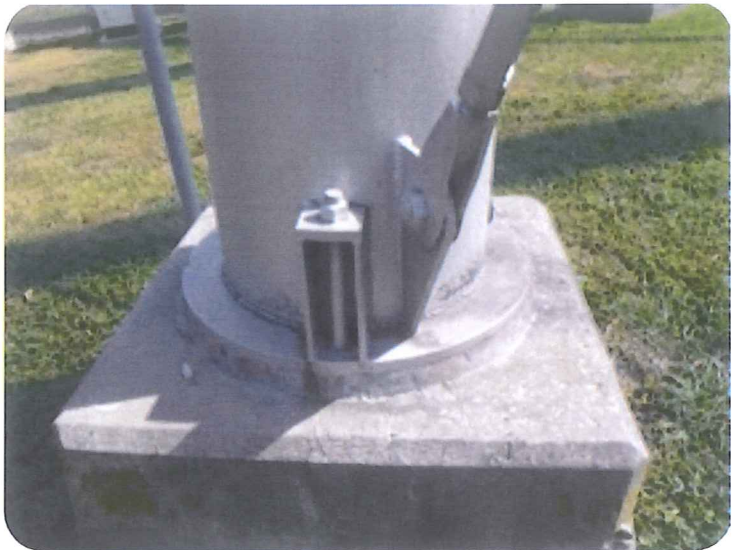
Anchor Bolts & Foundation

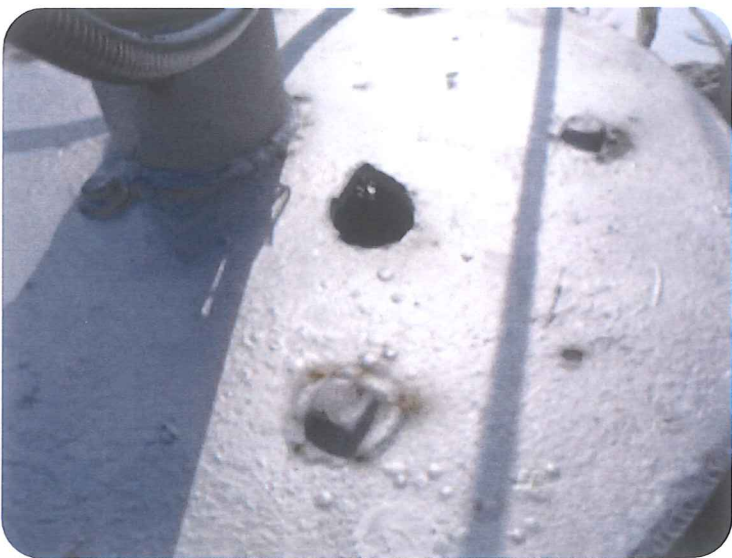
Holes in Vent

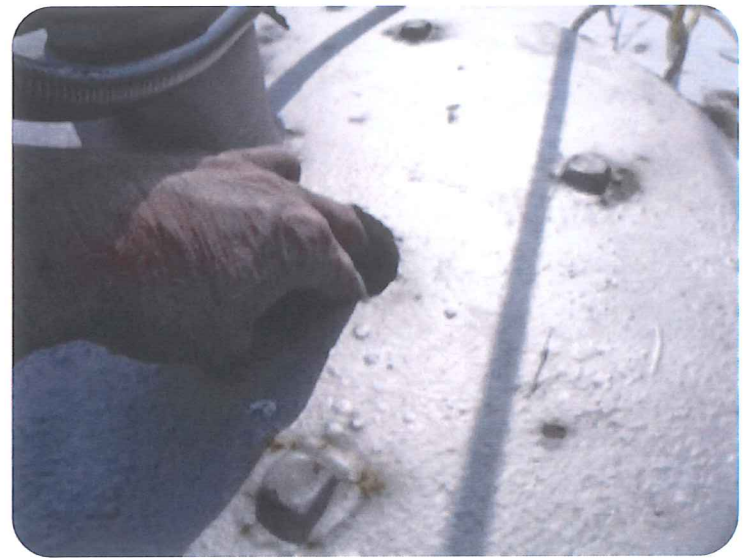
Holes in Vent

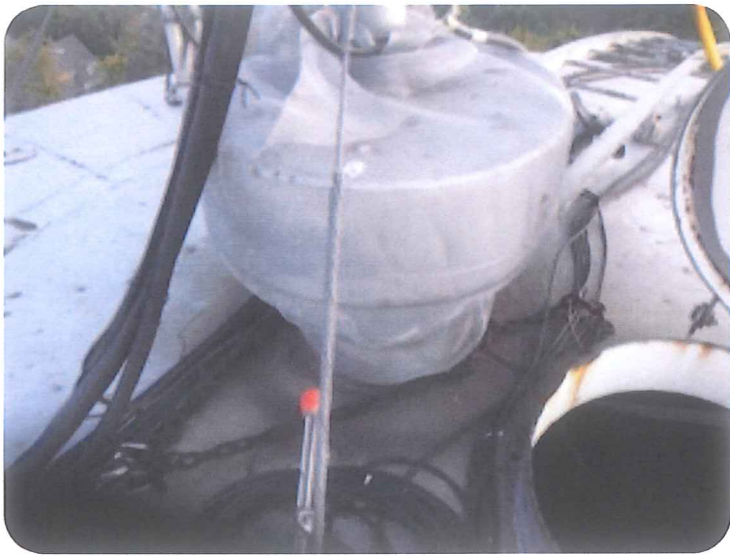
Vent System with Temporary Screen Wrap

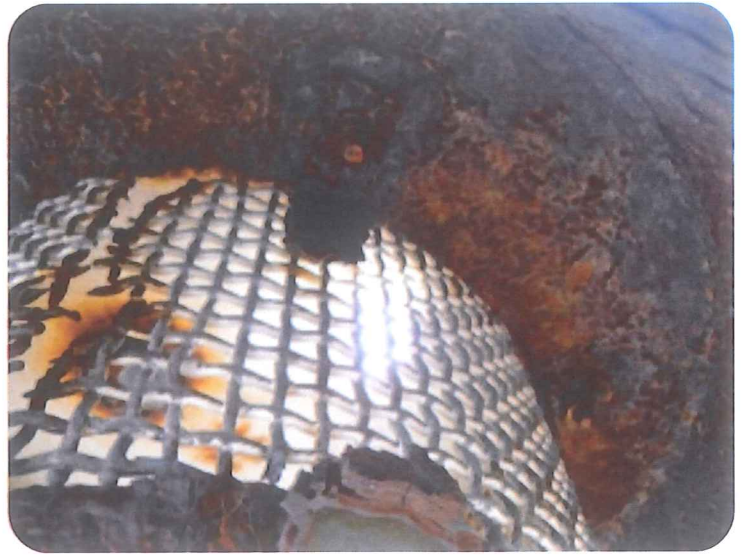
Windrods	There are 3 sets of windrods, 2 sets of struts, and 8 sets of belly rods. They are tight.	
Vent	The vent system is in poor condition and needs to be replaced as soon as possible. There are gaps and a big hole in the top of the vent and the screen is corroded with rust. We wrapped screen wire all around the vent, as a temporary fix, but this area needs to be addressed before spring. The vent stack is 46".	Install a new frost proof vent. Inspect the vent annually per DNR recommendations.
Vent Screen	The vent screen was deteriorated. We wrapped screen wire all around the vent, as a temporary fix, but this area needs to be addressed before spring.	Inspect the vent screen annually per DNR recommendations.
Upper Roof Hatch	There is a 24" round roof hatch. It has a 6" raised lip. We installed a gasket on the hatch and the hatch fits tight. The hatch is locked.	Inspect the hatch annually per DNR recommendations.

Underneath Vent & Vent Screen Corroded with Rust

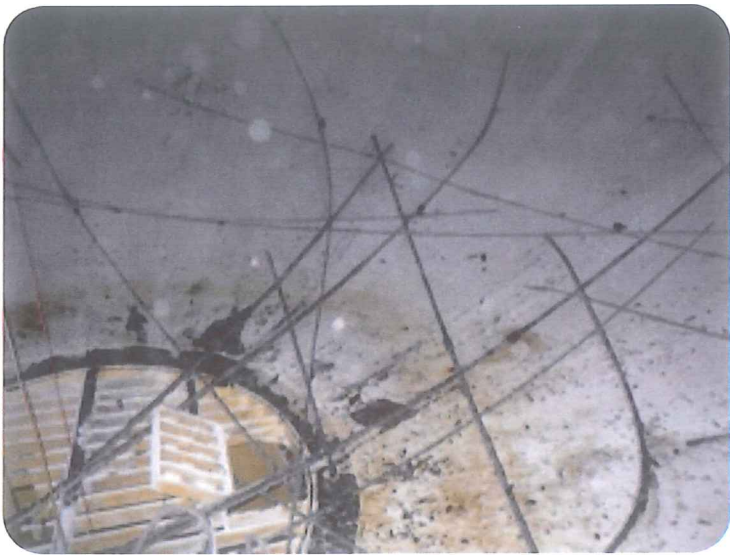
Bottom of Wet Bowl, Rust on Surface of Tank, & Broken Cathodic Rods that we Cleaned Out

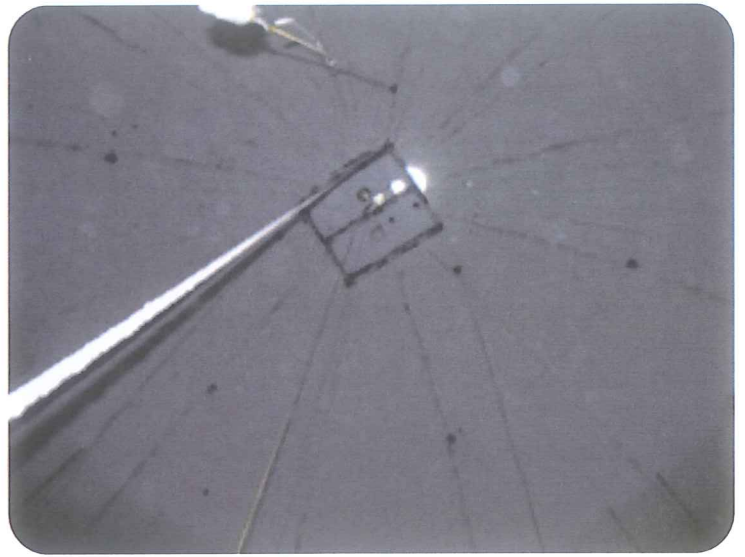
Landing Area in Top of Tank is Rusted & Corroded

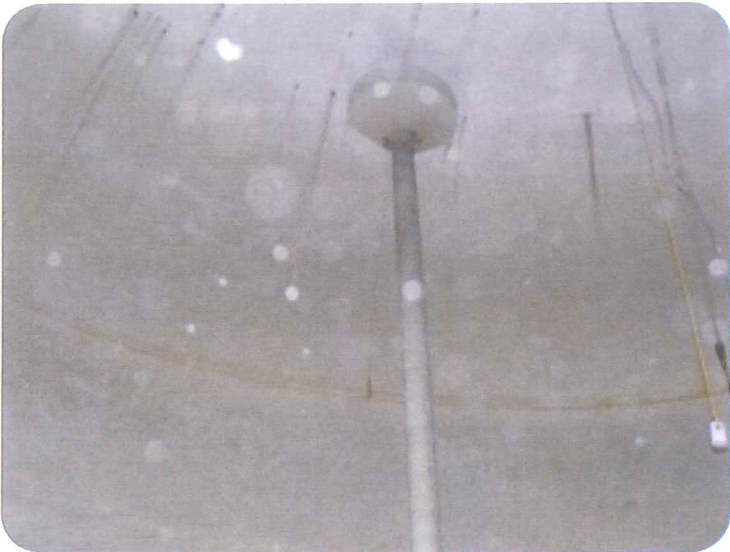
Rust Spots on Ceiling of Tank

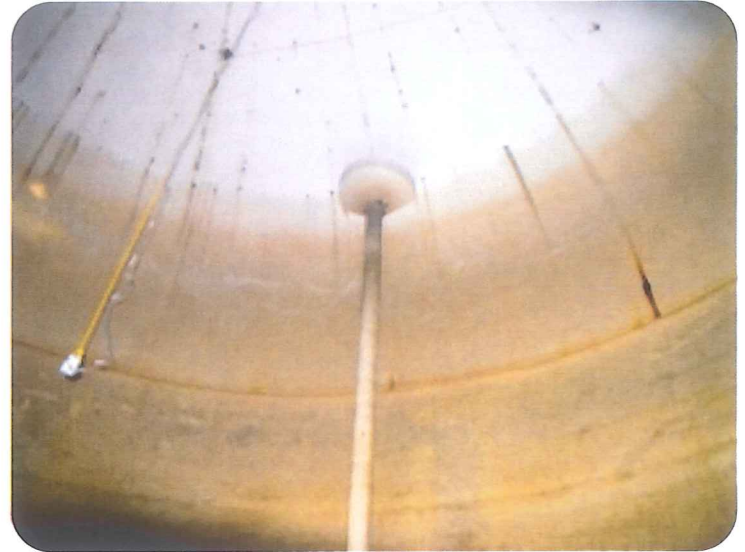
Rust Spots on Ceiling of Tank

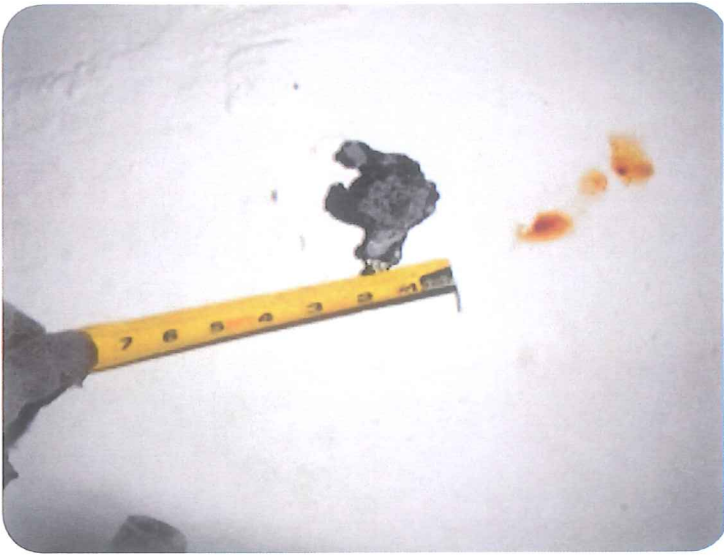
Paint Blistering Off Interior Walls

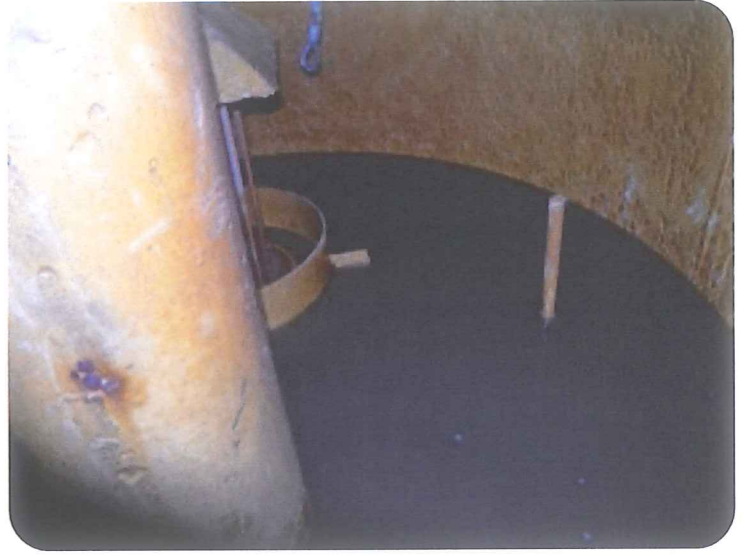
Overflow Pipe/Sludge in bottom of Tank Prior to Cleaning

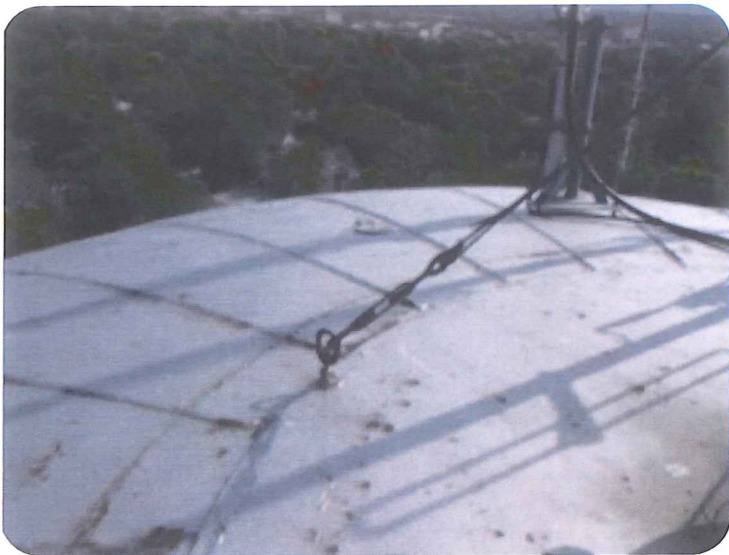
Rooftop Surface with Paint Deteriorating & Rust Present
