Example Defect – Identified in Lawrence (June 3rd, 2014)

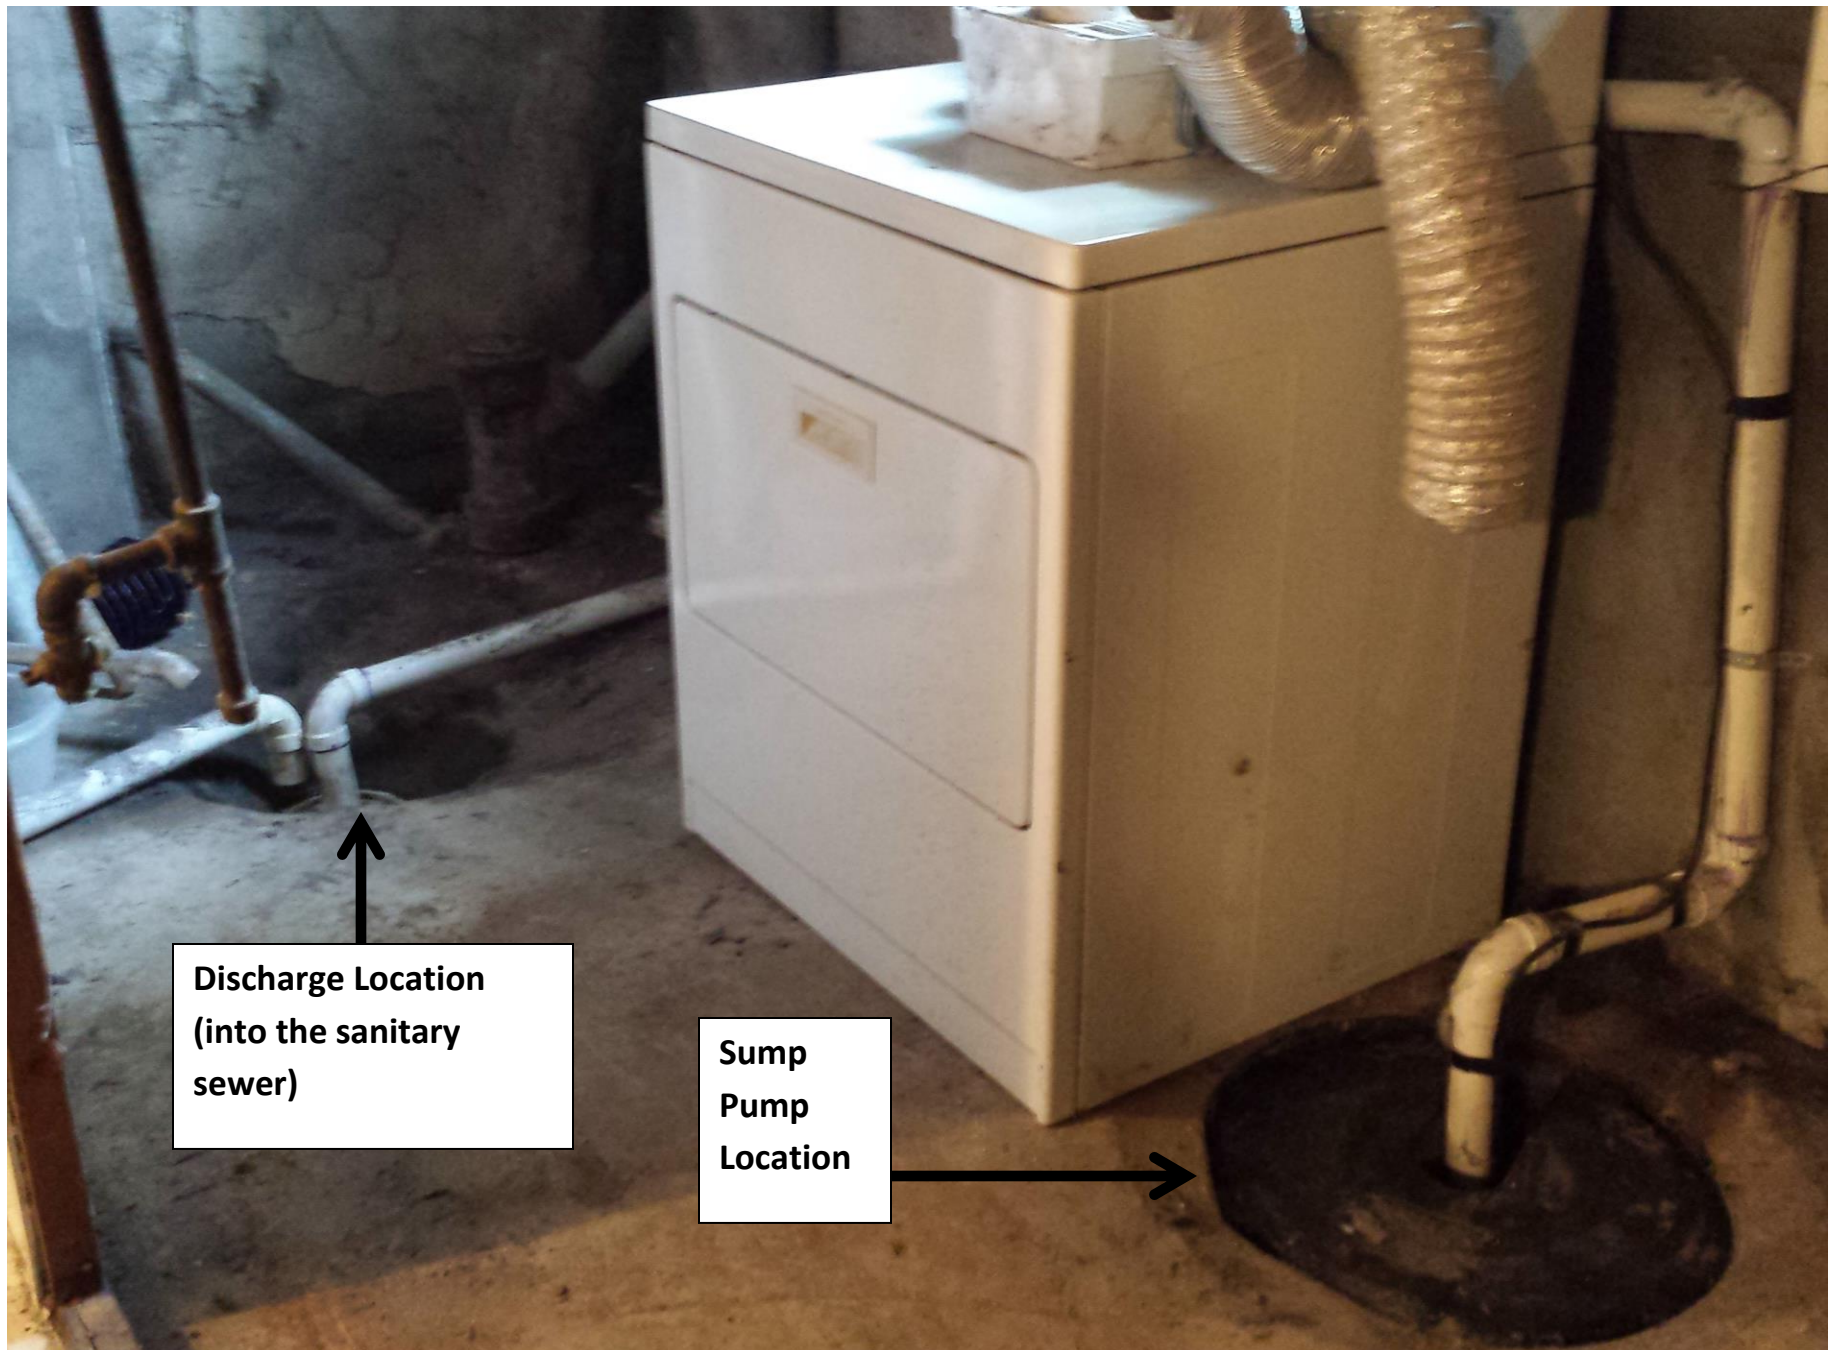
**Discharge Location
(into the sanitary
sewer)**

**Sump
Pump
Location**
