Reference: Bioscience and Technology Business Center  
West Facility  
Located on Bob Billings Parkway - Lawrence, Kansas

## 4950 Research Parkway

### Existing Roof Report and Budgets to Replace

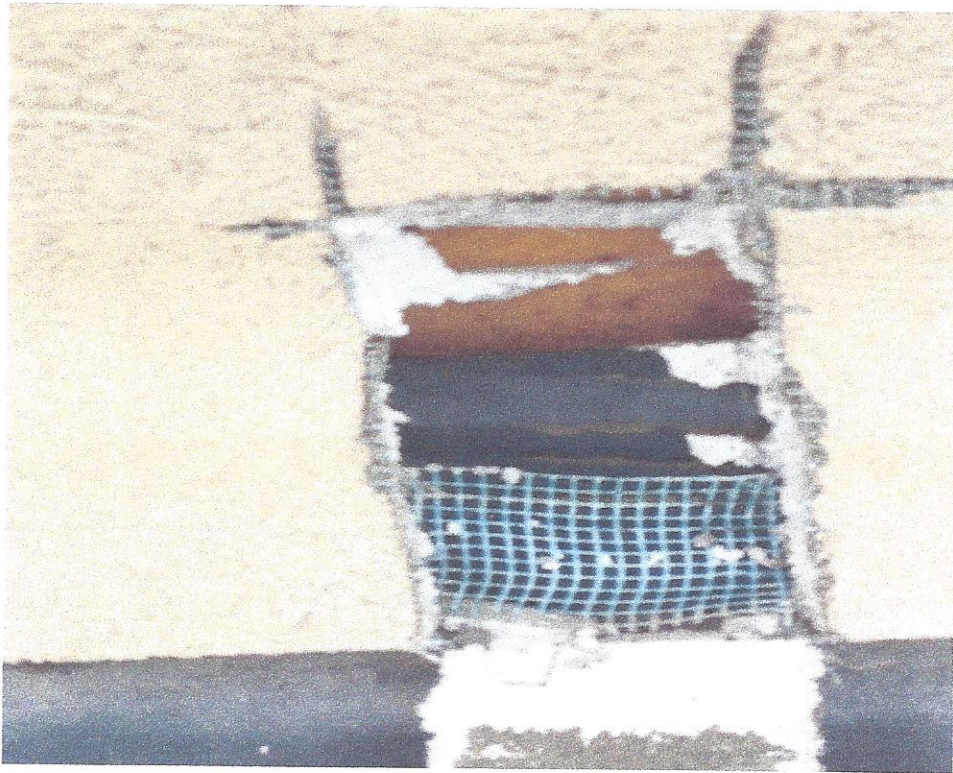
The ballasted EPDM roof was flashed up and under the EFIS (Exterior Finished Insulated System). The roof membrane was not secured to the back-up wall properly at the time of installation. With the shrinkage of the membrane; the EFIS wall covering was pulled away from the back-up wall and fractured the insulation in this assembly. As you can see in the photo, any water that get into the EFIS wall system will run down the back up wall and directly behind the roof membrane flashing and into the roof assembly and subsequently into the building.

At the very least, when a new roof assembly is installed, the EFIS system will have to be cut back a minimum of 10-12 inches above where the base of the system is currently. A second and better option would be to remove the EFIS system above the roof membrane areas and replace decorative insulated wall panels. This would eliminate needed repairs to the EFIS system in many areas around the facility.

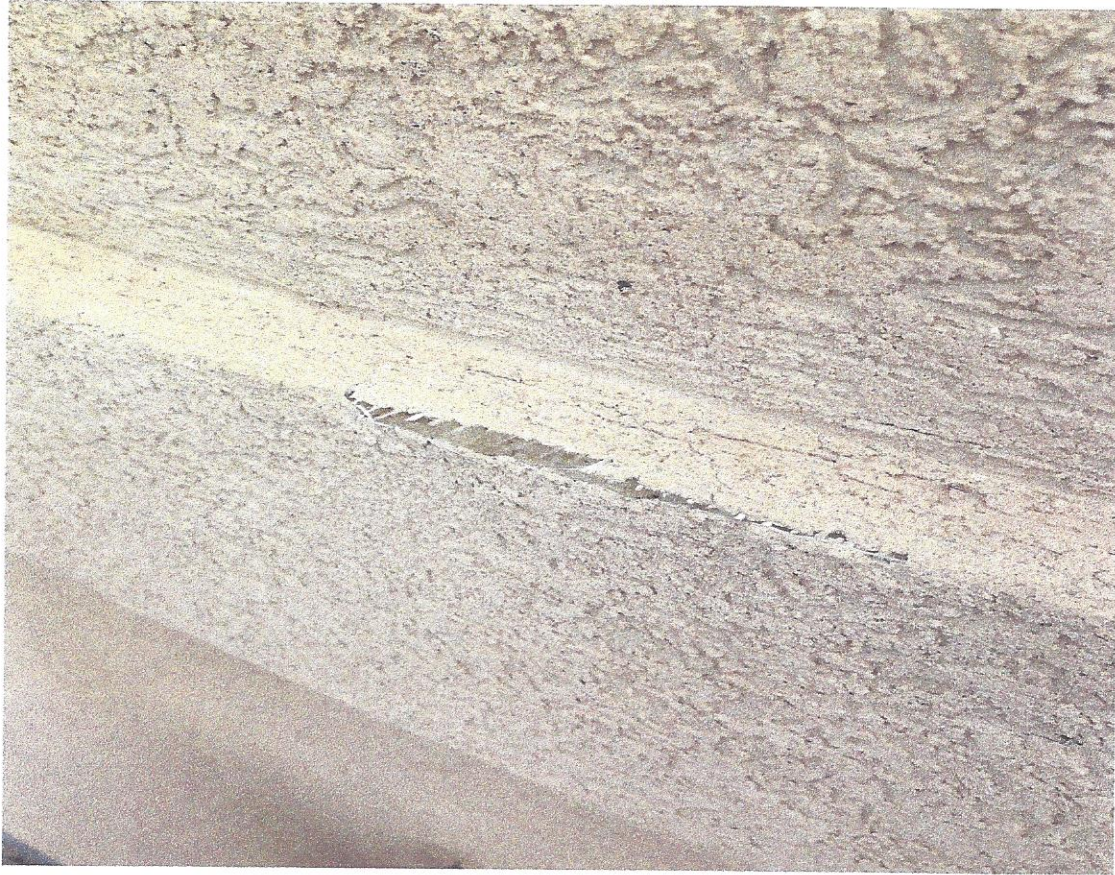
There are many areas around the EFIS wall assembly that are open and allowing water to enter the assembly. This also allows the insulation to get wet causing it to lose its insulating properties as well as freeze up in the winter causing further damage to the EFIS.

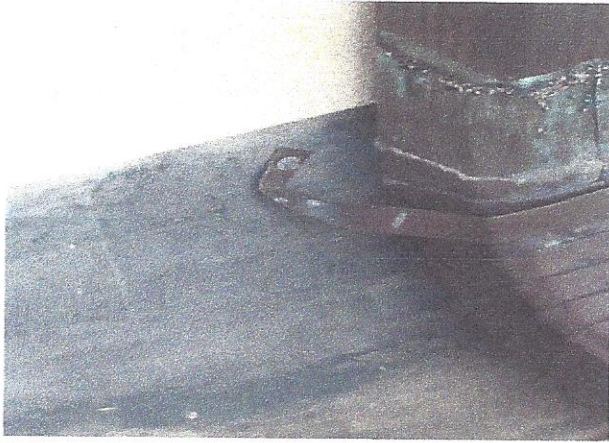
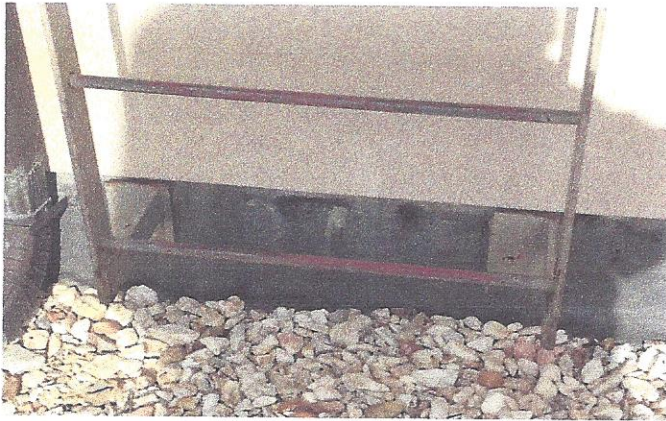
When secondary items were installed, mechanical fasteners were run directly through the base flashings of the membrane. This should never happen. These types of details would be corrected at the time of the new roof.

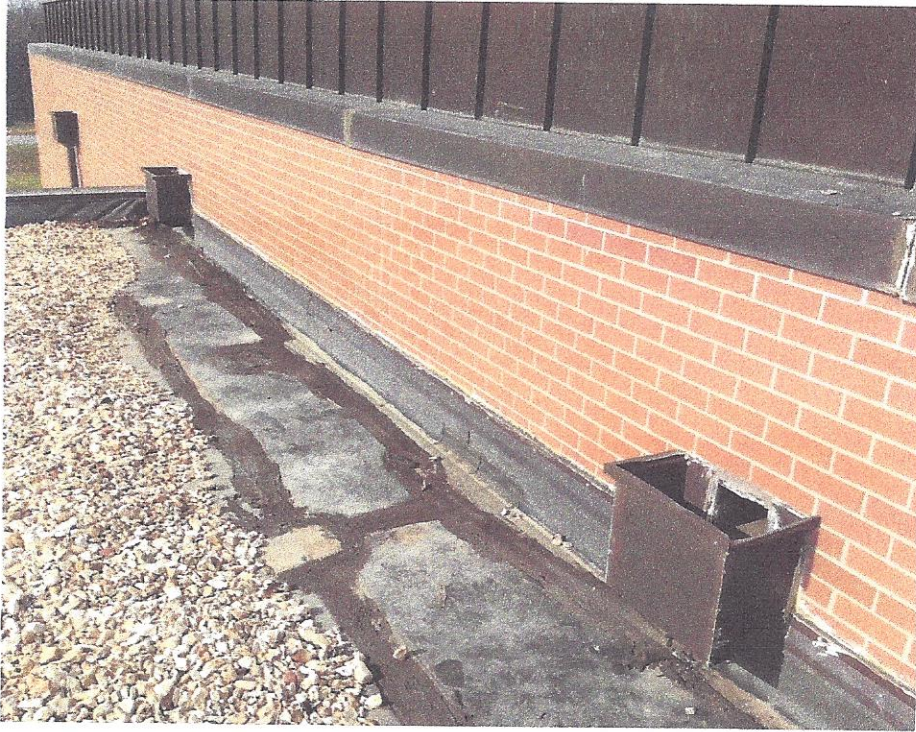
The short masonry wall on the south side of the facility appears to have the weep holes in the brick covered up by the existing roof; or they were never installed. This is another area where the interior could be showing up as a leak. It appears that someone attempted roof repairs on the membrane with an asphalt product that is not supposed to be used on this type of roof.

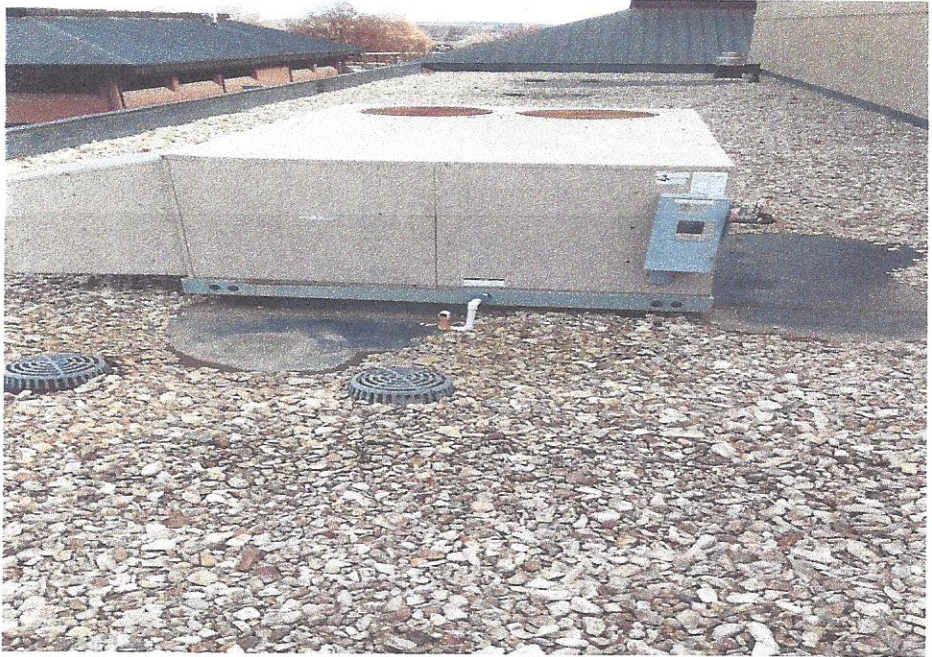
The mechanical unit on the north roof area is not high enough above the roof to flash properly. This unit would need to be raised about six to eight inches above the existing height. NRCA recommends that all mechanical curbs be a minimum of eight inches.

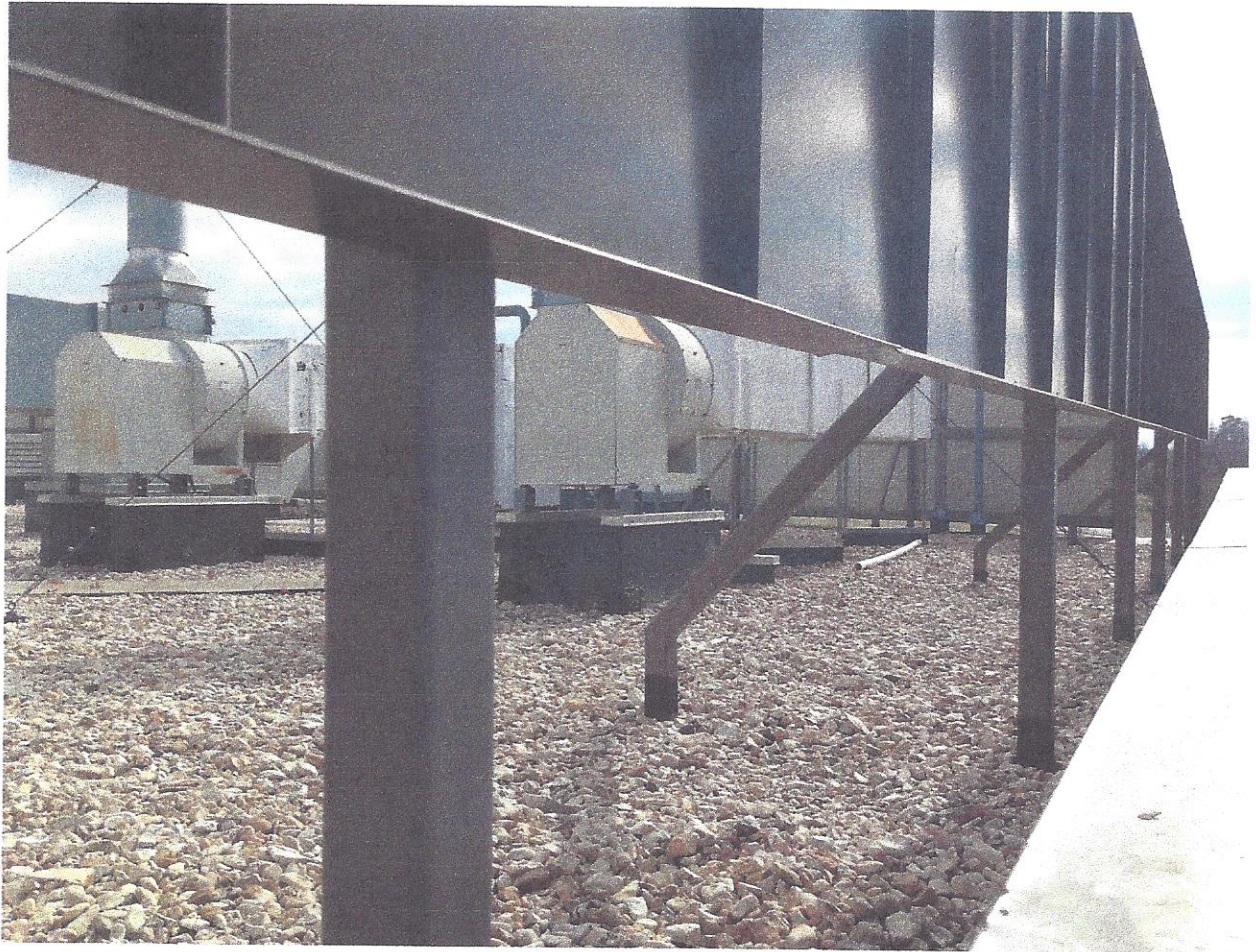
The upper roof has many different penetrations that will have to be flashed. This area will be very time consuming with all of the specific details work. It will be critical that all flashings are properly designed and installed to keep this area dry and maintenance free.
