DGM Consultants, P.A.

FIELD REPORT #01

Project	Carnegie Library	Date	5/15/2012 DGM Project # 2012014
Location	9 th and Vermont Lawrence, Kansas 66044	Contractor	The Garland Company, Inc
To	Mr. Lynn Applegate , Bldg & AquaticsSup City Of Lawrence 6 East 6th Street Lawrence, Kansas 66044	Owner	City of Lawrence
FAX		Weather	Sunny, 60-84°F
		Present	Greg Leslie Lynn Applegate
		PN	PO 005556

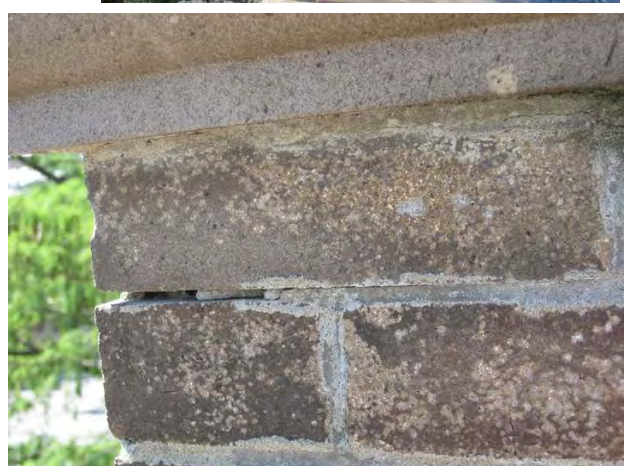
- (1) At the end of the original return wall we noted some open mortar joints in the brick.

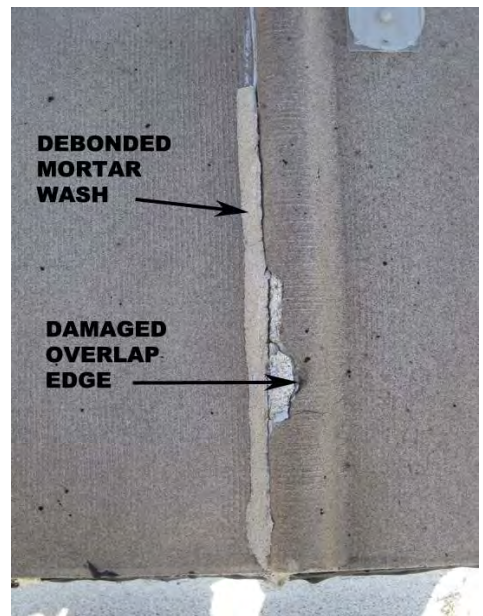
- c. West wall (36'-5"): Wall is capped with 25 terra cotta coping units, plus three pieces at the corner, from the original building that was replaced by this addition. These terra cotta coping units are in good condition, except for several chipped units and open joints.

The coping at the northwest corner has been made by mitering three original pieces.

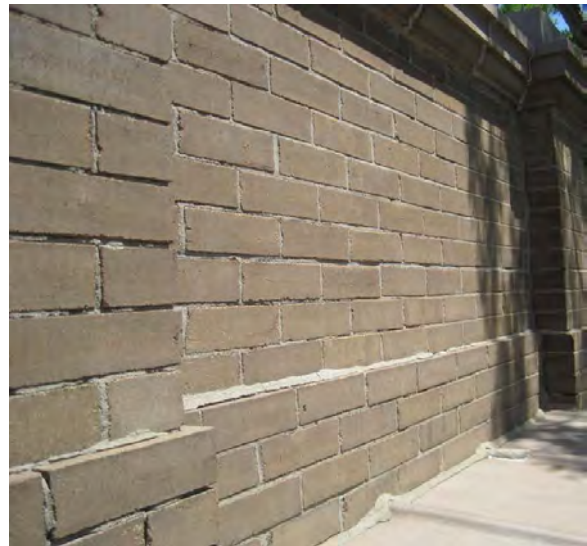
- (2) Parapets
 - (a) Some parapets were accessed with a ladder
 - (b) Eastern
 - i) Accessed with a ladder.
 - ii) Narrow mortar joints are weathered. Some pointing has failed. Watertable is in good condition, but some open joints were noted.

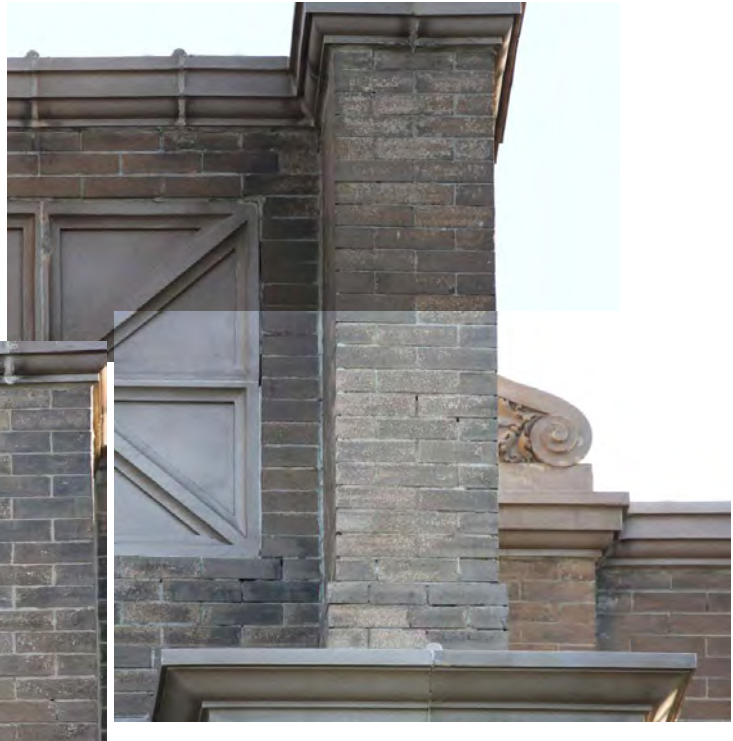
- (c) Center section: Masonry appears to be in good condition, except for some open joints between the bricks and the inlaid panels and mortar joints.

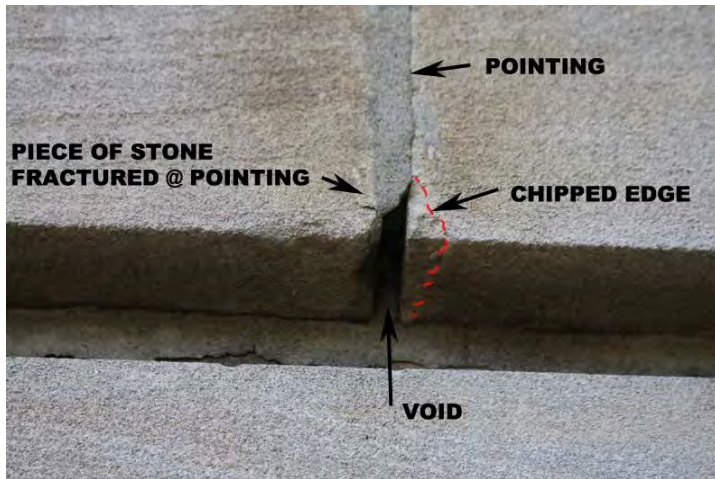
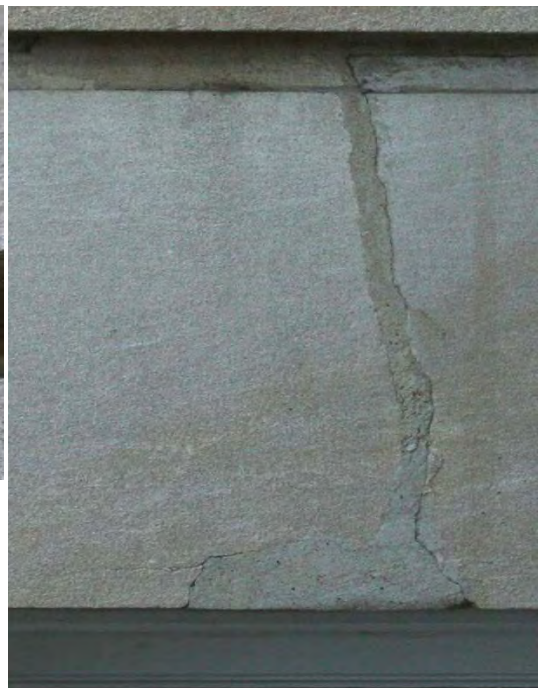
- (b) Signs of moisture coming through terra cotta joints were noted at the inside corner below the watertable.
- (c) Cracked lintels were noted at two basement openings. One crack extends up into the brick wall. Previous pointing and crack repairs,

near this location, are a concern. The pointing repair seems to be too shallow and as a result the edges of the stone foundation wall are cracked and chipped. Reference photos at the top of the next page. No guardrail at lower level stairwell.

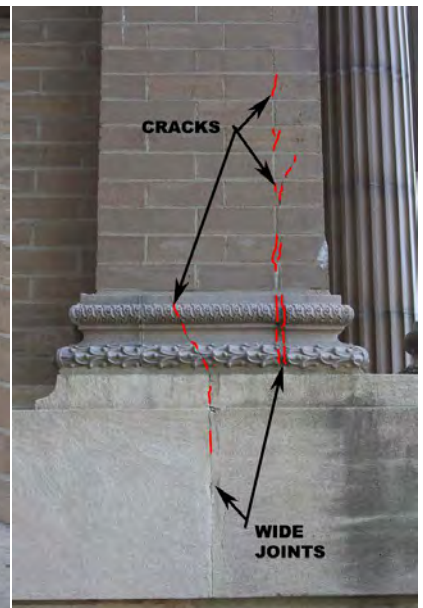
- (4) South Entrance
 - (a) The right terra cotta column capitals appear to be in excellent condition. One slightly chipped detail was noted.
 - (b) The base of the left wall corner is cracked on the west and south faces. Previous repairs have addressed the older cracks, but some cracks appear to be newer than the last repairs.

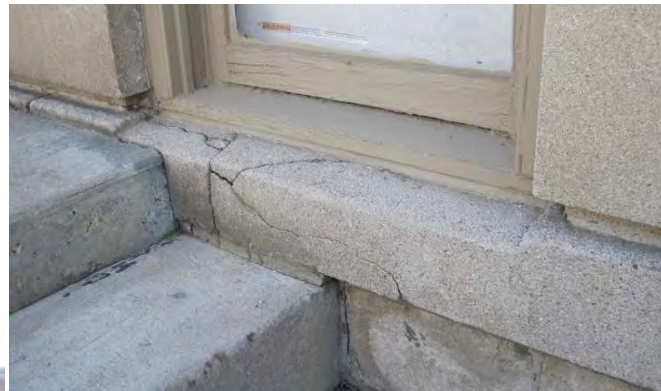
- (e) Cracked cast stone sill, at head of basement stair, is cracked
- (f) A stones in the stairwell

foundation wall is severely deteriorated.

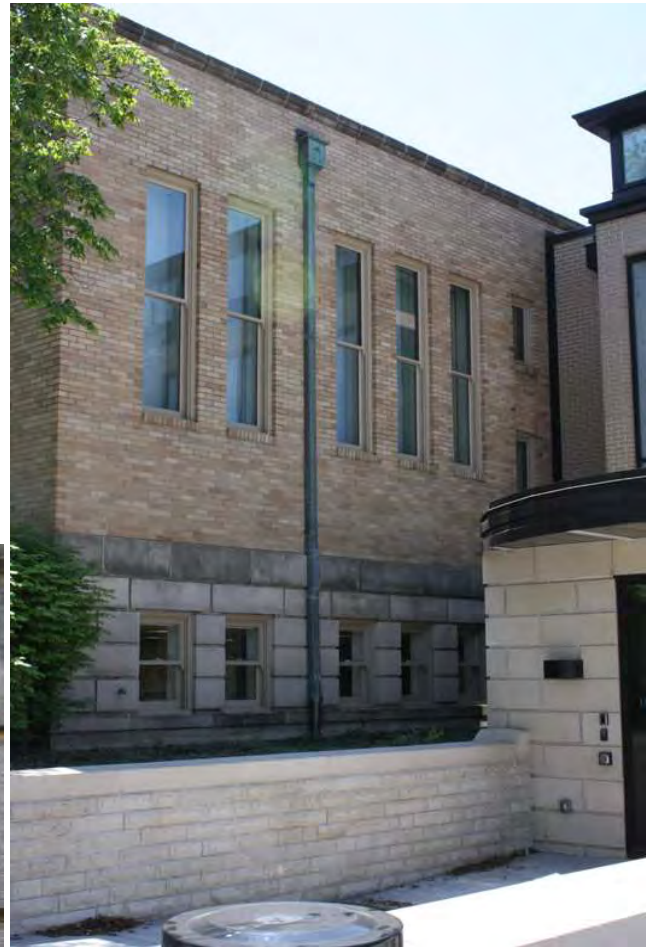
- d. North elevation
 - (1) 1937 Addition
 - (a) Western portion of elevation is partially visible from the northwest. Noted concerns were previously discussed.
 - (b) Eastern portion of north elevation is more visible from the northeast. Lintels were noted to be rusted along this elevation.

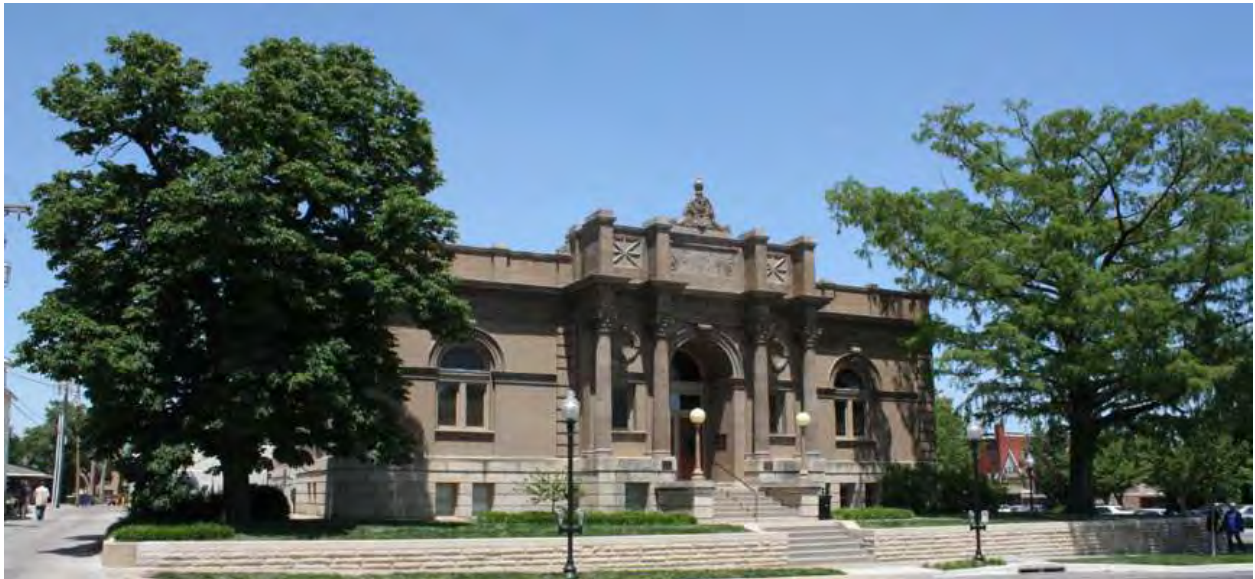
- c. Trees: The original building has two trees at the south elevation. The trees are located just off of the two corners about 16 to 17 feet (at about a 45 degree angle). The southeast tree is about 36 inches in diameter and the southwest tree is about 24 inches in diameter.

1. The two large trees on the south side of the building are likely desiccating the soil (drying it out) deep below the surface and even under the building beyond the tree's drip line. This in turn causes the soil to shrink and expand depending on the soil moisture content. The type of cracking on the west wall of the original building indicates that the corner of the building near the tree has settled enough to cause the southwest corner of the building to rotate southward, cracking the top of wall, opening the width of the window opening enough that the arch has partially failed, and cracking the wall below the window.
2. Repair
 - a. Option 1: Maintain consistent moisture content especially around trees.
 - b. Option 2: Remove trees
