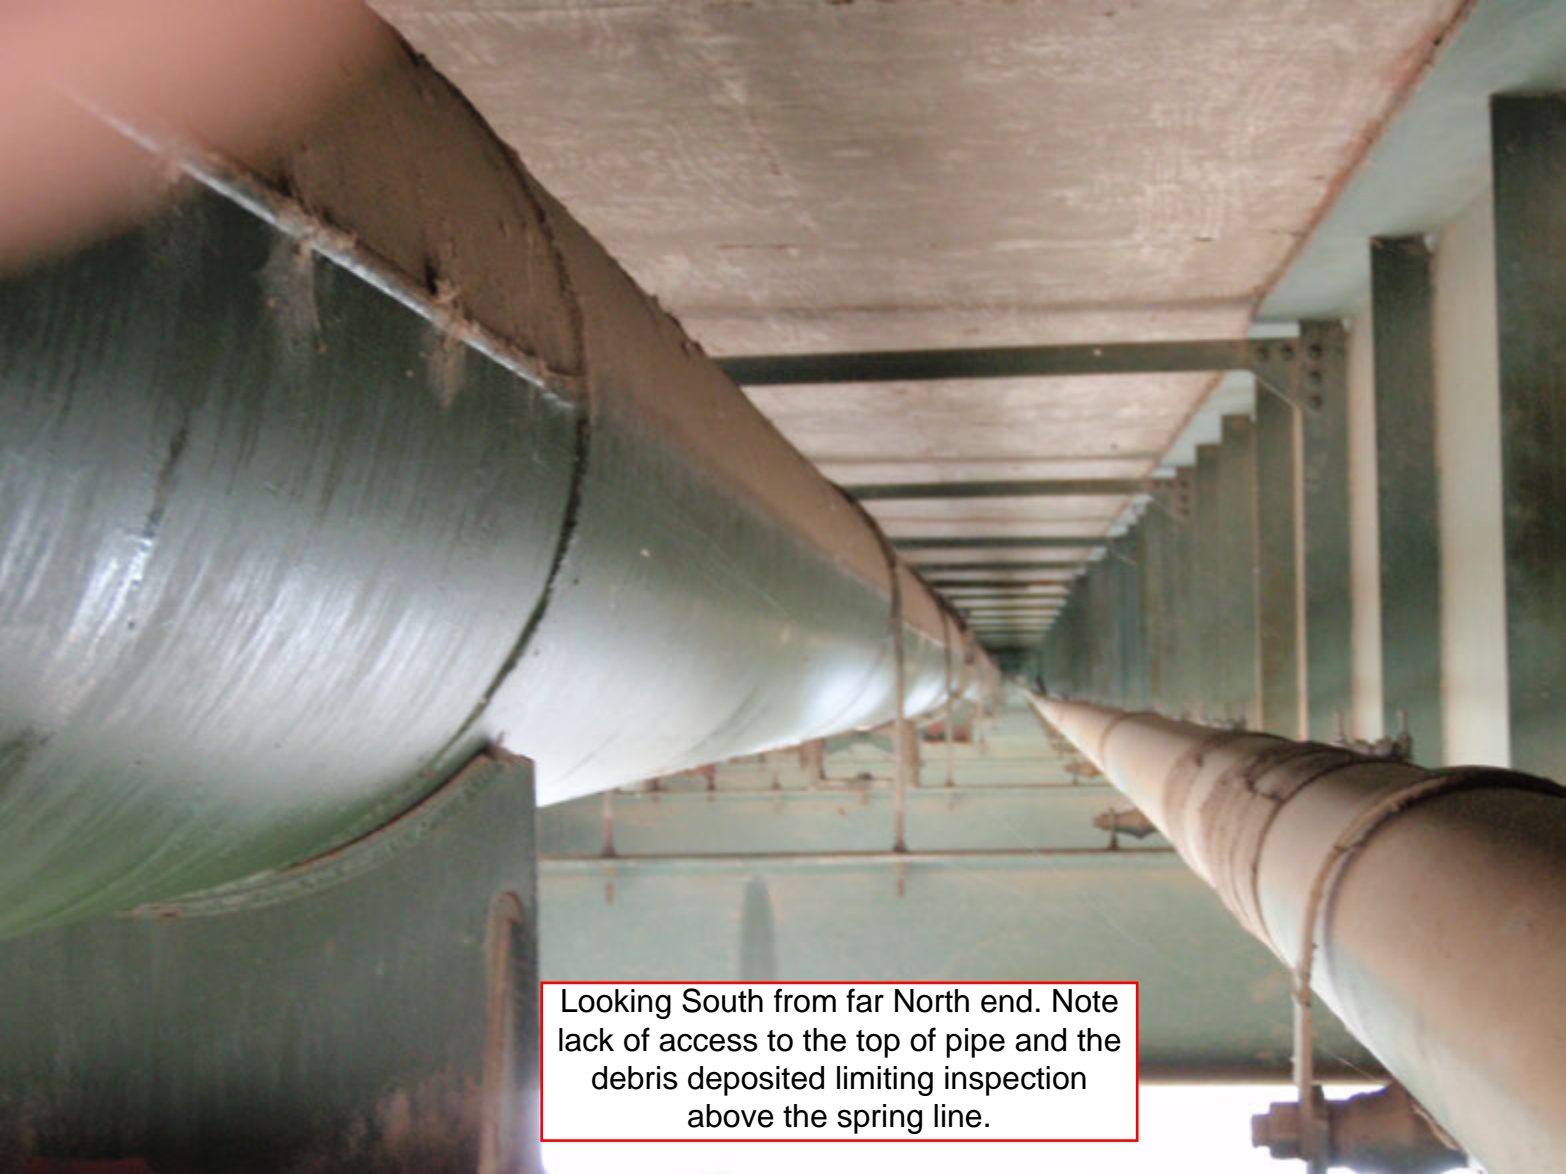
Looking South from far North end. Note lack of access to the top of pipe and the debris deposited limiting inspection above the spring line.

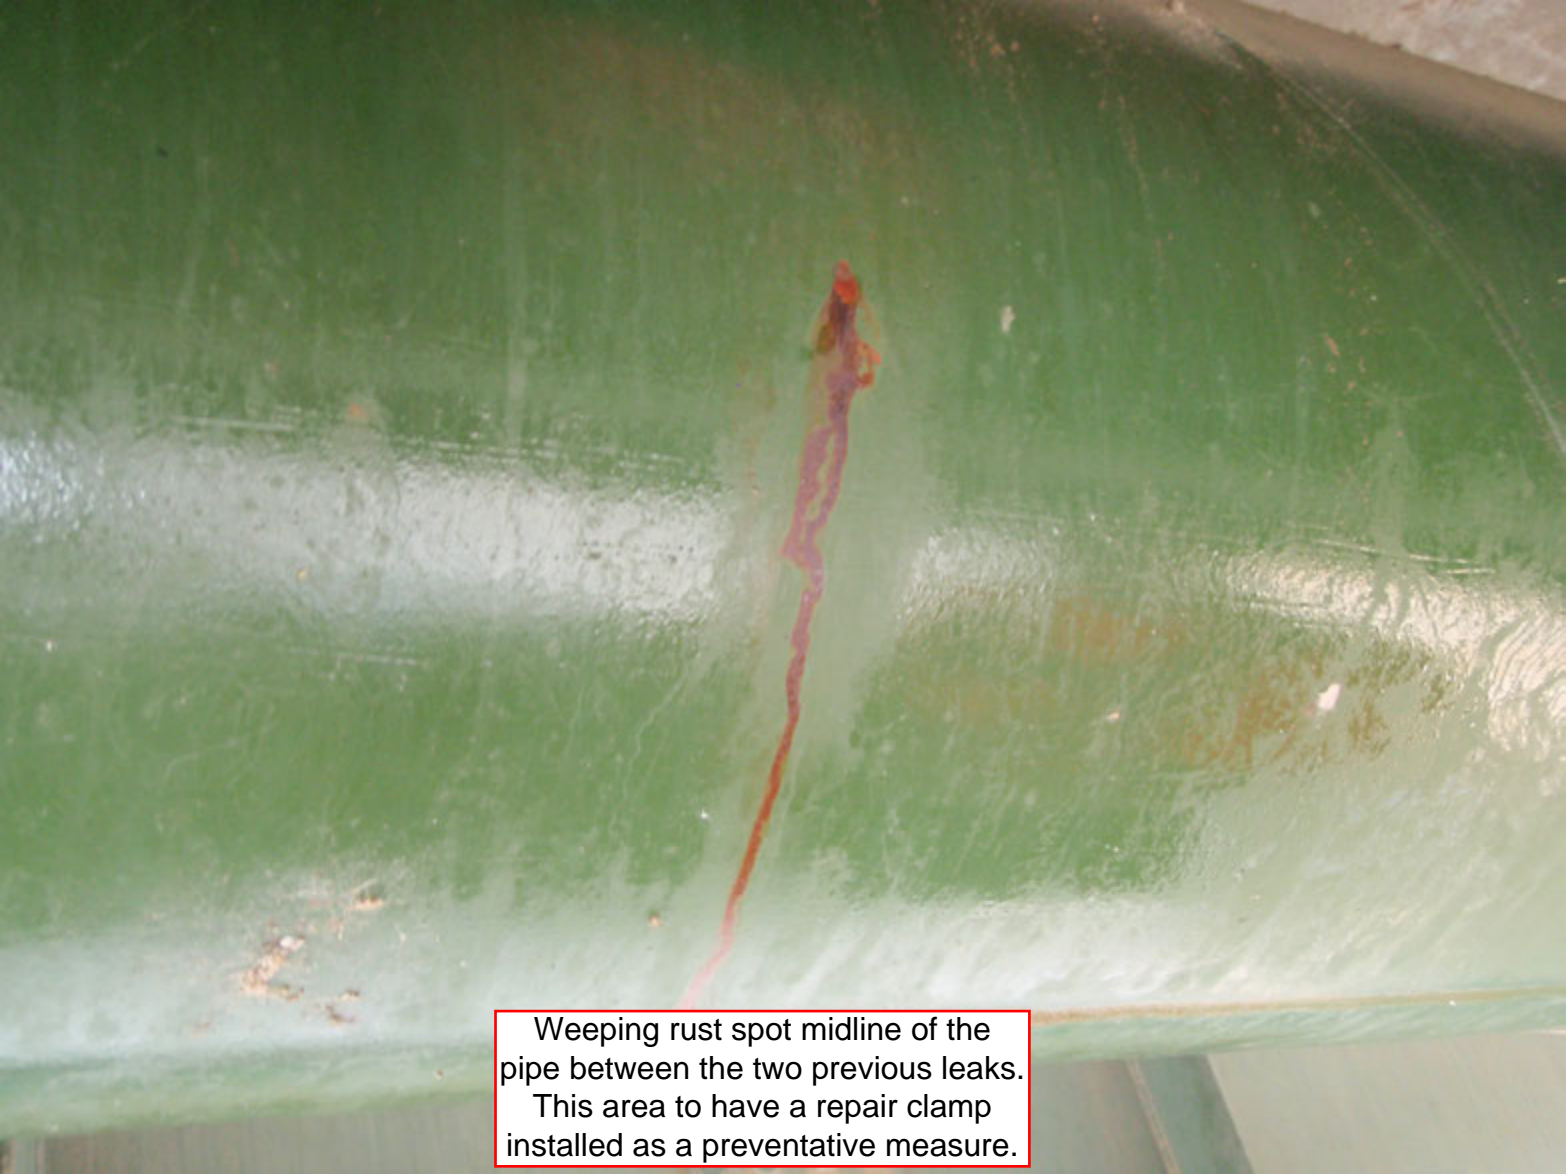
Weeping rust spot midline of the pipe between the two previous leaks. This area to have a repair clamp installed as a preventative measure.

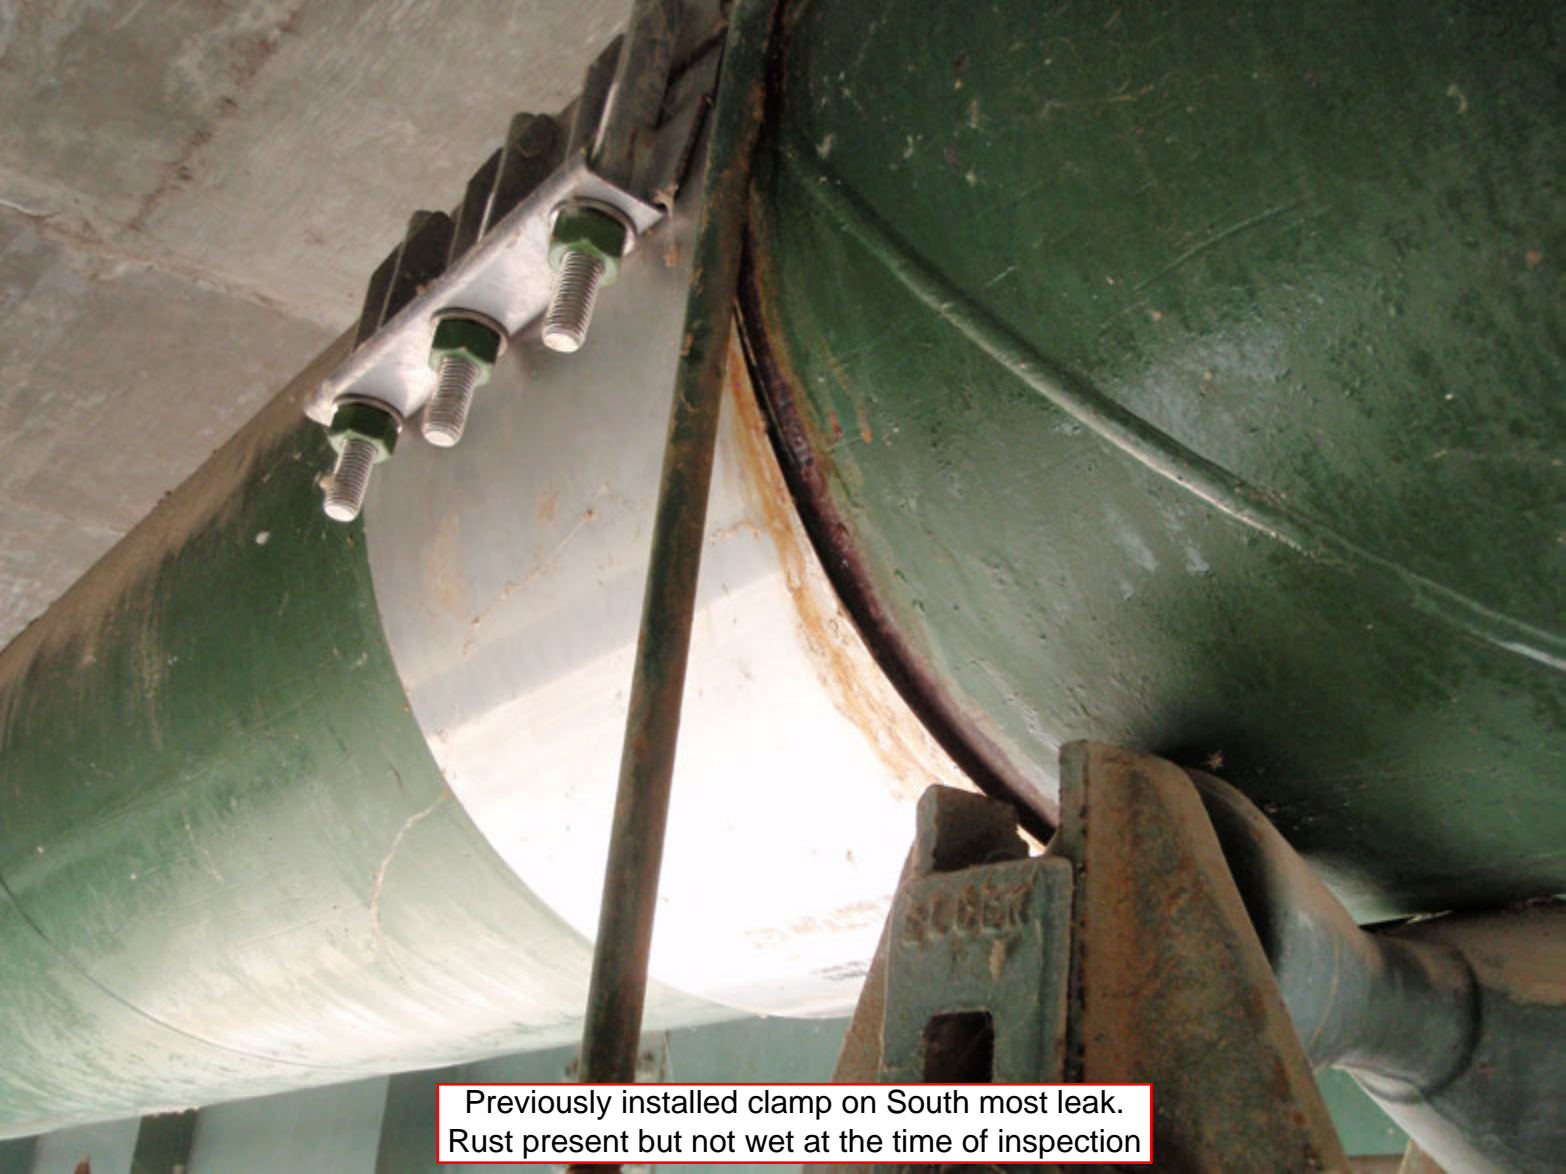
Previously installed clamp on South most leak.  
Rust present but not wet at the time of inspection

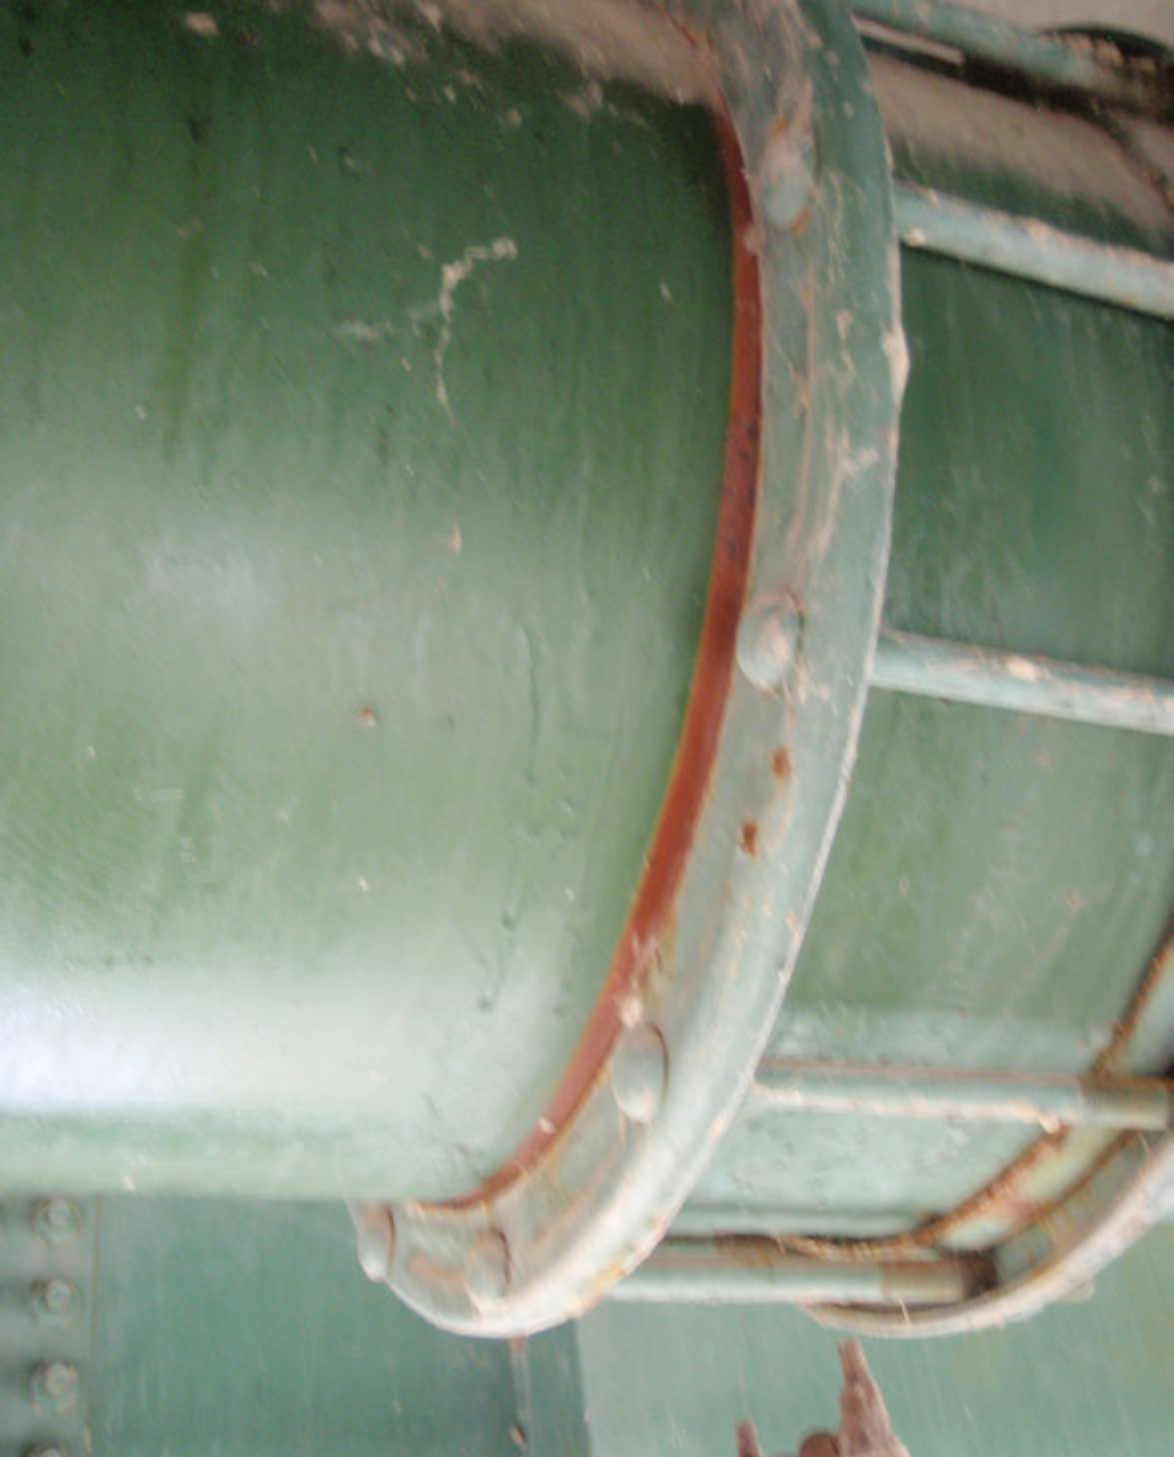
Coupling offset since coating. No evidence of leakage. Only one seen like it.

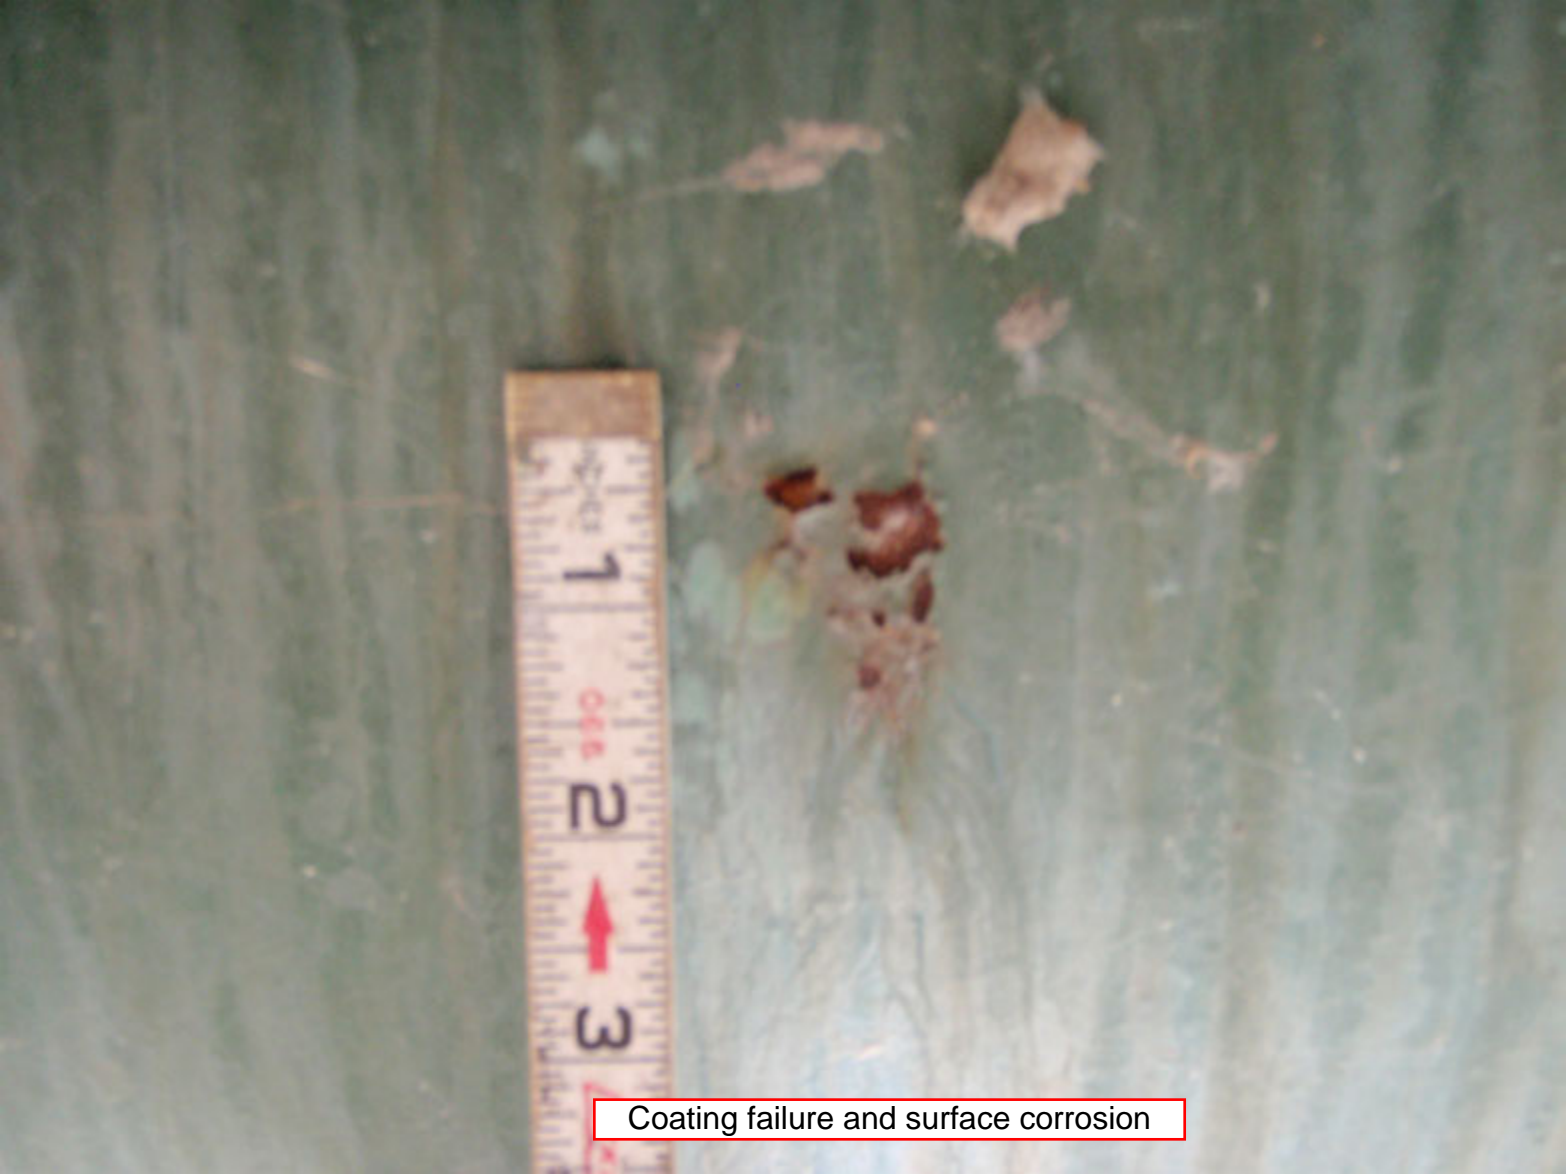
Coating failure and surface corrosion

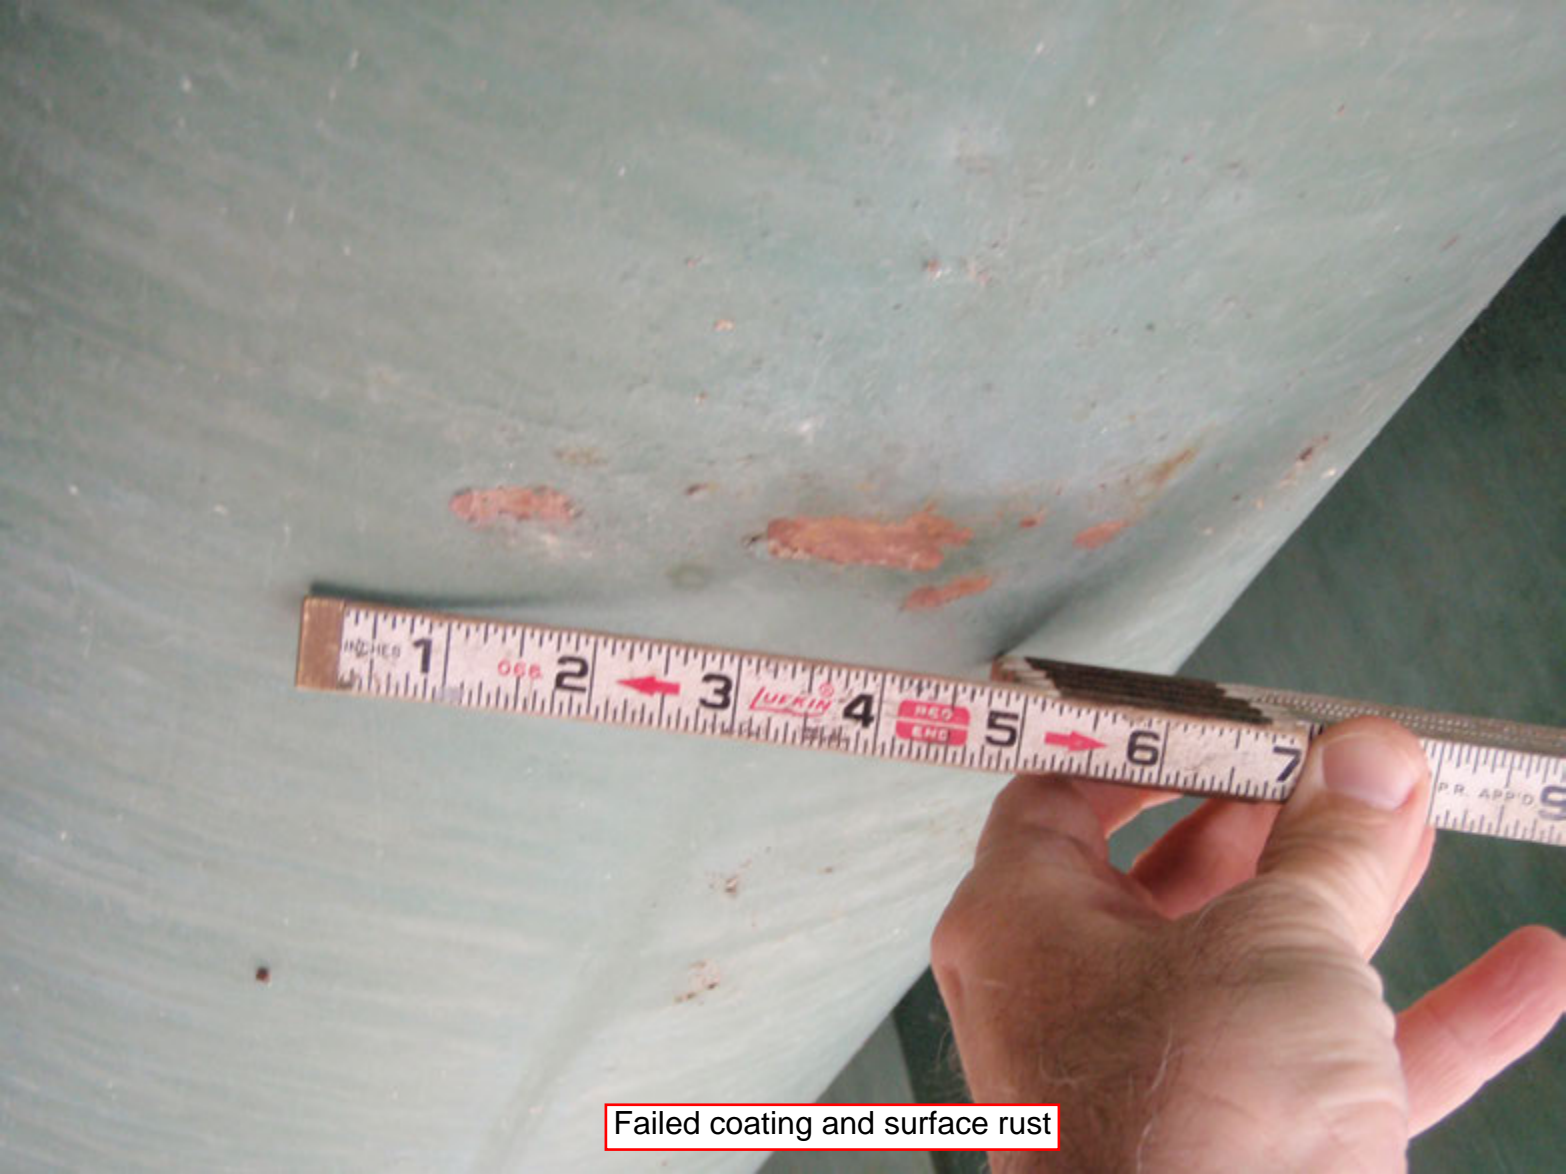
Failed coating and surface rust

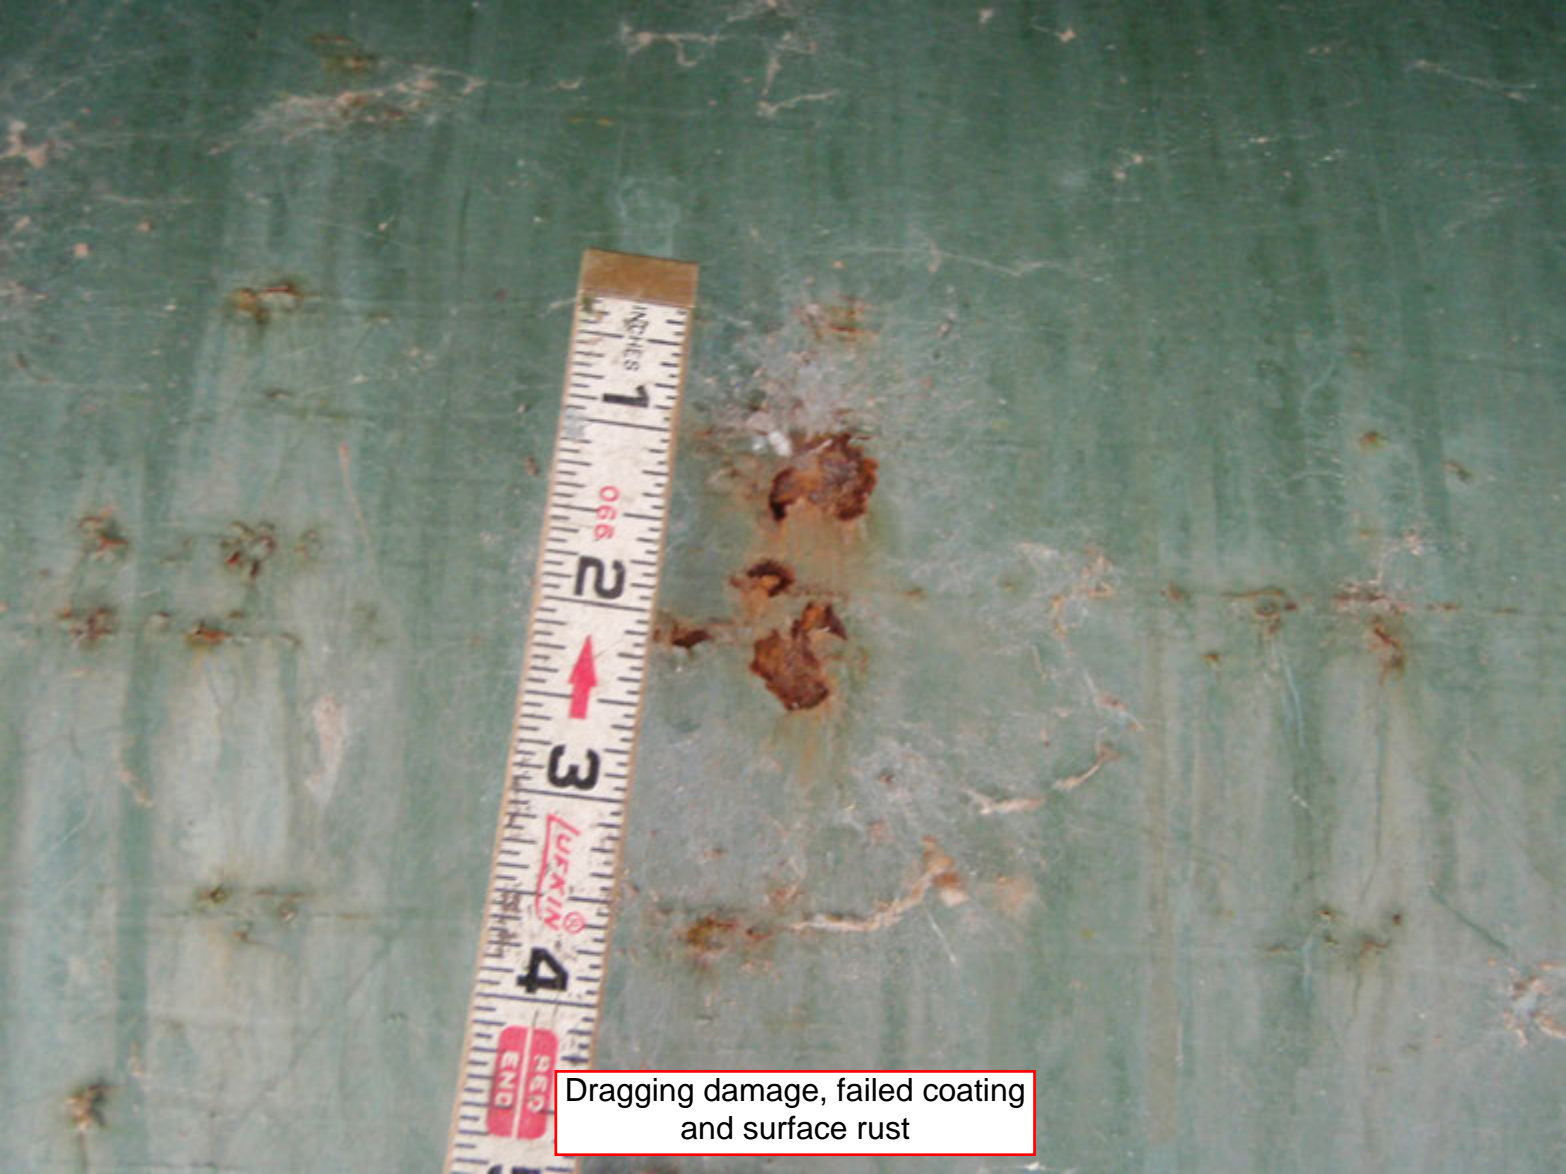
Dragging damage, failed coating and surface rust

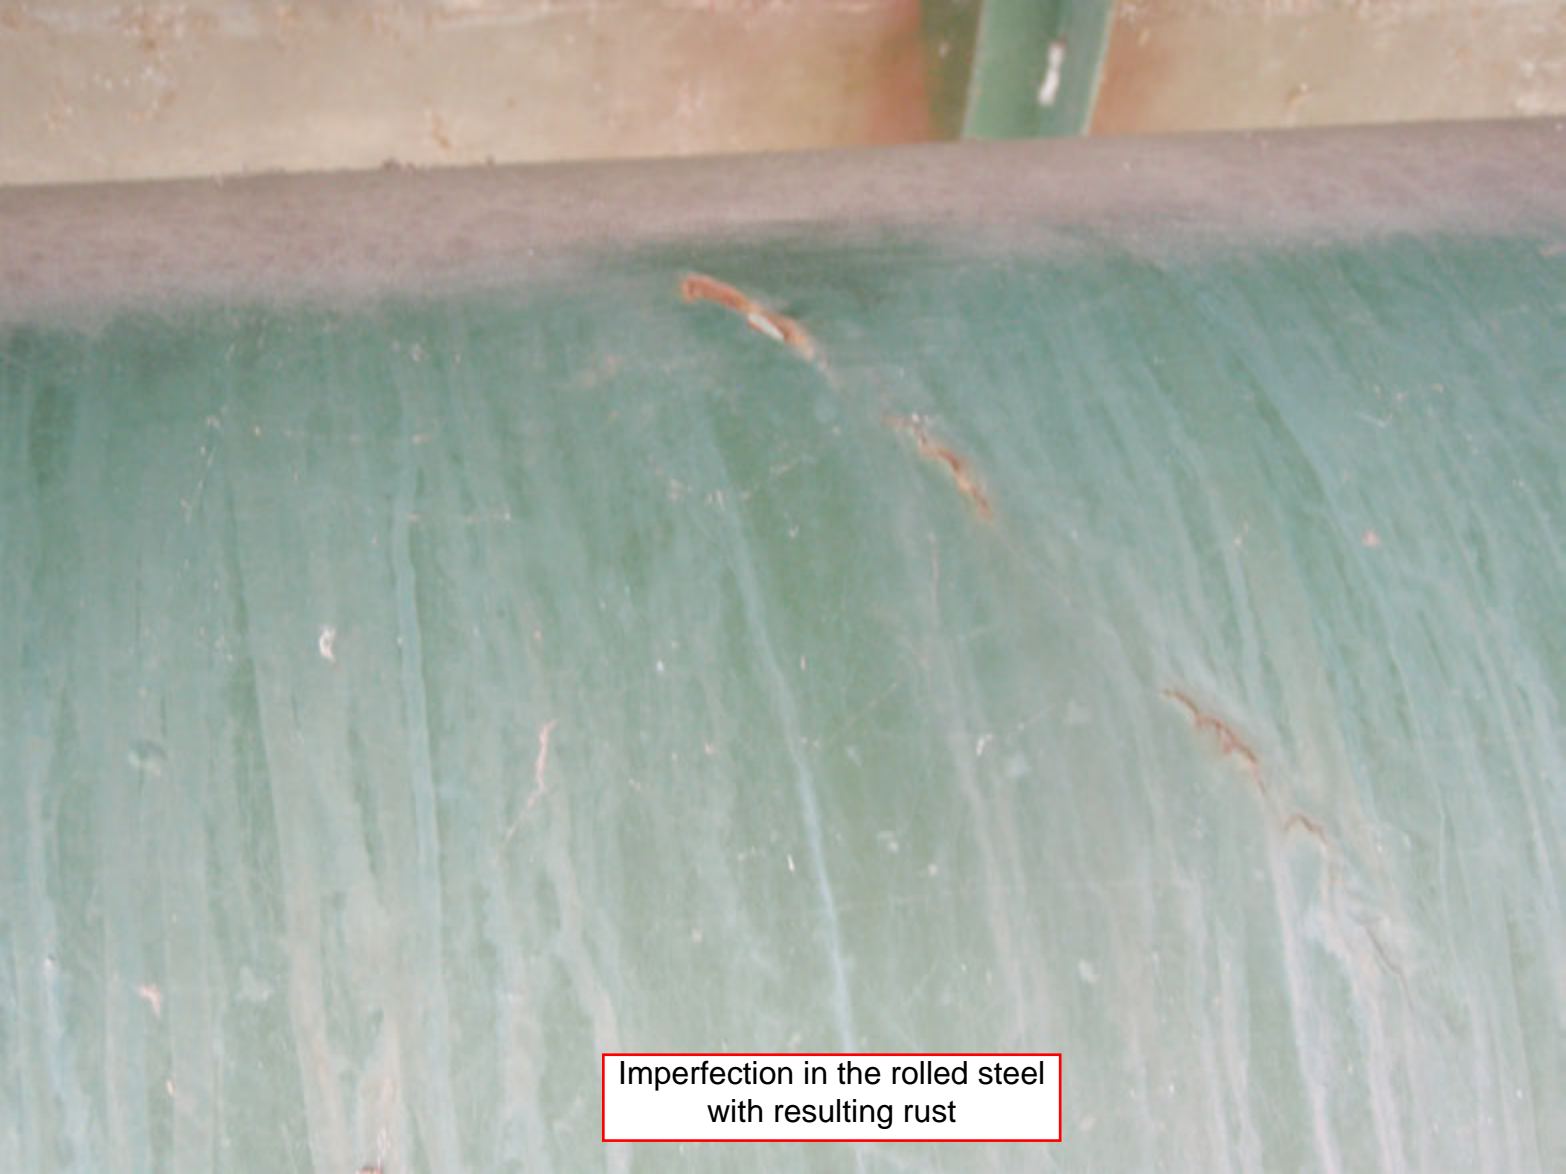
Imperfection in the rolled steel  
with resulting rust

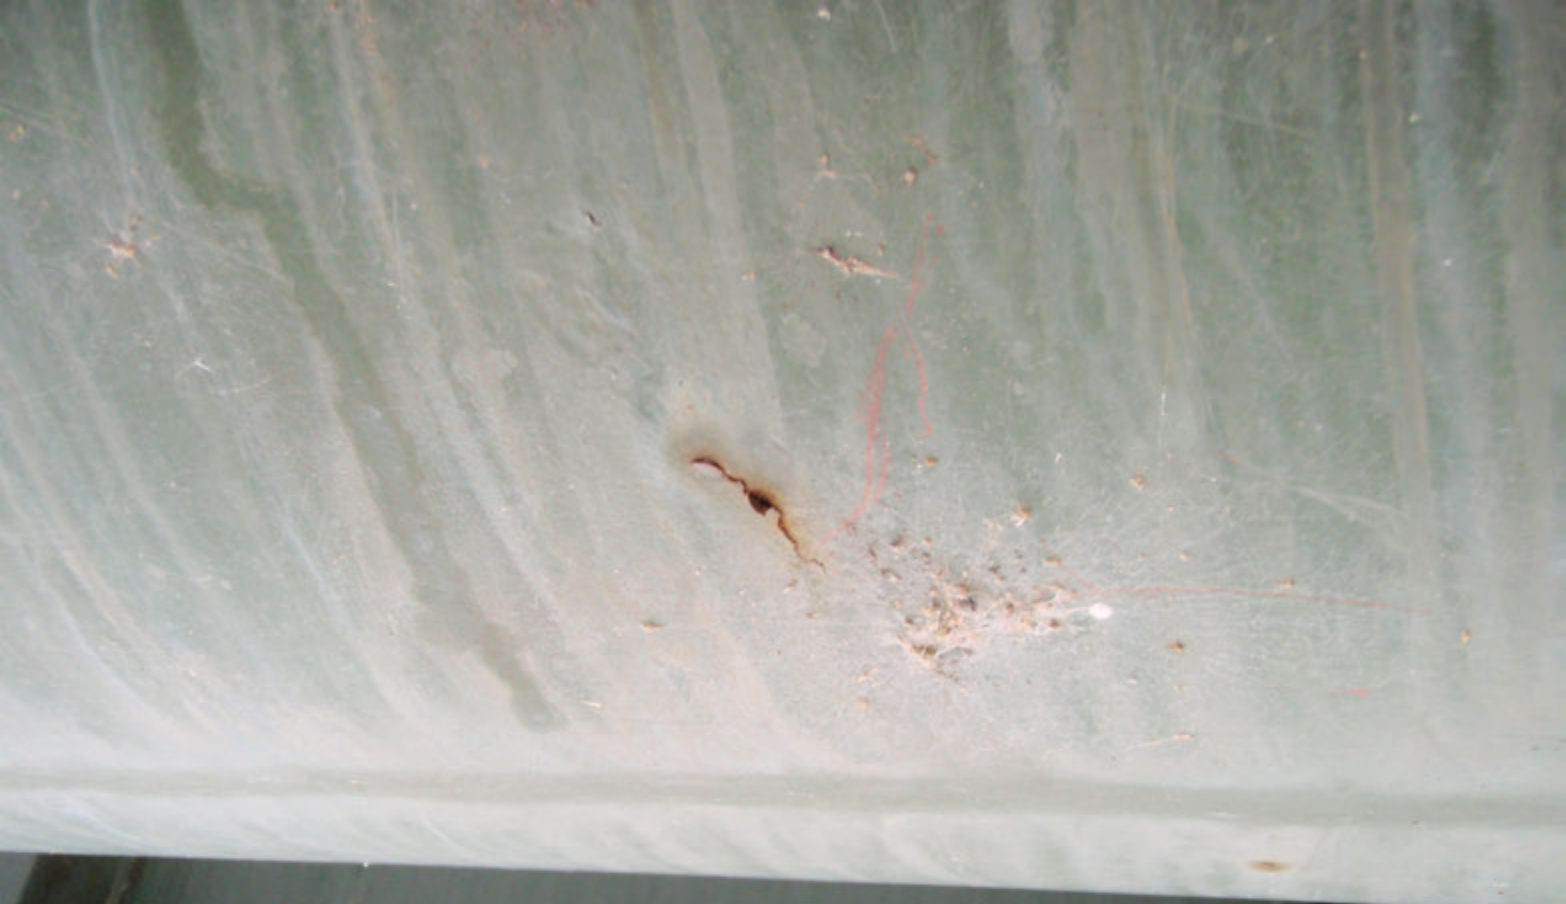
Imperfection in the rolled steel bottom of pipe in the same area as the previous with resulting rust

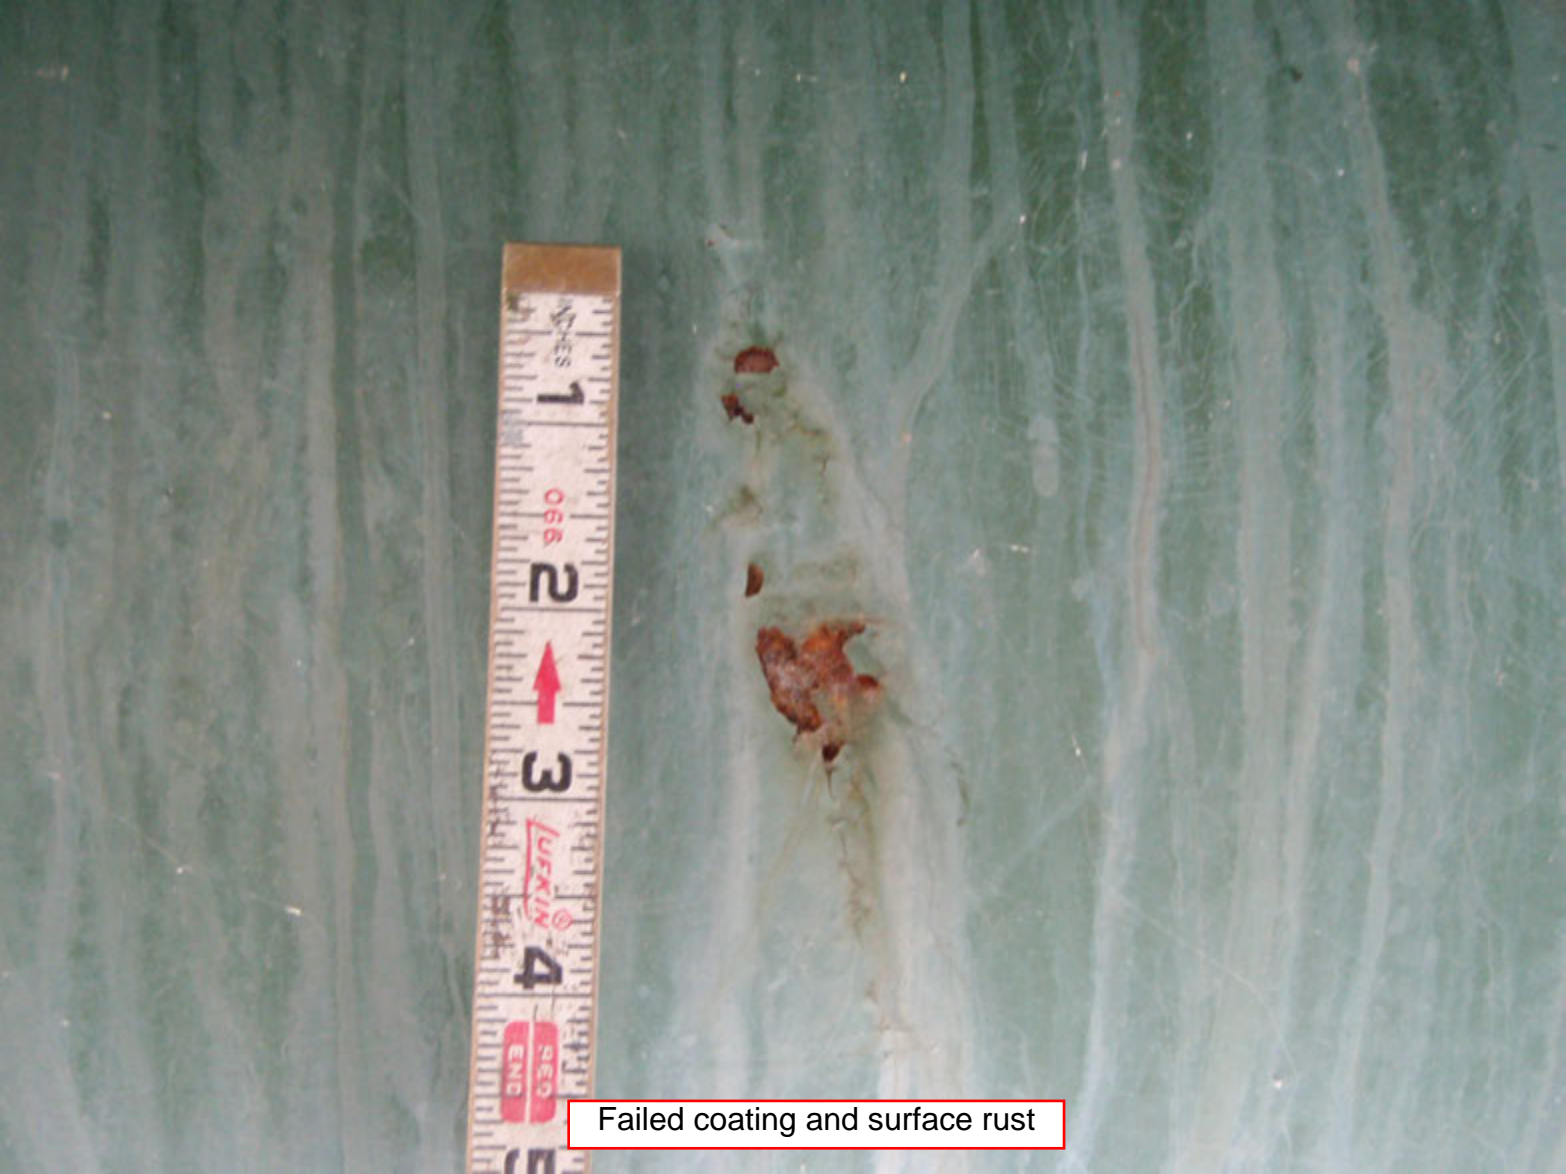
Failed coating and surface rust

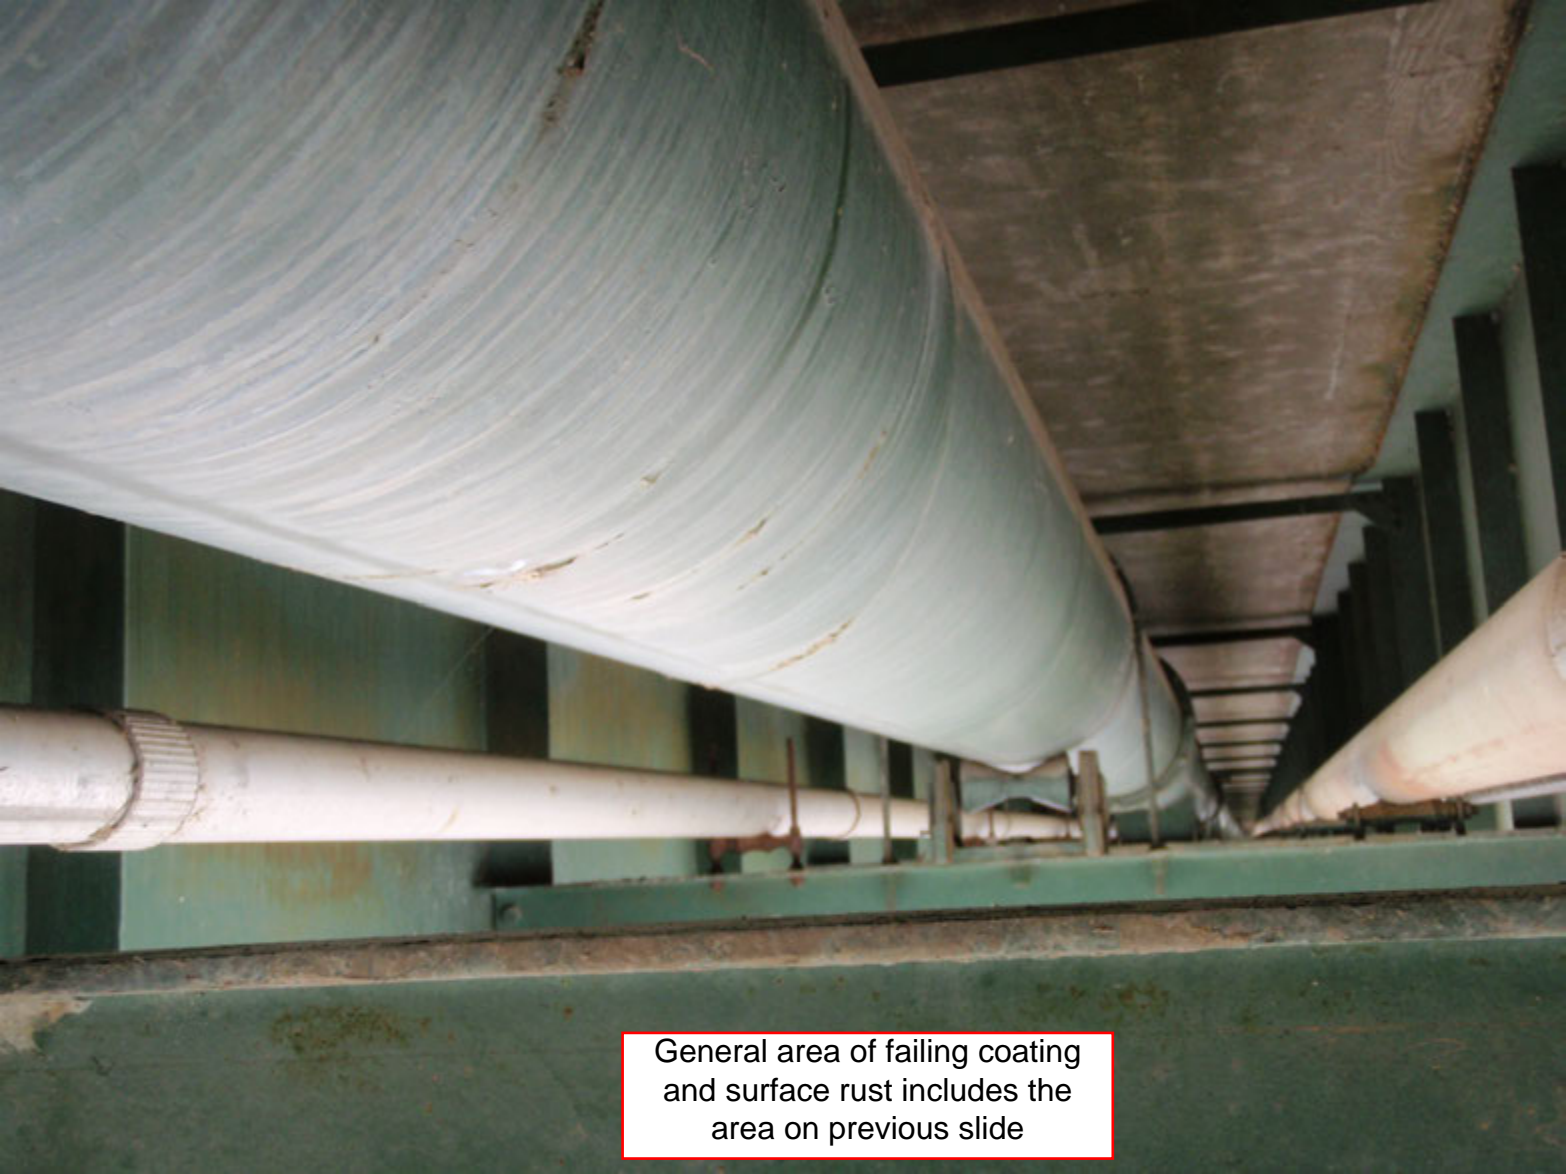
General area of failing coating and surface rust includes the area on previous slide

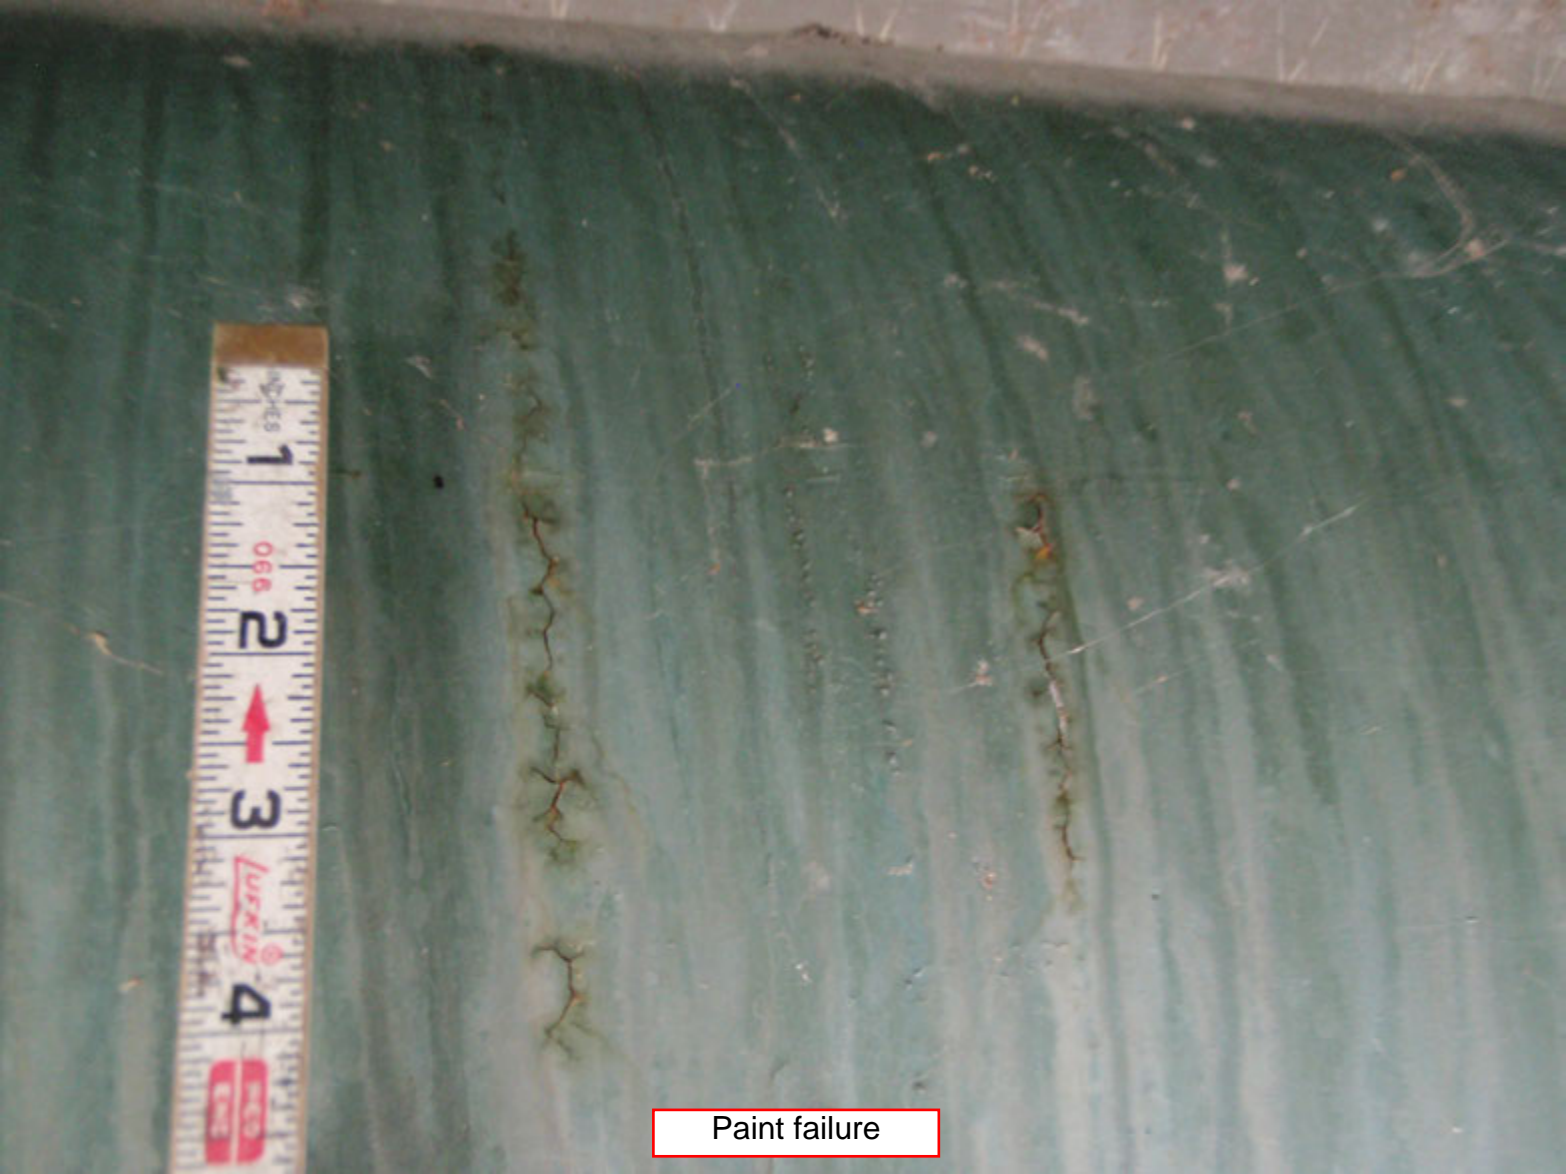
Paint failure

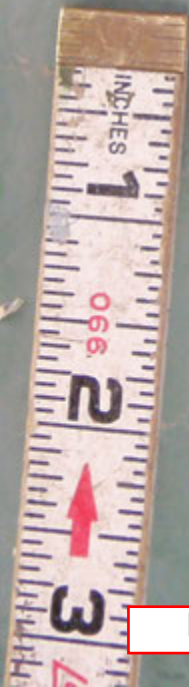
Paint failure
