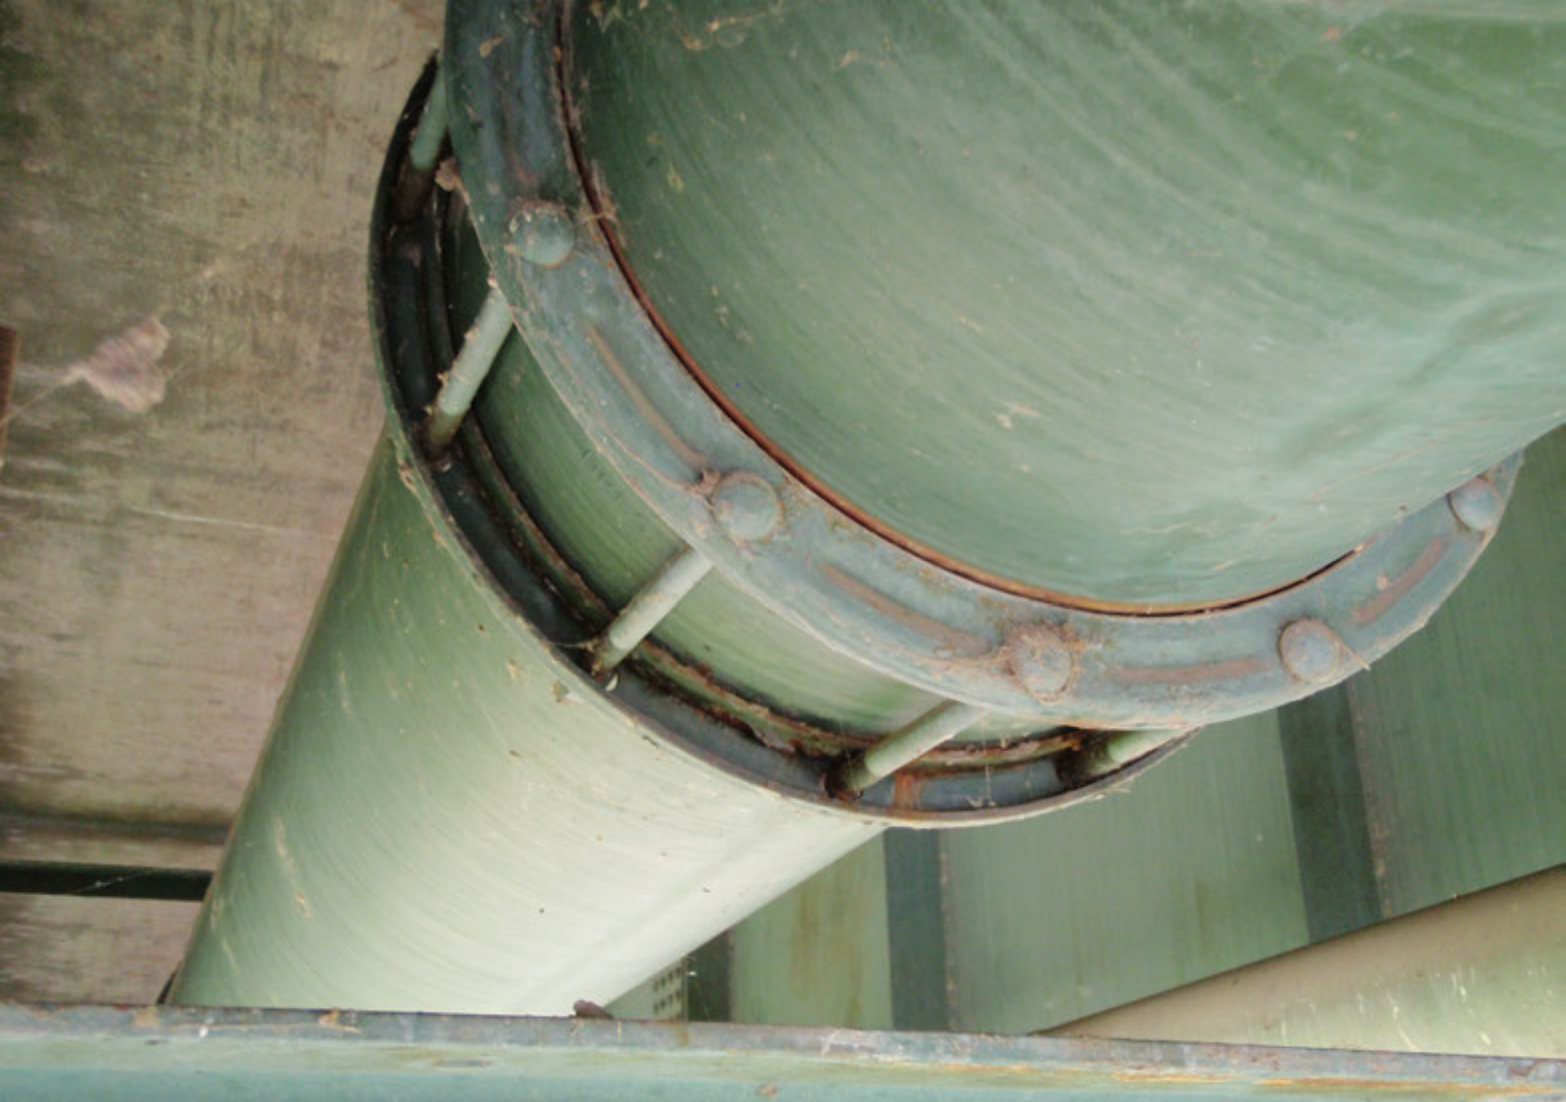
Typical coupling condition

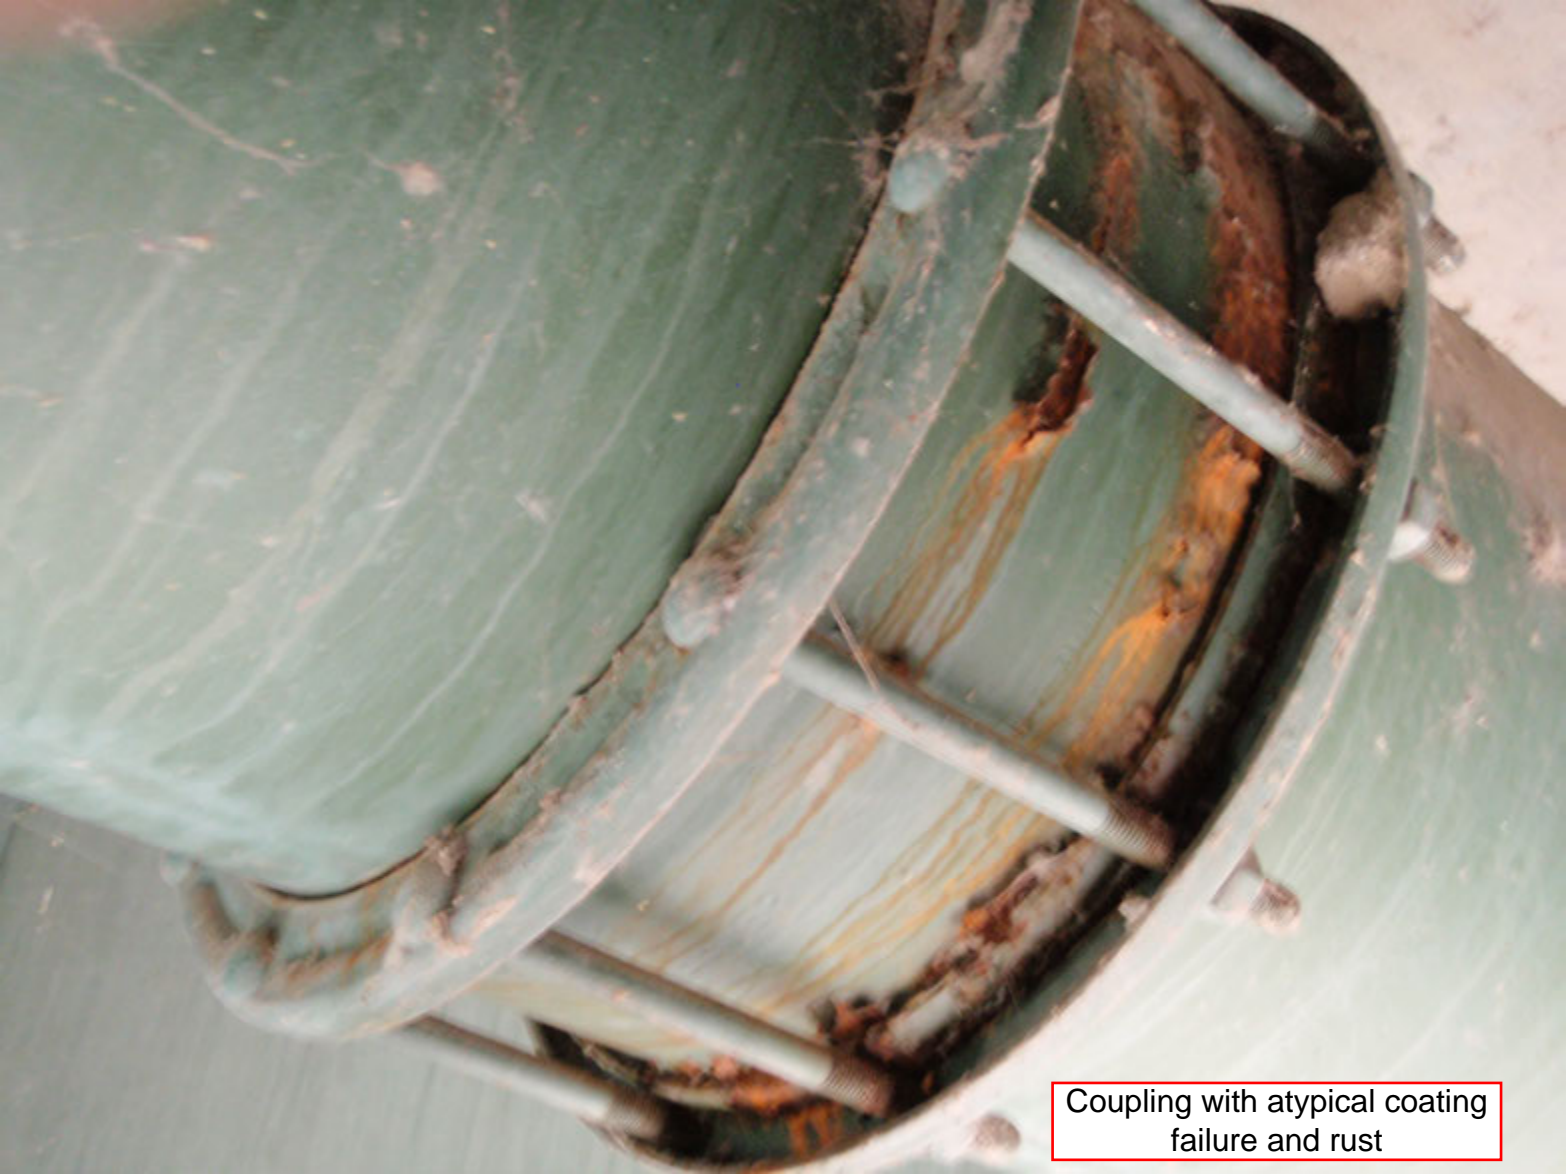
Coupling with atypical coating failure and rust

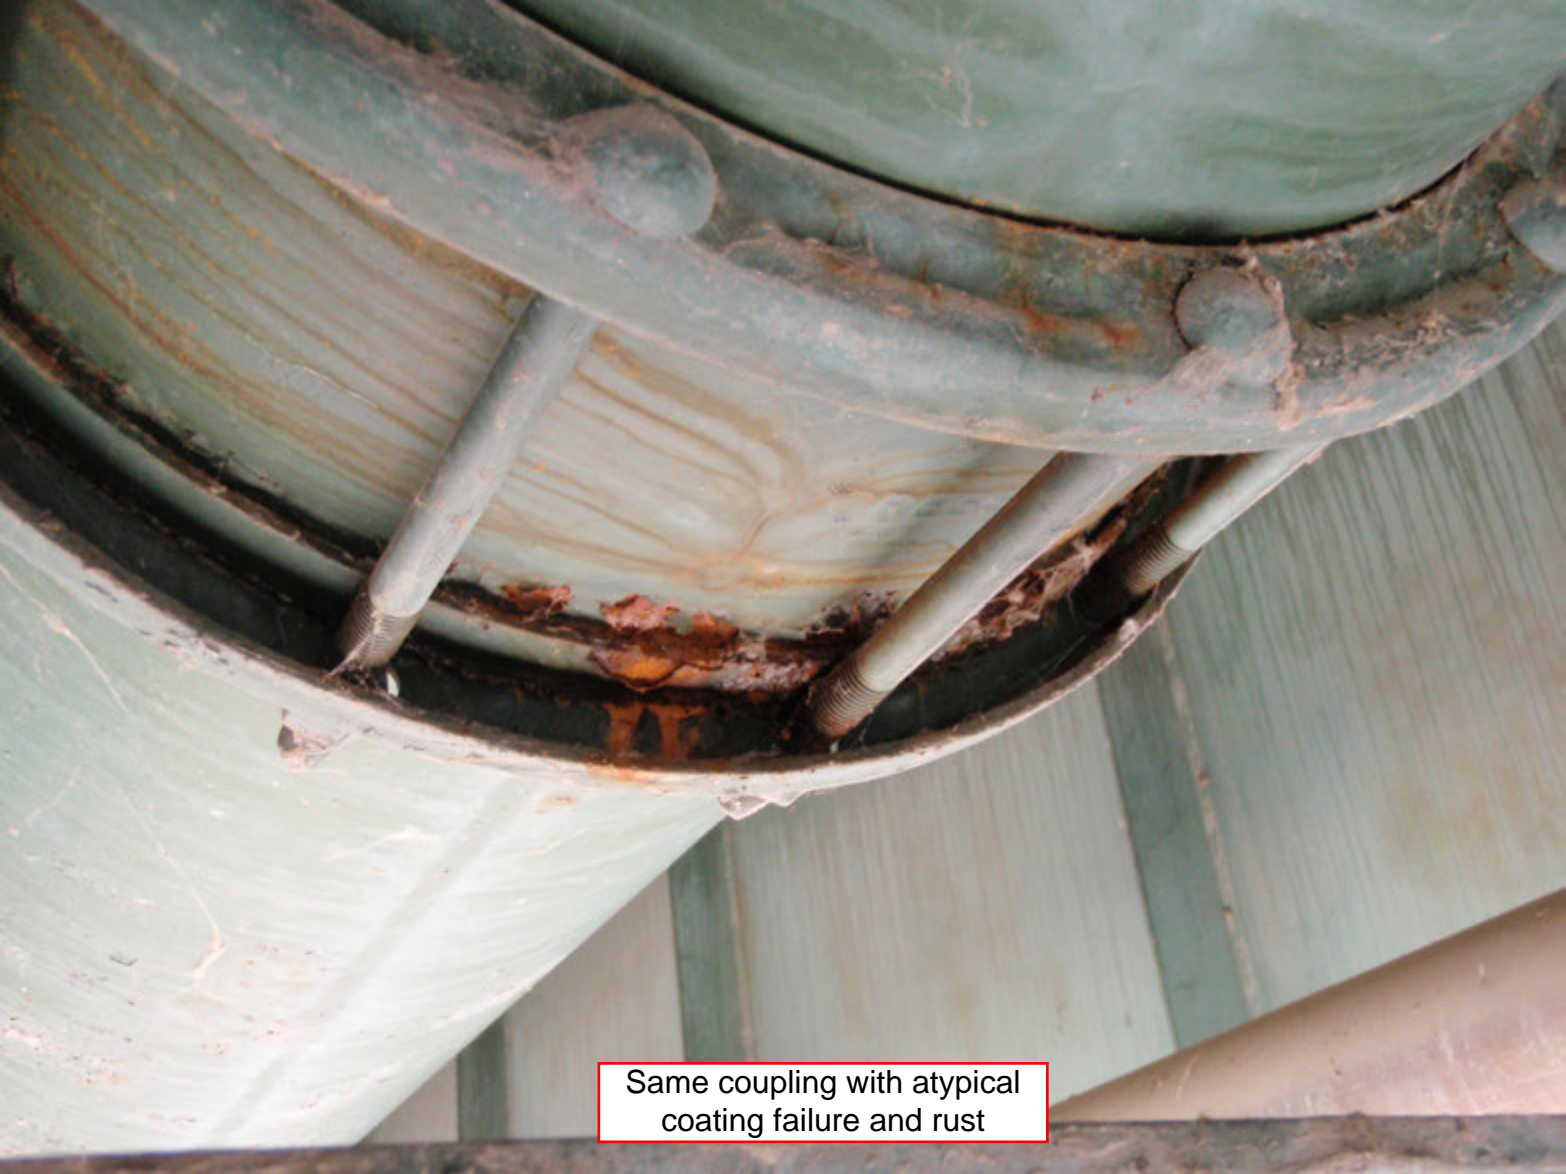
Same coupling with atypical coating failure and rust
