912 Chalk Hill Court - 07/09/2015 (search warrant/inspection)

912 Chalk Hill Court (exterior), 07/09/2015 (search warrant/inspection)

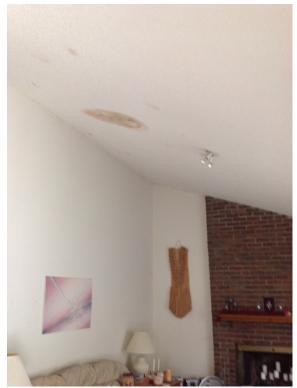
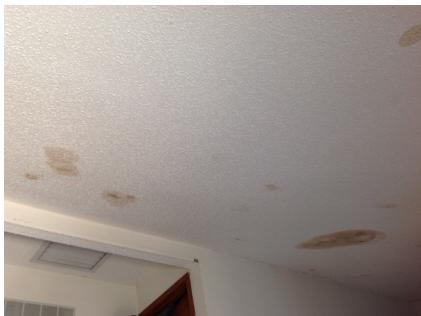
Entry level, living room – ceiling shows evidence of water leaking/staining:

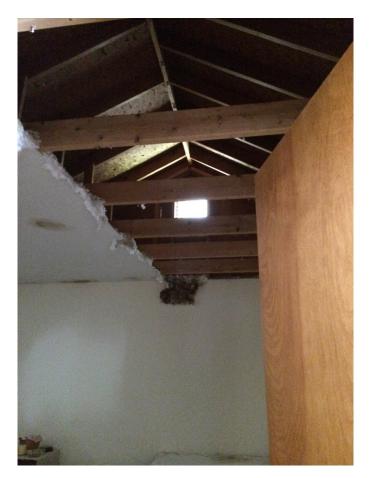
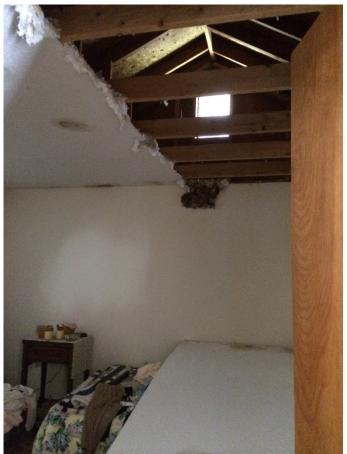
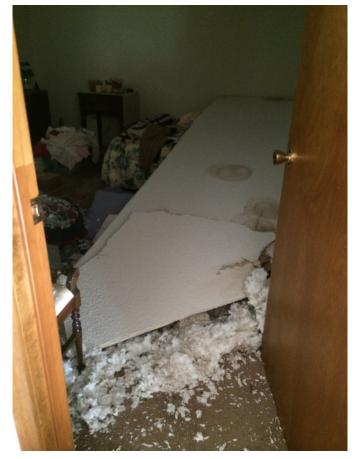
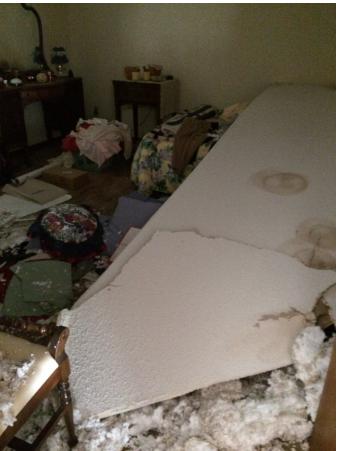
Upper level, South bedroom, (portion of ceiling fallen)

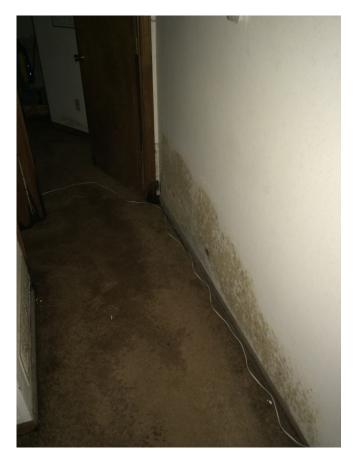
Lower level, hallway leading into bathroom and bedroom (mold and carpet saturated)

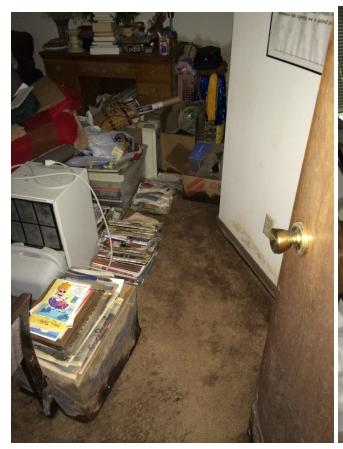
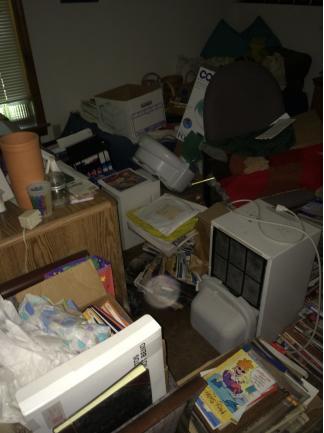
Bedroom, lower level, carpet saturated:

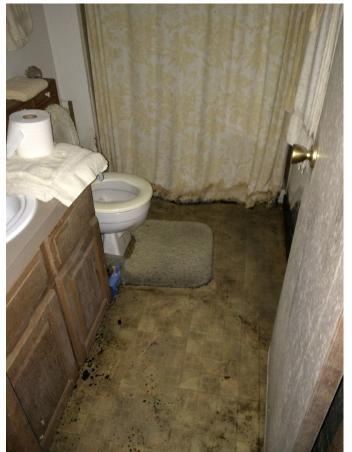
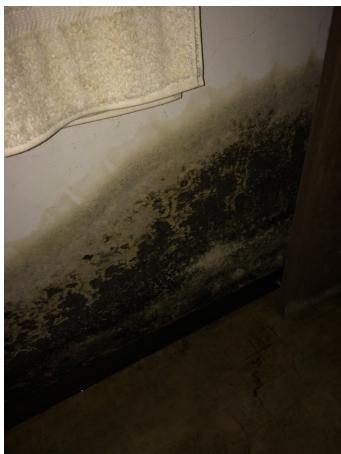
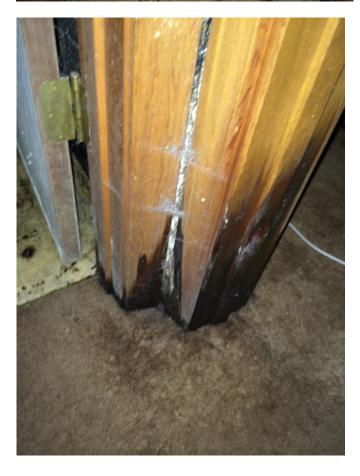
Bathroom, lower level, water on floor, mold

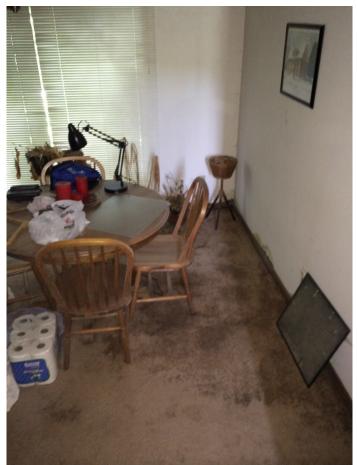
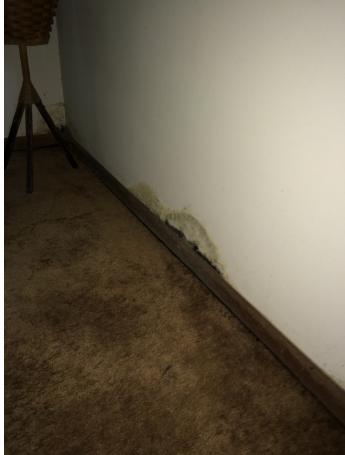
Dining area / sliding door, carpet saturated and mold on walls

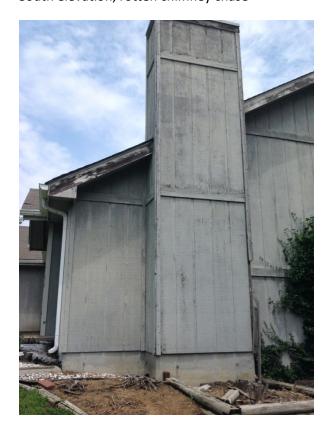
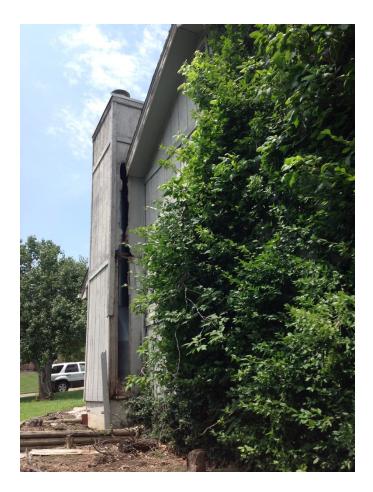
South elevation, rotten chimney chase

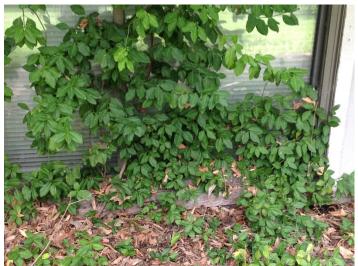
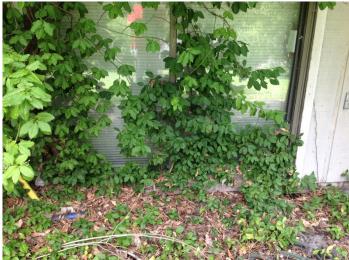
Rear sliding door (lower level), sill plate rotted out.
