ARCHITECTURAL/ENGINEERING  
**EVALUATION & STUDY**  
— FOR —

**FIRE STATION**  
**# 1**

LAWRENCE, KANSAS

NOVEMBER 22, 2010

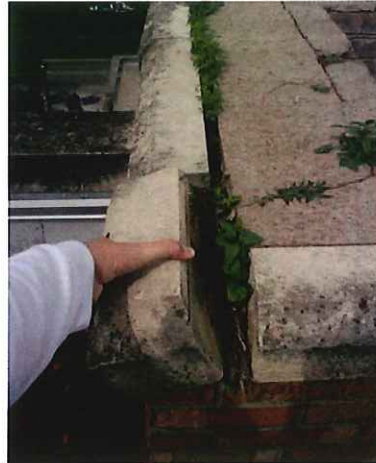
- 4 Stone copings at top of hose tower no longer have mortar joints. Corrective measure required to prevent water infiltration.

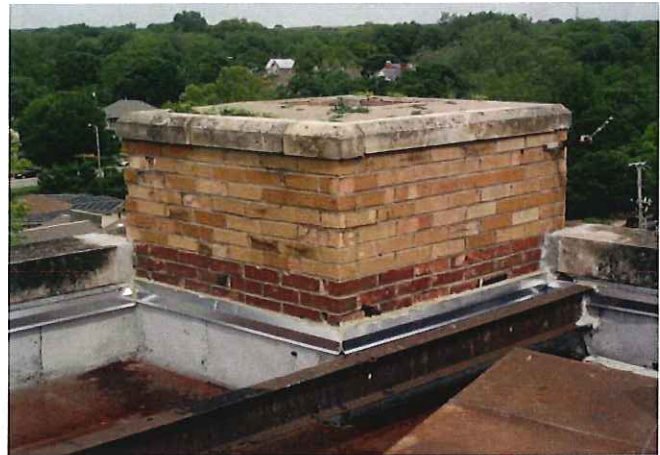
- 5 Main stair tower roof ponds water and will increase deterioration of new roof membrane. Roof should be adjusted to drain properly.

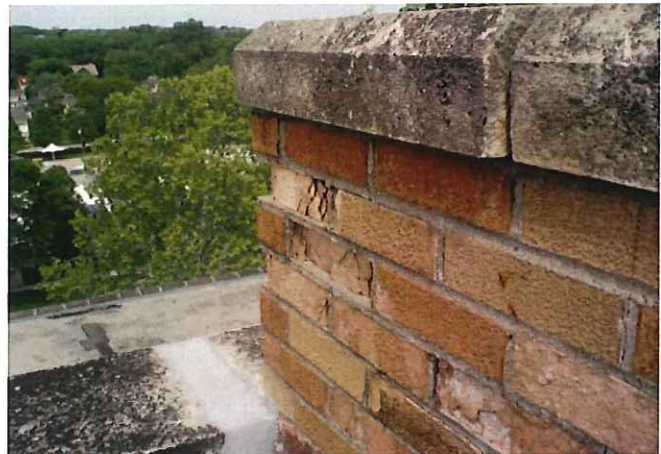
- 6 Typical brick masonry veneer deterioration near leaking wall cap stone. Corrective measures required immediately.

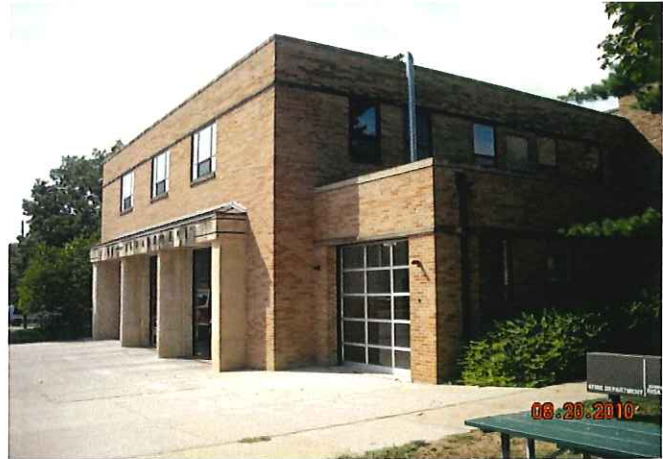
- 7 Apparatus Bay front apron appears to be in good repair. Replacement could be considered as optional. Stone pillars between overhead doors show signs of damage apparently due to vehicle collisions. Cleaning, repair or replacement of these stone pillars base pieces should be considered, and bollards installed to prevent similar damage in future.

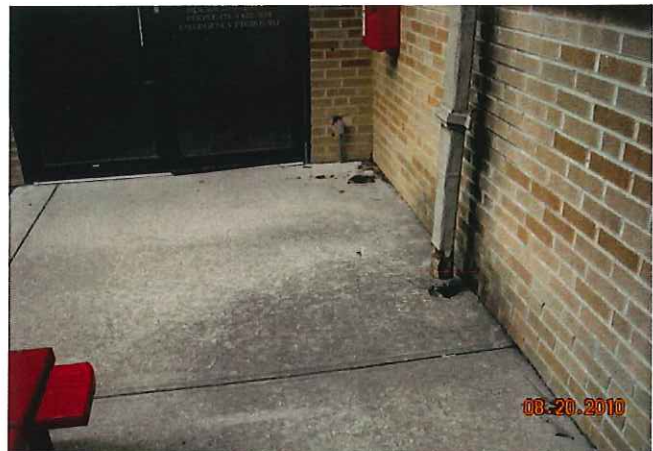
- 8 Drainage issues at building perimeter should be addressed to prevent further deterioration of building foundations and exterior paved surfaces.

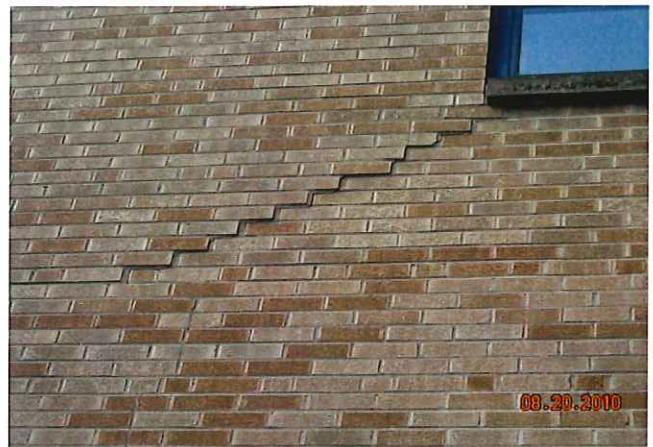
- 9 Brick masonry veneer deterioration below window on West side of building. Stone window sills should be cleaned in place prior to new window installations.

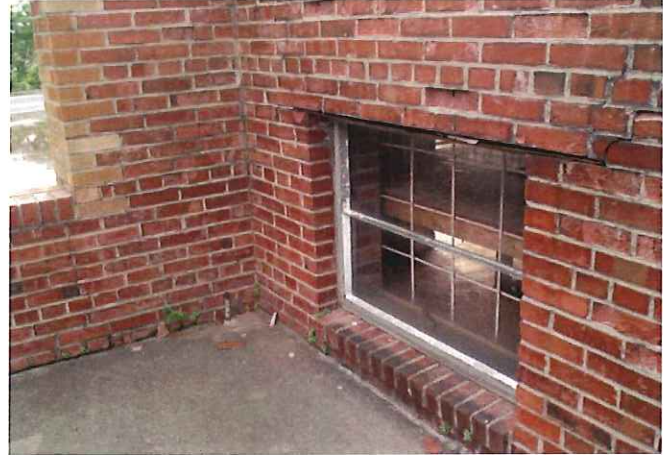
- 10 Brick masonry veneer deterioration is common in the exterior North exit stair. Years of exposure to the elements has increase masonry deterioration in this area. Consider provide open air roof structure to protect again future deterioration.

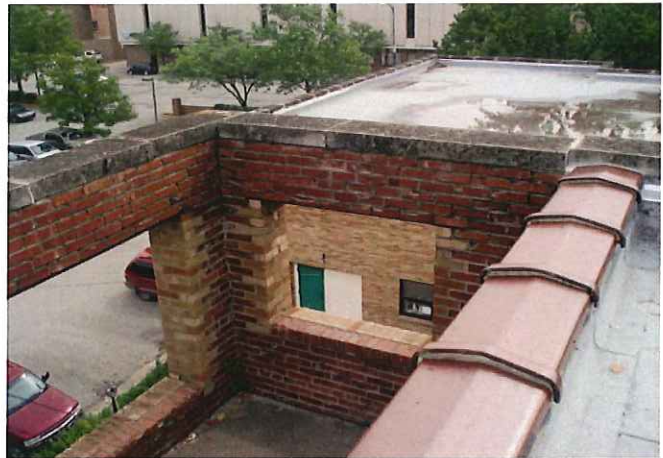
- 11 North exit stair open to the elements. The stair provides effortless access to the facility roof and thusly posses a security issue for the entire building.

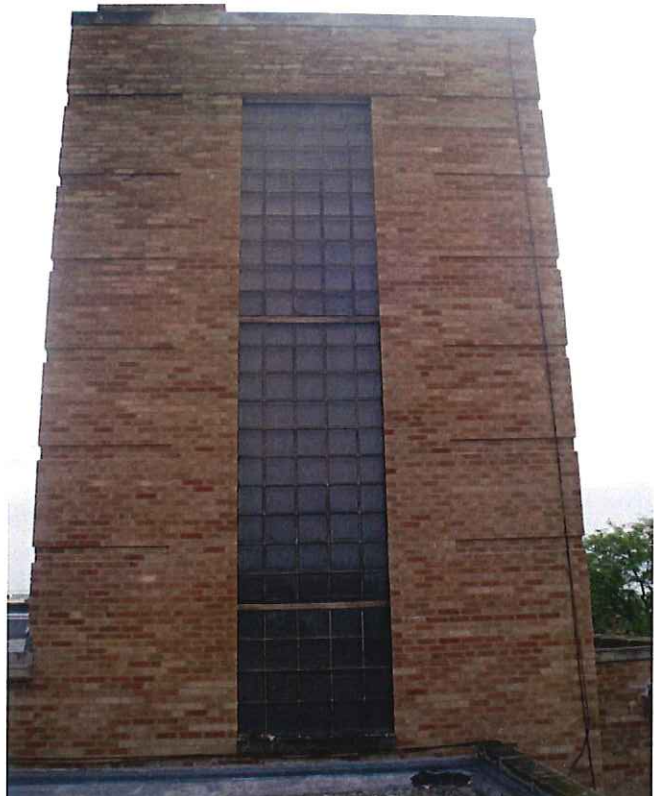
- 12 Glass block window openings and associated steel have deteriorated substantially. Further study will be required to determine if removal and replacement is warranted.

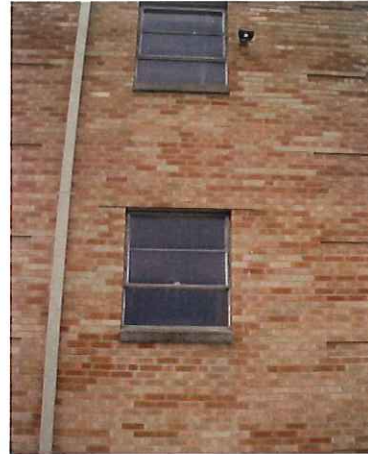
- 13 Replacement of any remaining steel framed windows with aluminum thermally broken window systems is recommended. Sleeping room windows have been replaced previously, but will need to be replaced in proposed new dorm configuration.

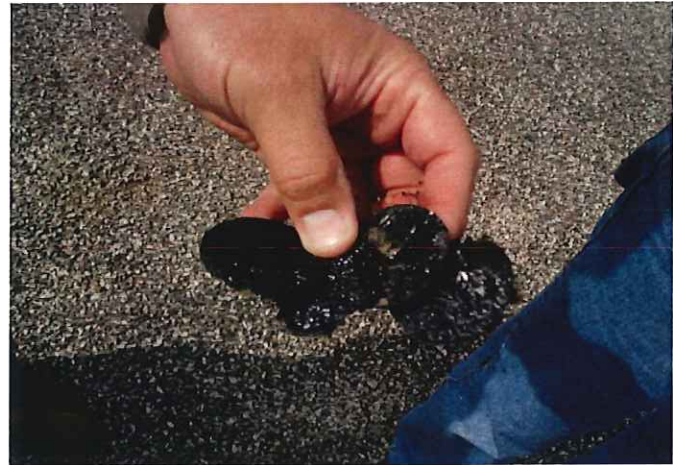
- 14 Refer to the attached roofing consultant report for existing roof conditions and recommendations

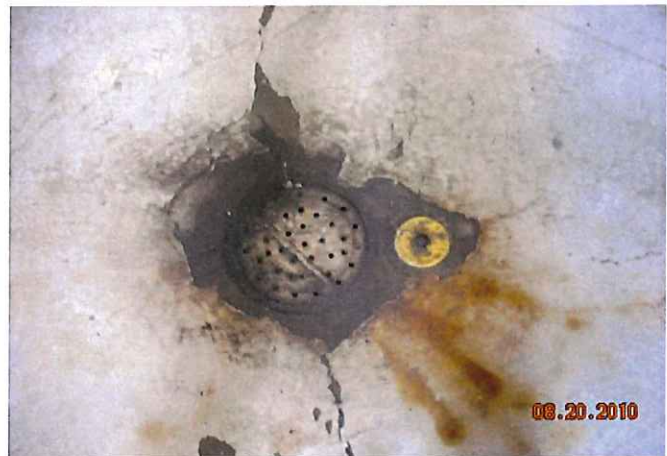
- 17 Existing floor drains in the bay area, are area type drains. Current department standards would provide for trench drains to ease in floor cleaning and firefighter safety.

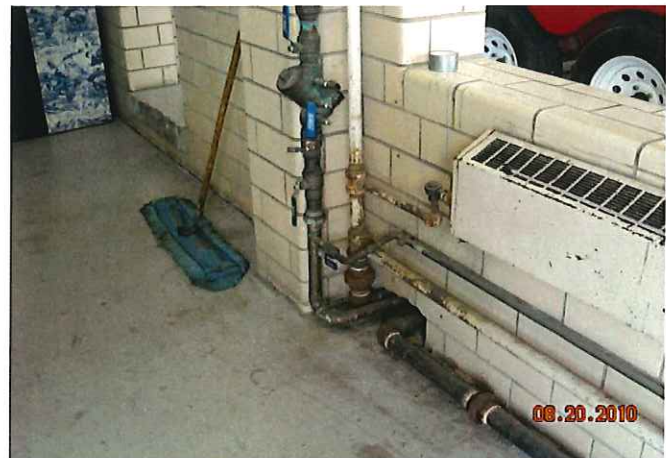
- 19 Mechanical system in facility is reaching its servicable life. Refer to attached mechanical engineers report. Much of this equipment could be removed cleaning up the bay perimeter is a full mechanical retro fit is undertaken.

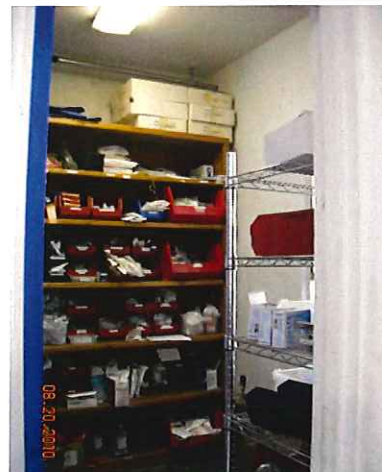
- 20 Existing medical storage is located well directly off of the apparatus bay, but is undersized and does not have adequated hvac control.

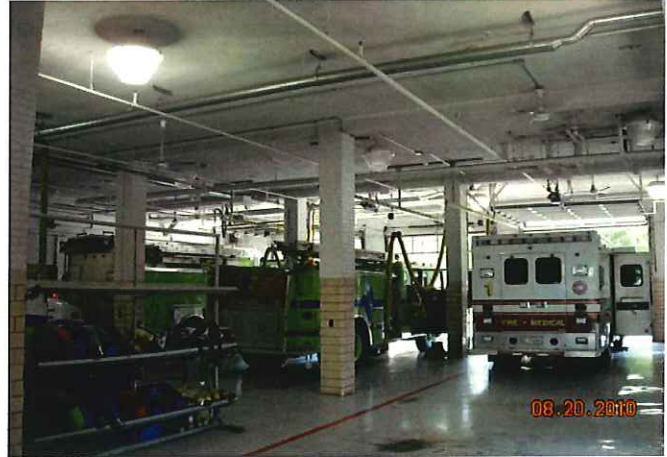
- 21 Existing configuration of the apparatus bays will likely remain the same in any remodel of the building. Lighting, mechanical, and exhaust systems replacement are proposed as part of any substantial remodel.

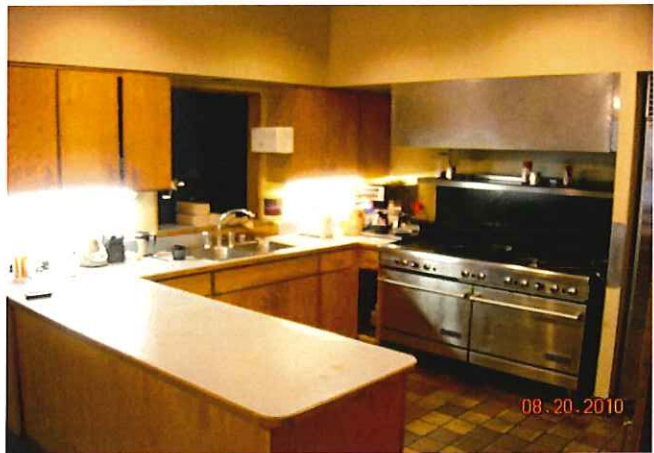
- 22 Existing kitchen/dining area is undersized for current staffing and the stove exhaust hood does not appear to have the appropriate overhang required currently by code. Expansion fo this space is recommended.

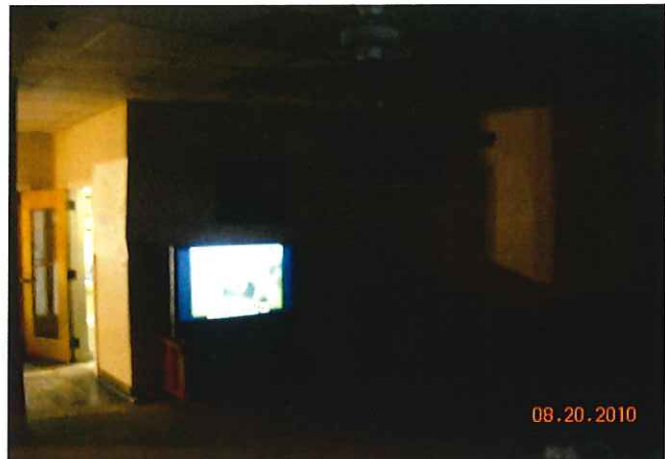
- 23 Dayroom are is undersized for current staffing and has limited access to natural light. Expansion of this space is recommended.

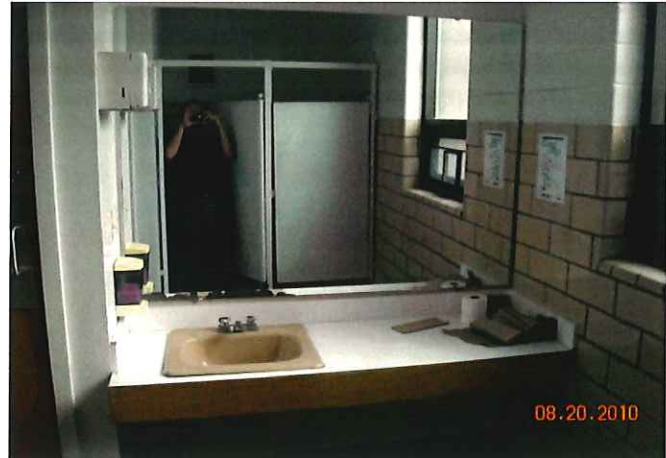
- 24 The existing restrooms located near the current dayroom area in disrepair, are not accessible, and do not support multi-gender use. It is recommended that these restrooms be relocated and updated as part of remodel activity.

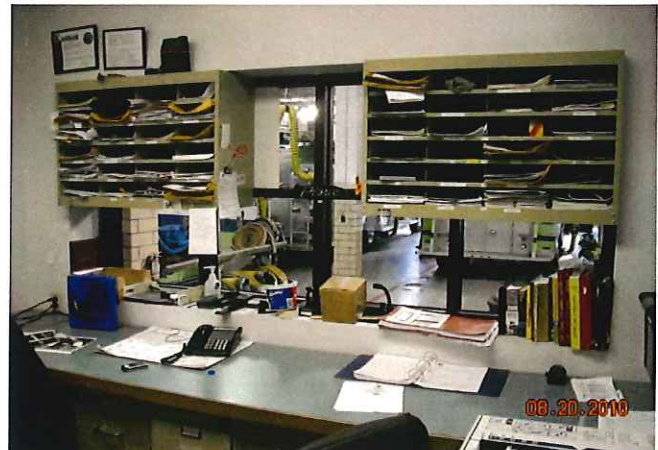
- 25 The existing station office is severely undersized when compared to comparable spaces in newer stations. Currently, the office is positioned well to see the interior of the apparatus bay, but cannot see the apron or the front door for station security. Relocation of this space is recommended to improve station office areas of observation improving overall station security.

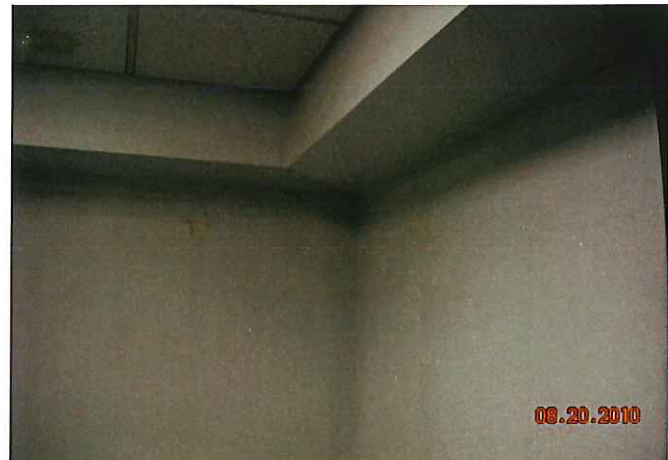
- 28 Deterioration of interior wall finishes is occurring in the Southwest corner of the male sleeping dorm due to roof failure above. Refer to roofing consultant write-up for recommendations.

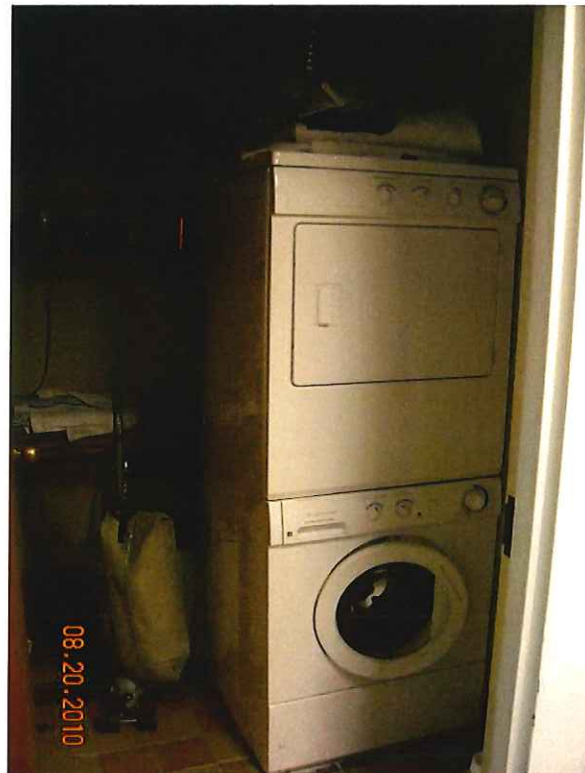
- 29 Existing apartment style stacked laundry equipment is not adequate for the staffing load using the building at any one time, Replacement with more efficient residential style washer and dryer is recommended.

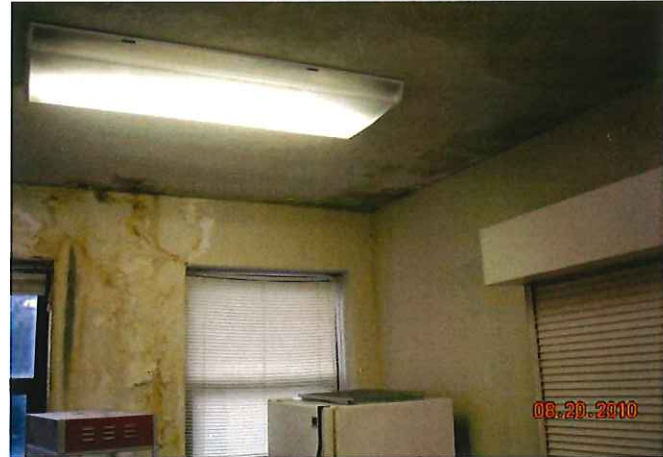
- 32 Deterioration of interior wall finishes, in the kitchen serving the Senior Center ballroom, is occurring along the west elevation of the building due to roof failure above. Refer to roofing consultant write-up for recommendations.

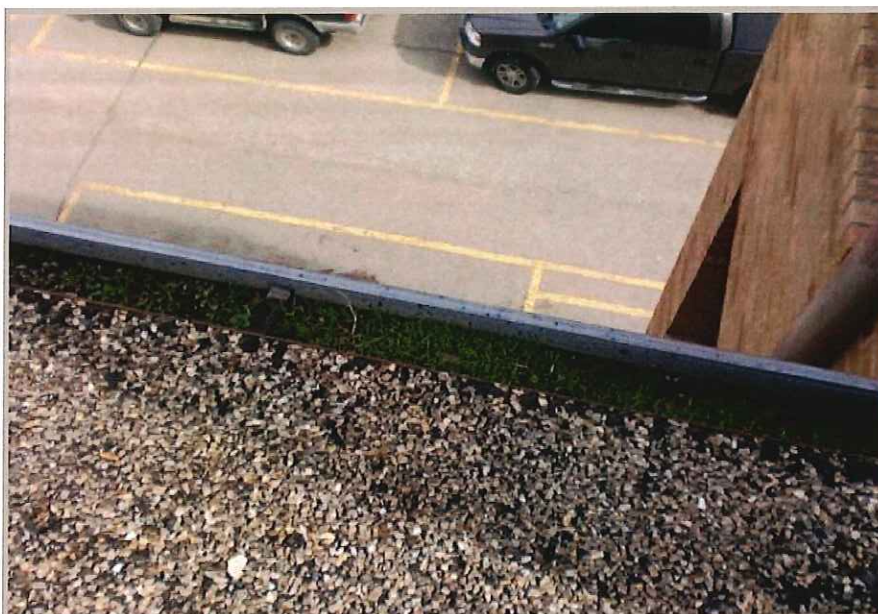
Gutters are full of gravel and grass. This should be cleaned out to keep water off the roof

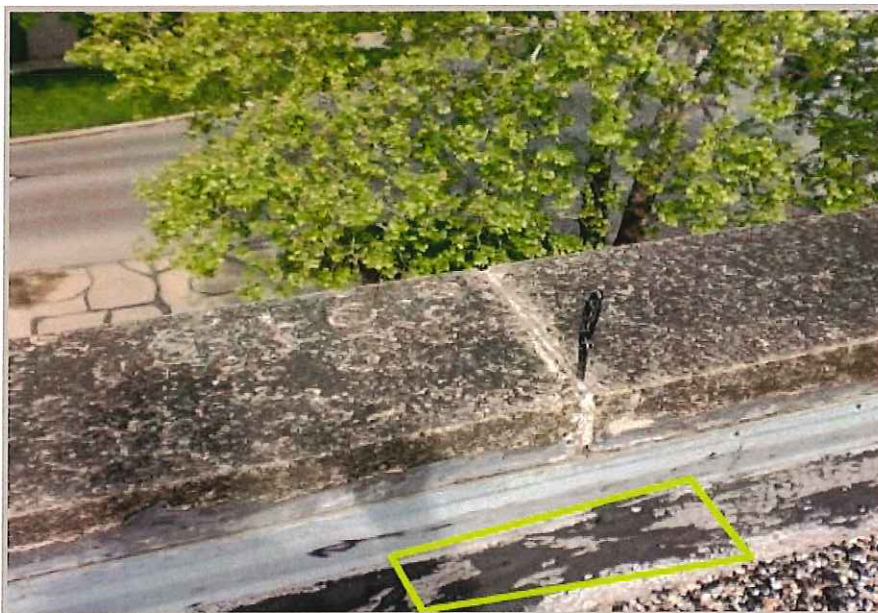
Base flashings appear to be made of Asbestos material. This will need to be checked in a lab to confirm.

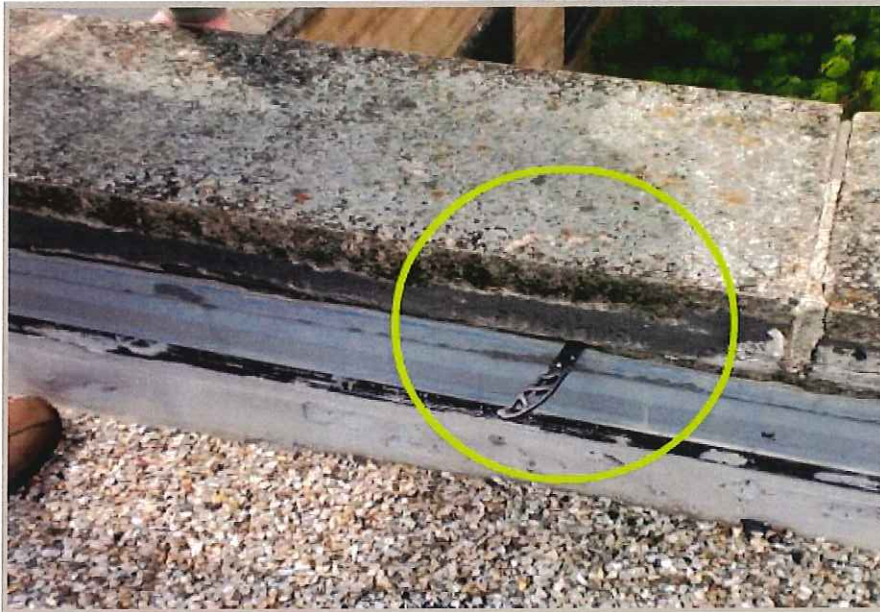
Area between the parapet wall and coping caps needs to be sealed to keep water from penetrating behind the flashings. This area shows where water is getting in behind the termination bar and under the roofing system.

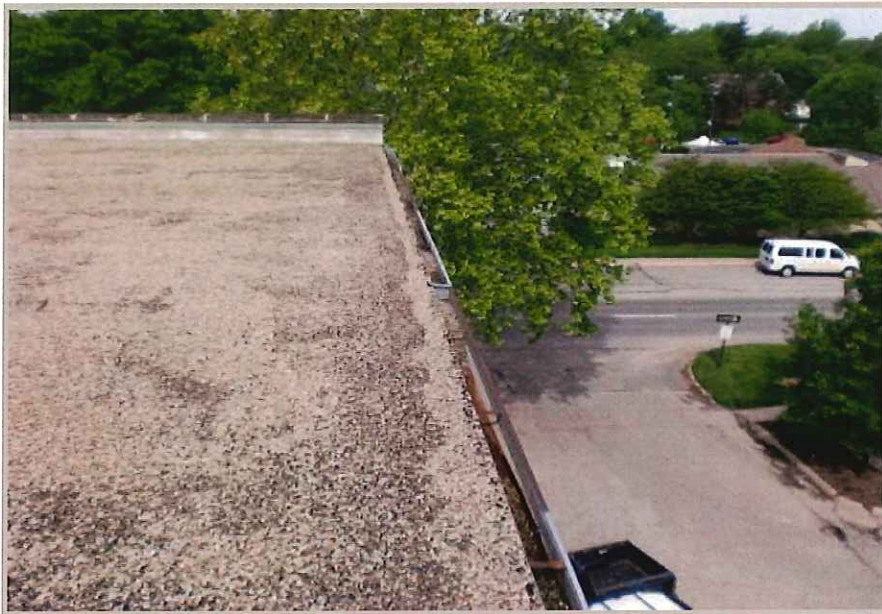
Majority of dark areas along the North wall are blisters.

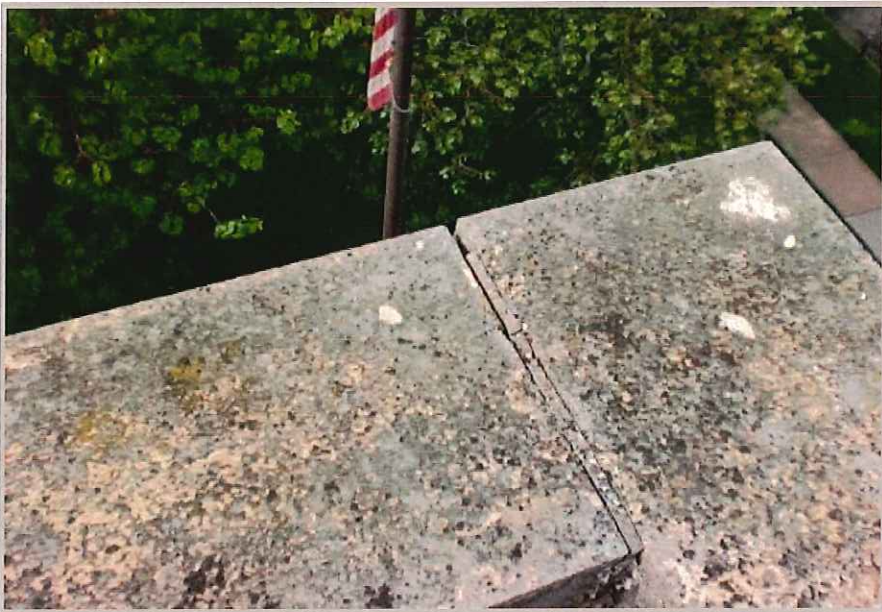
The joints on the stone coping caps are failing. Water gets between the blocks and runs into the brick wall as well as under the roofing system.

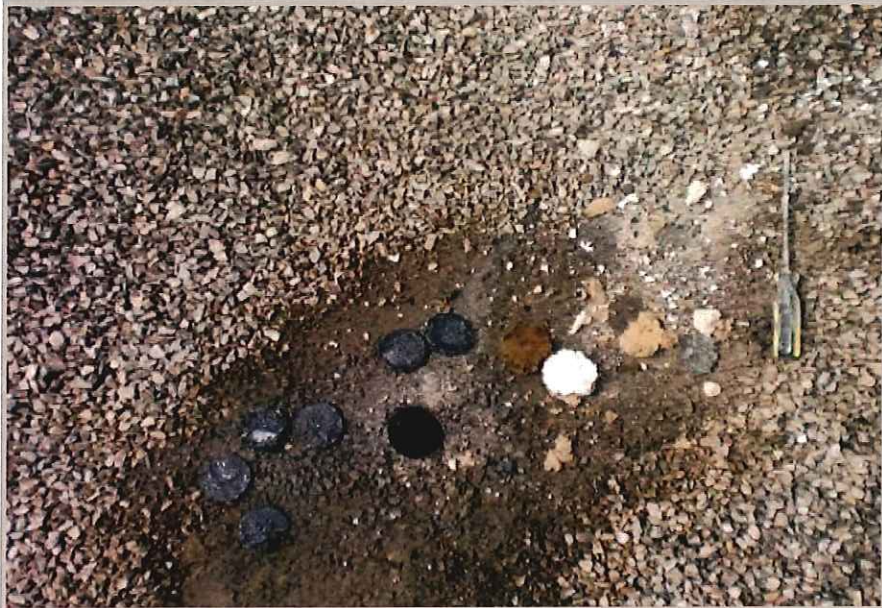
Core sample indicates there are 2 roofing systems on this facility. The roofing system under the Built up Roof with gravel is still in good shape and may be the reason the water is not penetrating the inside of the building.

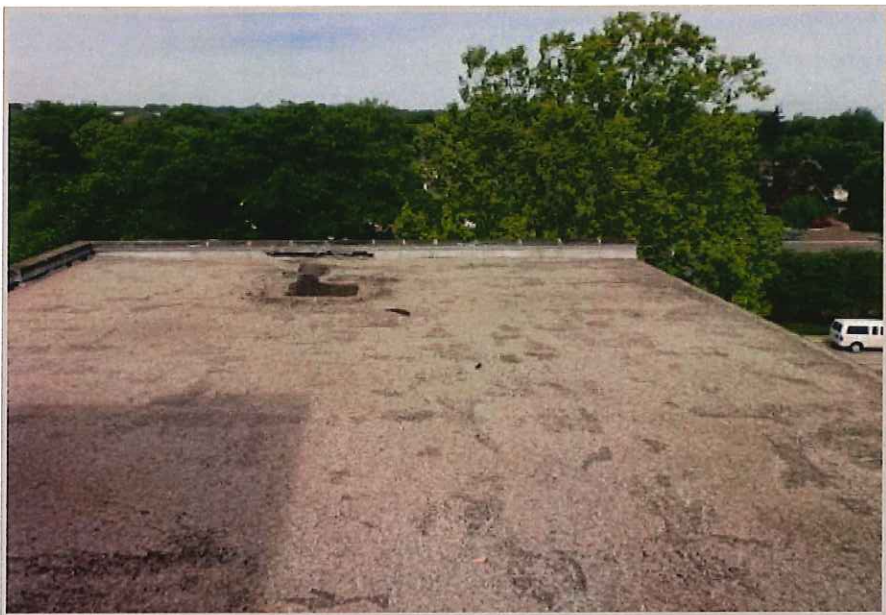
This section is covered with blisters to the extent you need to be carefull where you walk to keep from breaking the blisters open. Blisters are caused by moisture and gases under the membrane.

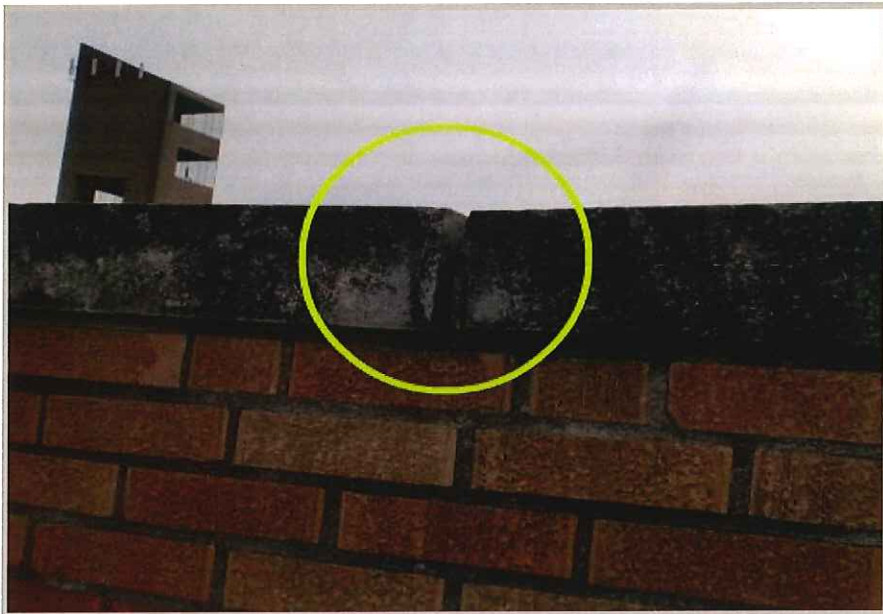
Joint on coping blocks do not have any sealant between the blocks.

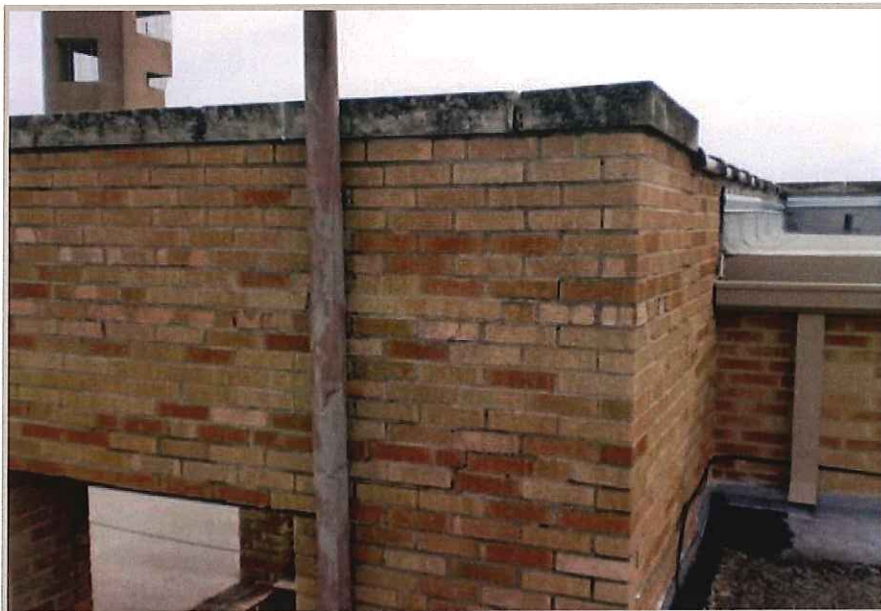
Bricks are flaking apart caused by water trying to evacuate the inside of the brick.

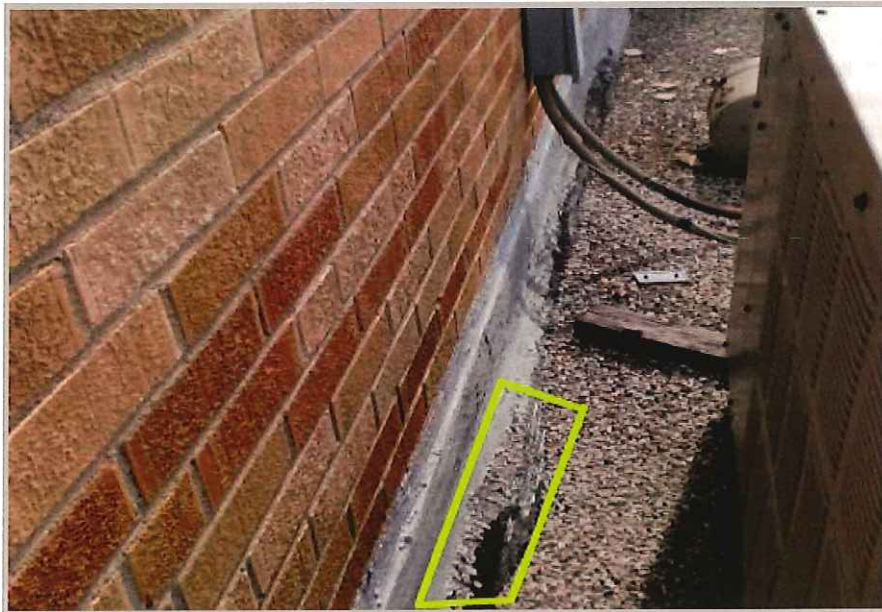
Flashings are pulling apart, scrim is exposed.

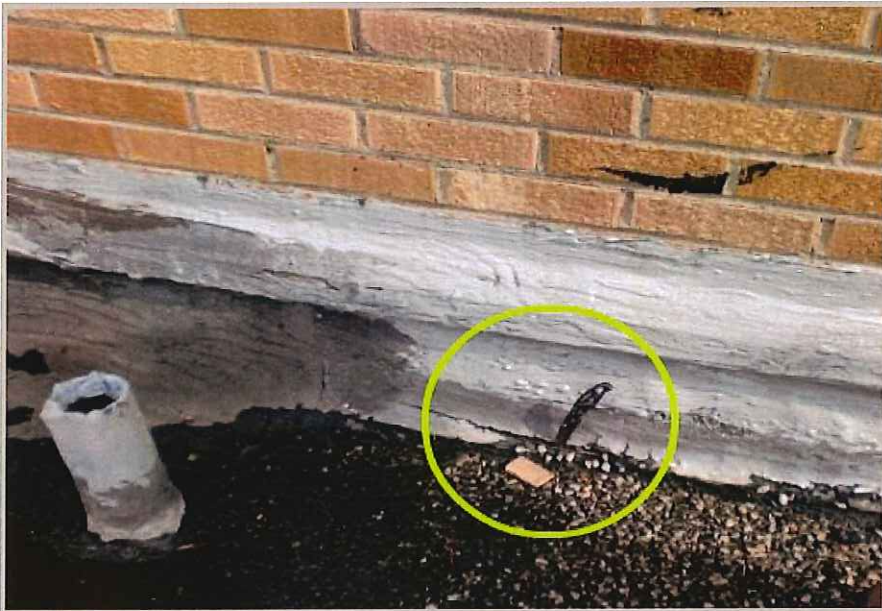
Flashing is cracked, allowing water in under the membrane.

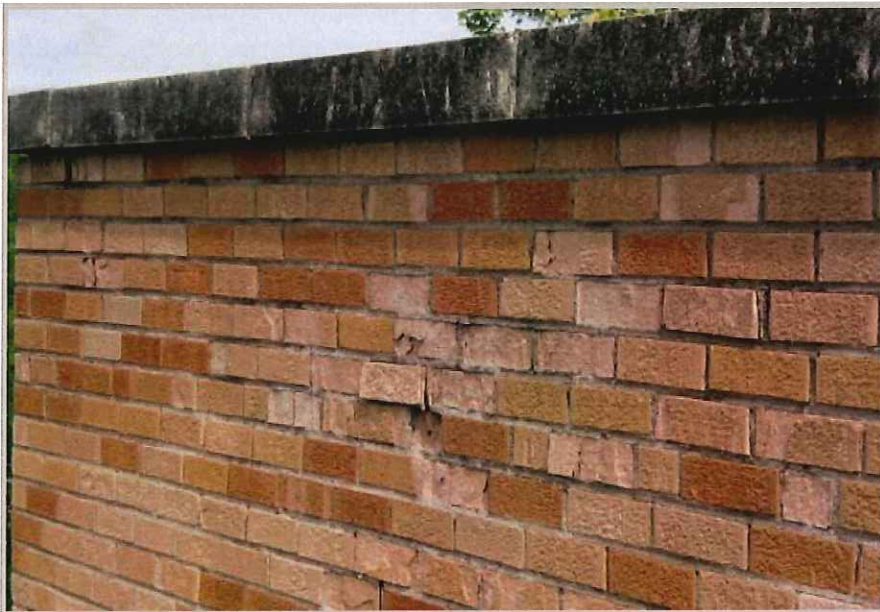
Bricks are flaking off the wall due to water standing inside the bricks. There needs to be a way for water to drain out to resolve this problem.

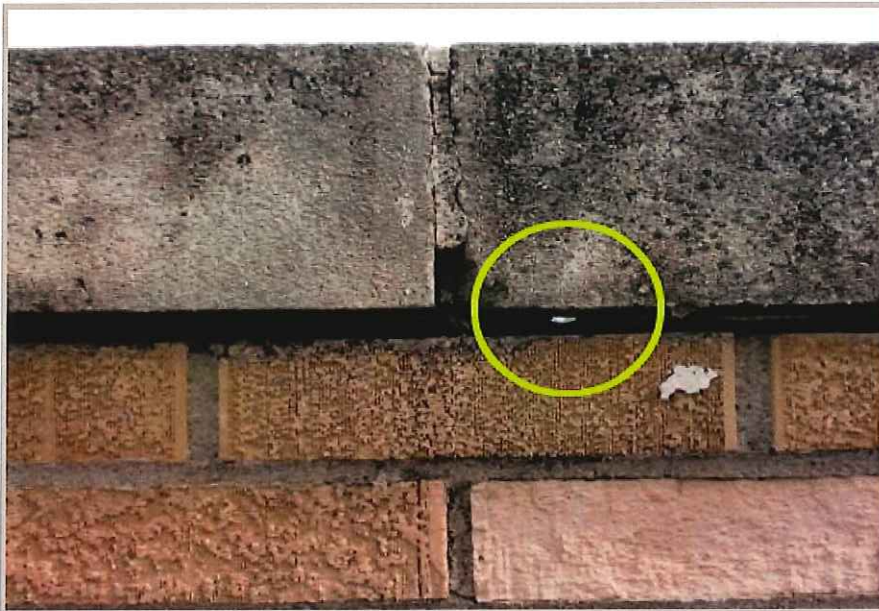
Daylight is showing under the bricks.

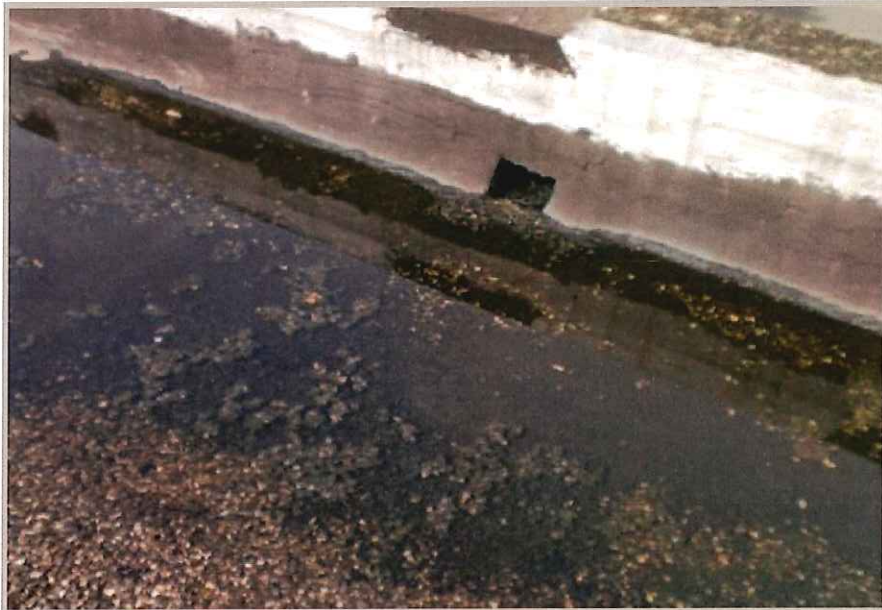
Flood and Gravel roofs are capable of holding some water although roof should drain better.

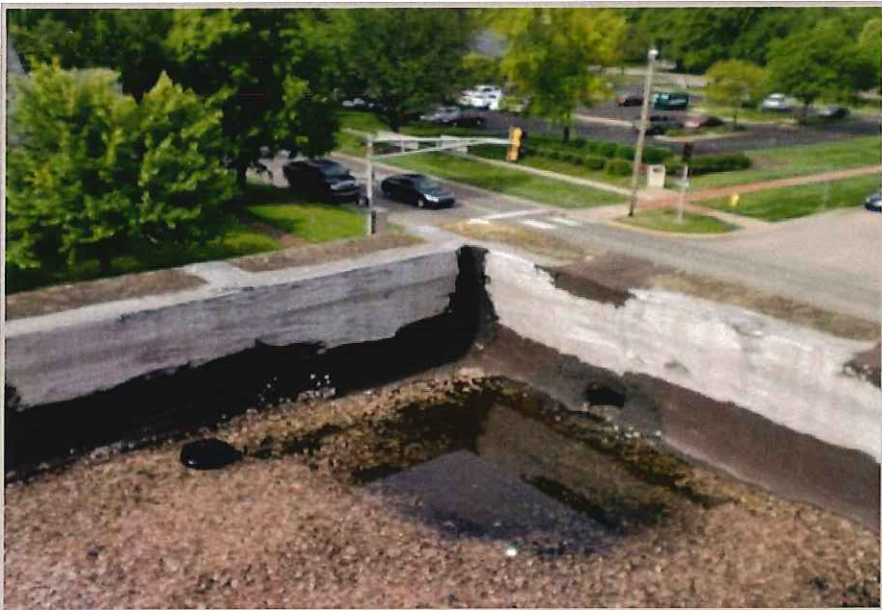
Southwest corner, water standing around scupper.

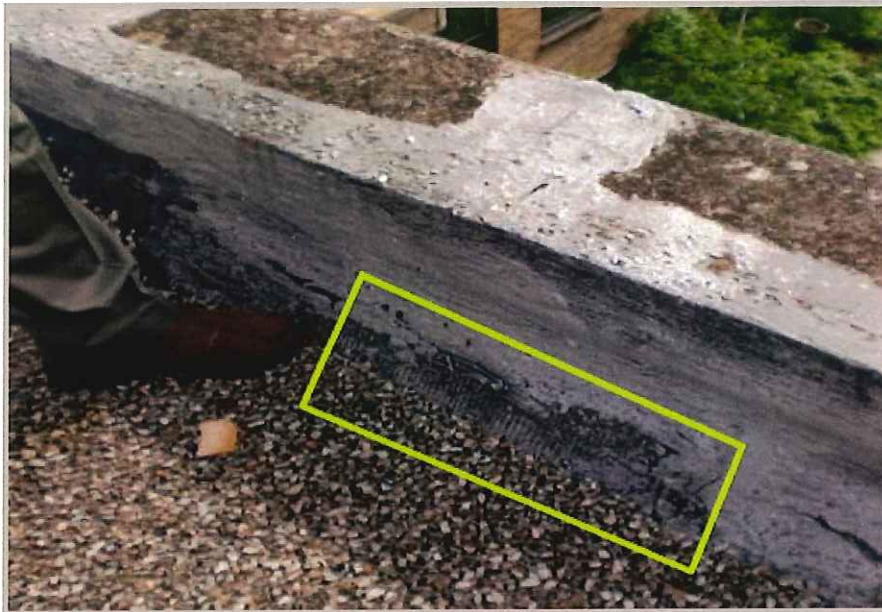
Membrane has worn away leaving the scrim exposed. UV rays are damaging to these types of areas.

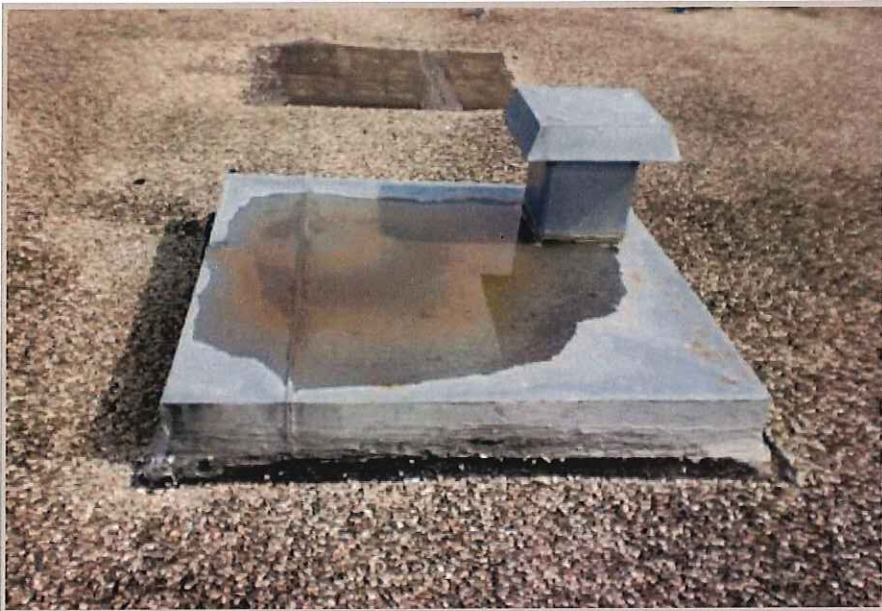
Flashings under the vents are in bad shape.

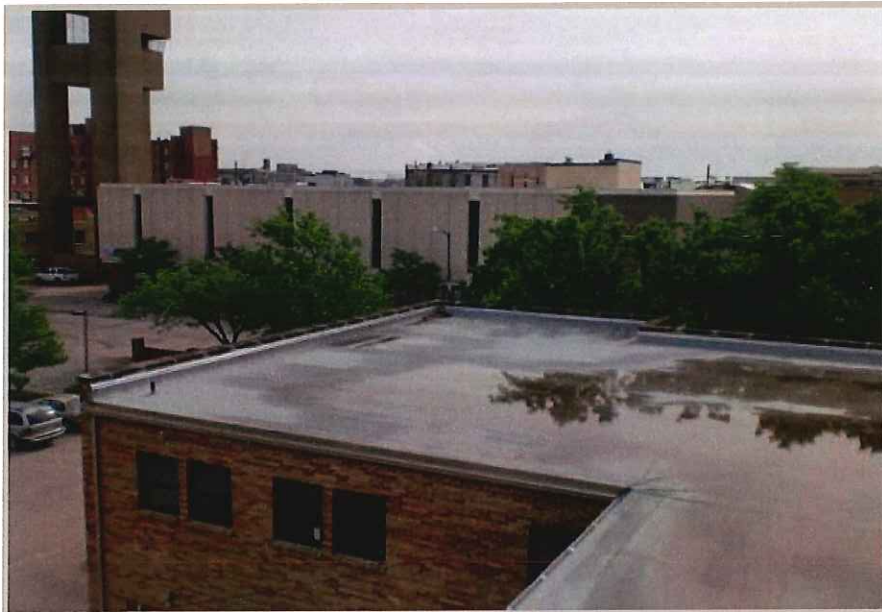
This roof has no drainage at all. All the water runs towards the Southeast corner with no where to go. The roofing system that has been installed on this facility is not designed to hold water and will only shorten the life of the system.

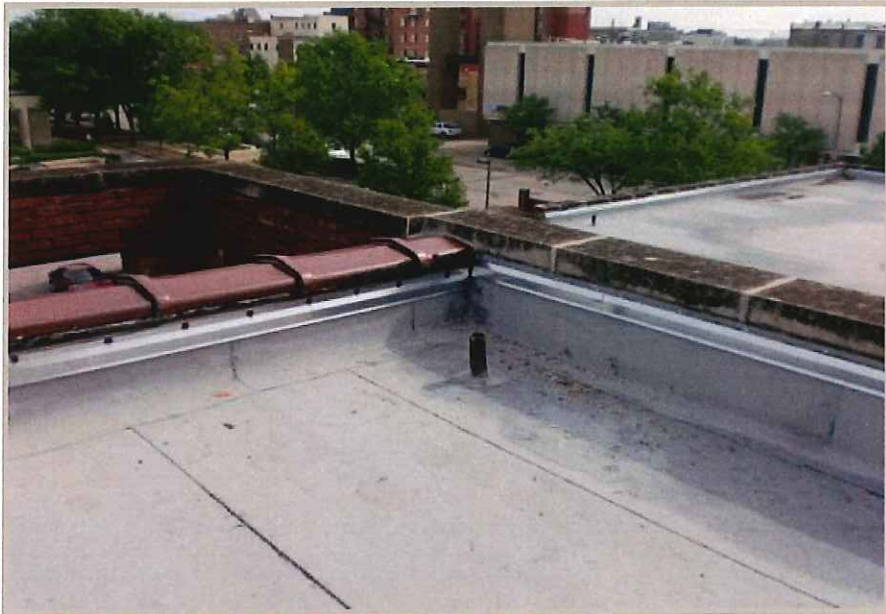
This section drains well and is in good shape.

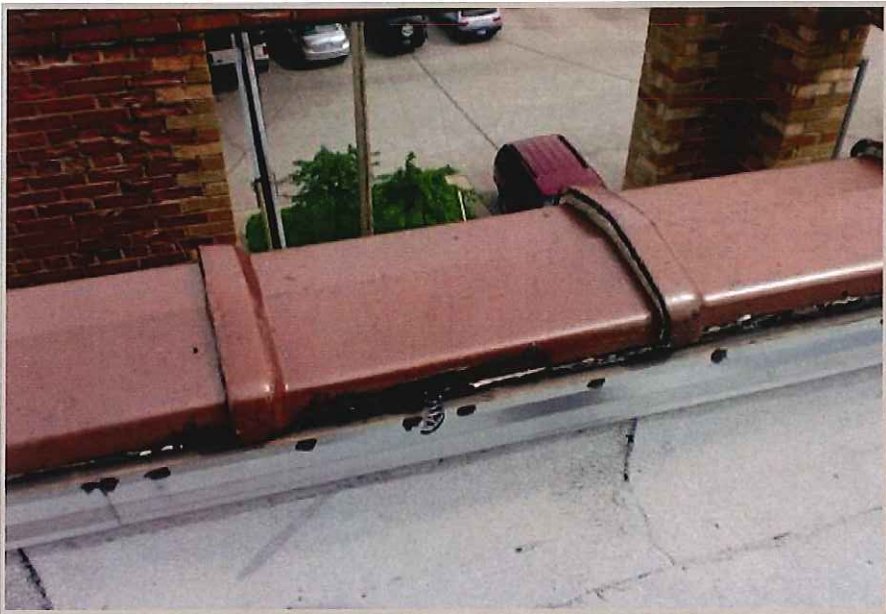
Poor repairs have been made on the Stone Coping Caps. Water is getting under the Stone Caps and draining inside the wall cavity.
