City of Lawrence

LAWRENCE HISTORIC RESOURCES COMMISSION
AGENDA FOR **JANUARY 17, 2019**
CITY HALL, 6 E 6TH STREET
6:00 PM

Clouse Inspection Services
Clouse Inspection Services, 1512 Burning Tree Ct.
Lawrence, Kansas 66047

816 Ohio, Lawrence, Ks

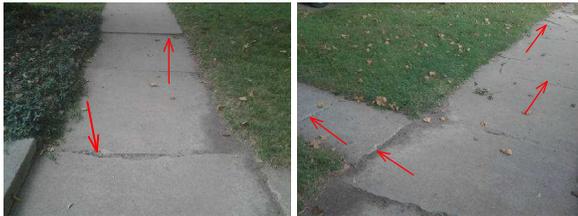
1. Walks: Concrete - Damaged or deteriorated, recommend estimate for repair or replacement by a licensed contractor.

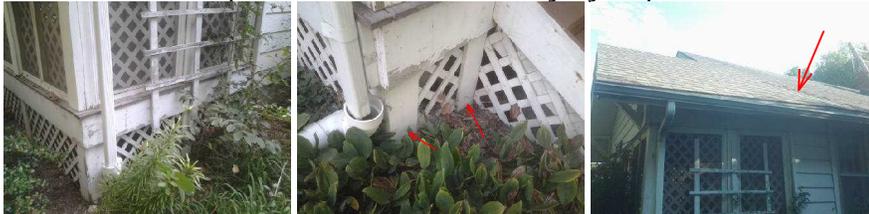
3. Porch: Wood - 1) It appears front porch may have settled putting stress on roof components. 2) Wood support posts are in soil, this does not meet today's standards. Recommend further evaluation and repair as deemed necessary by a qualified contractor.

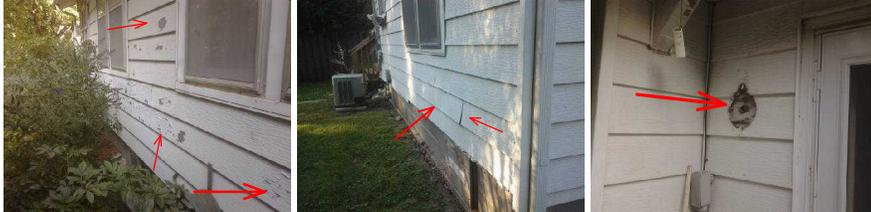
1. Type: Aluminum siding - :1) Loose and damaged siding. 2) Paint peeling. Recommend further evaluation and repair by a qualified contractor.

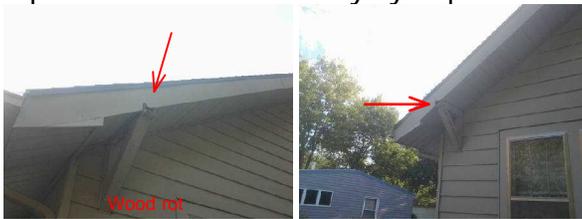
2. Trim: Wood, Aluminum - Wood rot or moisture damage noted. This condition may let moisture enter these areas and damage other building components. Recommend further evaluation and repair as deemed necessary by a qualified contractor.

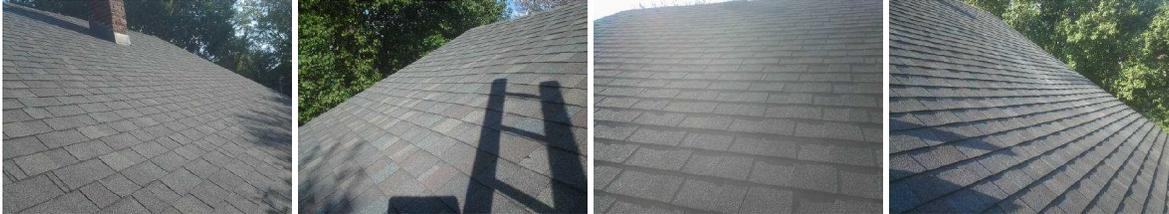
2. Unable to Inspect: 100%
3. Material: Asphalt shingle
4. Type: Gable
5. Approximate Age: 5-10
6. Flashing: Aluminum - Nail heads are not sealed. This condition presents an area that moisture may enter and damage building materials. Recommend further evaluation and repair by a qualified roofing contractor.

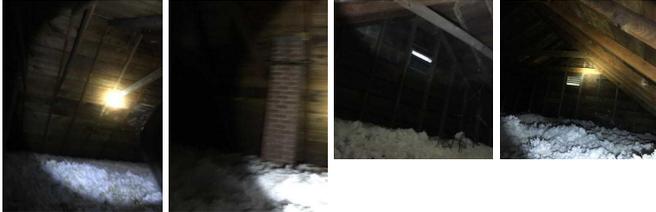
2. Unable to Inspect: 100%
3. Roof Framing: 2x4 Rafter - The roof structure is 2x4 rafters, vertical support members are not noted at time of inspection. Recommend further evaluation and repair as deemed necessary by a qualified contractor.
4. Sheathing: Dimensional wood
5. Ventilation: Gable and roof
6. Insulation: Blown in, Fiberglass
7. Insulation Depth: 10"
8. Moisture Penetration: None noted at time of inspection.
9. Bathroom Fan Venting: Electric fan

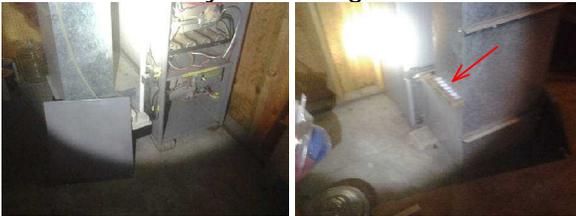
10. Distribution: Metal duct
11. Circulator: Gravity
12. Draft Control: Automatic
13. Flue Pipe: Single wall - Unit may be venting into unlined chimney. Recommend further evaluation and repair as deemed necessary by a qualified contractor.

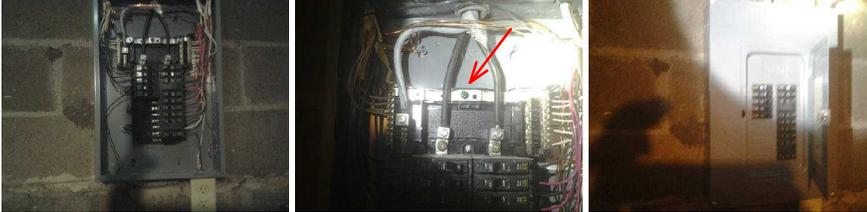
8. Manufacturer: Square D - The panel located in basement is a bonded downstream panel, downstream panels should not be bonded. Recommend further evaluation and repair by a qualified electrical contractor.

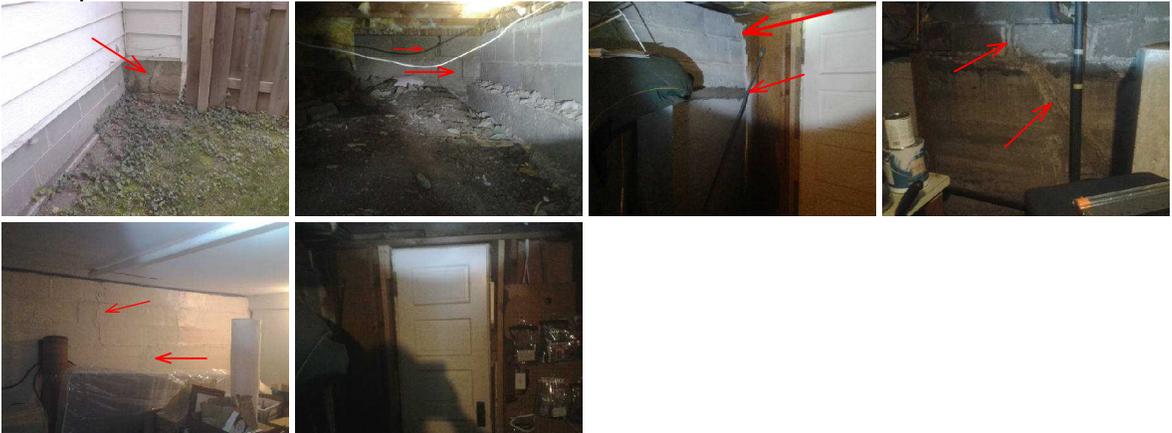
1. Structure Type: Wood frame
2. Foundation: Concrete
3. Differential Movement: Crack with displacement - 1) Noted cracks with differential movement. 2) It should be noted the basement and main floors appear to be sloped to northwest corner of the home. :Recommend further evaluation by a qualified concrete specialty contractor or structural engineer prior to the end of the inspection contingency period to determine the scope of repair necessary to assure the foundation system will perform as intended including costs for the repair.

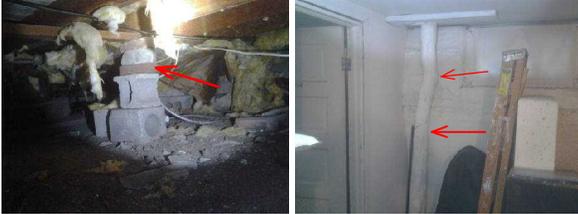
- 4. Beams:
- 5. Bearing Walls: Frame
- 6. Joists/Trusses: 2x8
- 7. Piers/Posts: Block piers and brick piers - 1) Improper support pier in crawl space. 2) Improper support post in basement. Recommend further evaluation and repair by a qualified contractor.

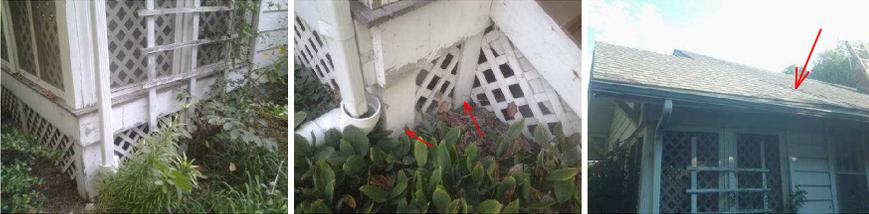
1. Porch: Wood - 1) It appears front porch may have settled putting stress on roof components. 2) Wood support posts are in soil, this does not meet today's standards. Recommend further evaluation and repair as deemed necessary by a qualified contractor.

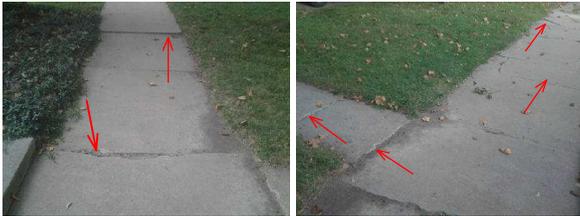
1. Walks: Concrete - Damaged or deteriorated, recommend estimate for repair or replacement by a licensed contractor.

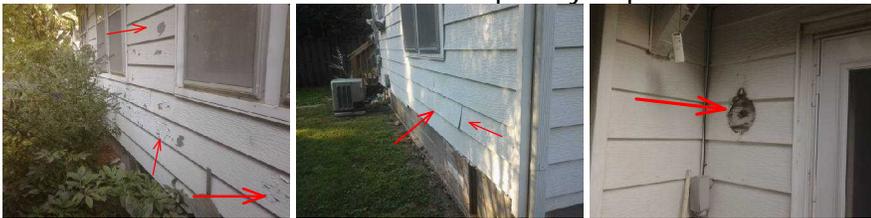
2. Entire home Exterior Surface Type: Aluminum siding - :1) Loose and damaged siding. 2) Paint peeling. Recommend further evaluation and repair by a qualified contractor.

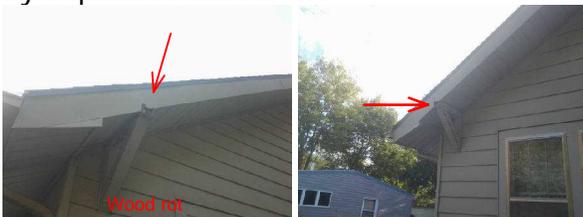
3. Trim: Wood, Aluminum - Wood rot or moisture damage noted. This condition may let moisture enter these areas and damage other building components. Recommend further evaluation and repair as deemed necessary by a qualified contractor.

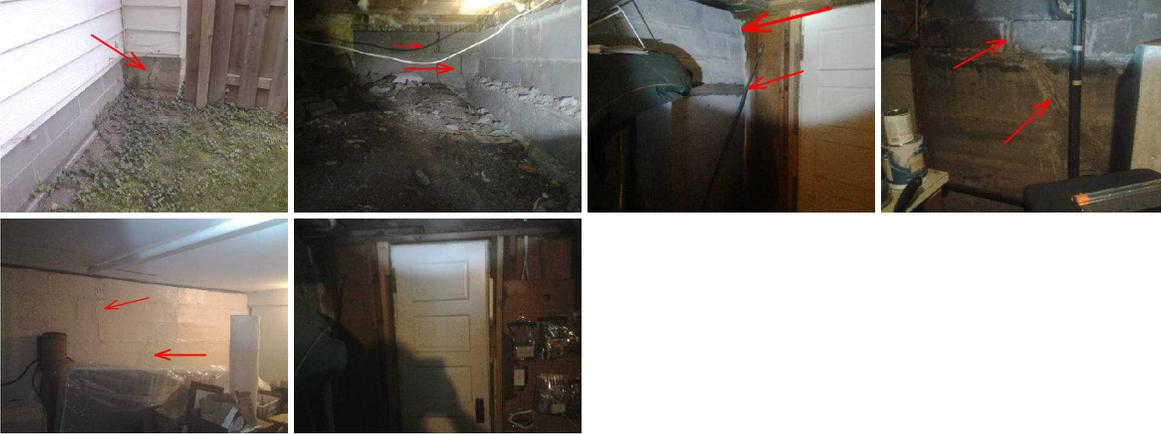
Differential Movement: (continued)

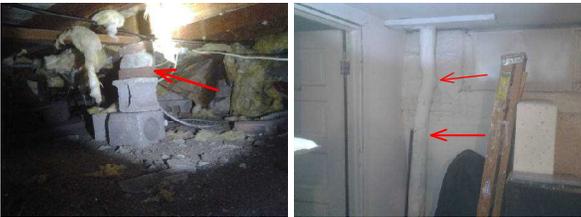
12. Piers/Posts: Block piers and brick piers - 1) Improper support pier in crawl space. 2) Improper support post in basement. Recommend further evaluation and repair by a qualified contractor.
