# Memorandum

## City of Lawrence

**TO:** David Corliss  
**FROM:** Jeanette Klamm  
**CC:** Dave Wagner  
Mike Lawless  
Philip Ciesielski  
**Date:** November 13, 2012  
**RE:** Oread water tank inspection results

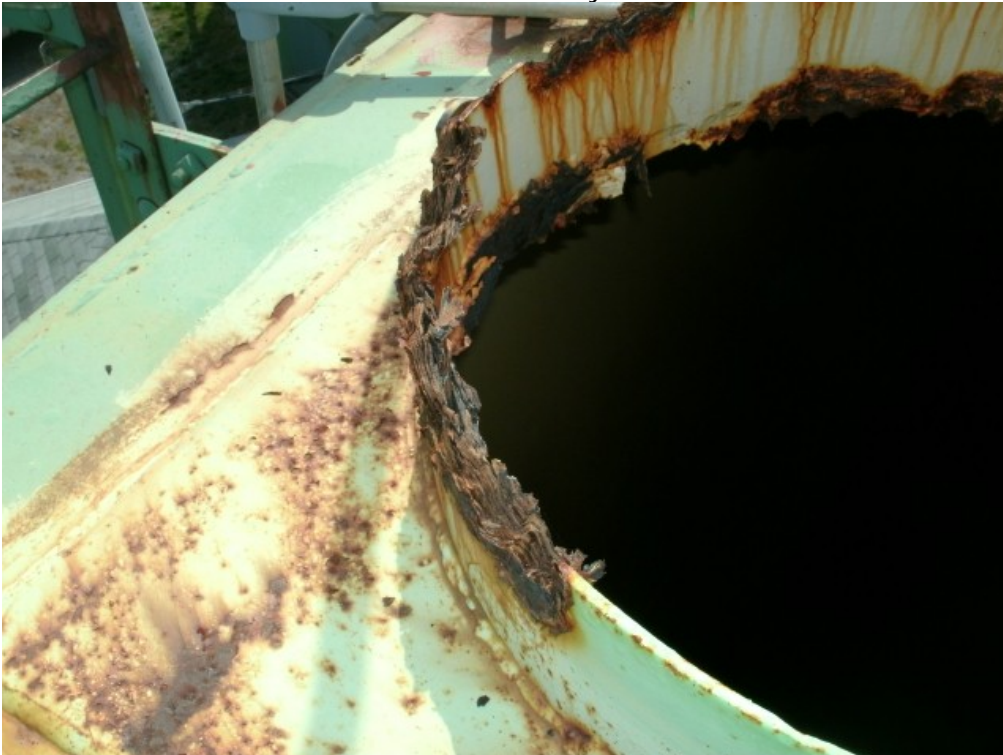
The roof hatch on the north tank shows heavy corrosion.

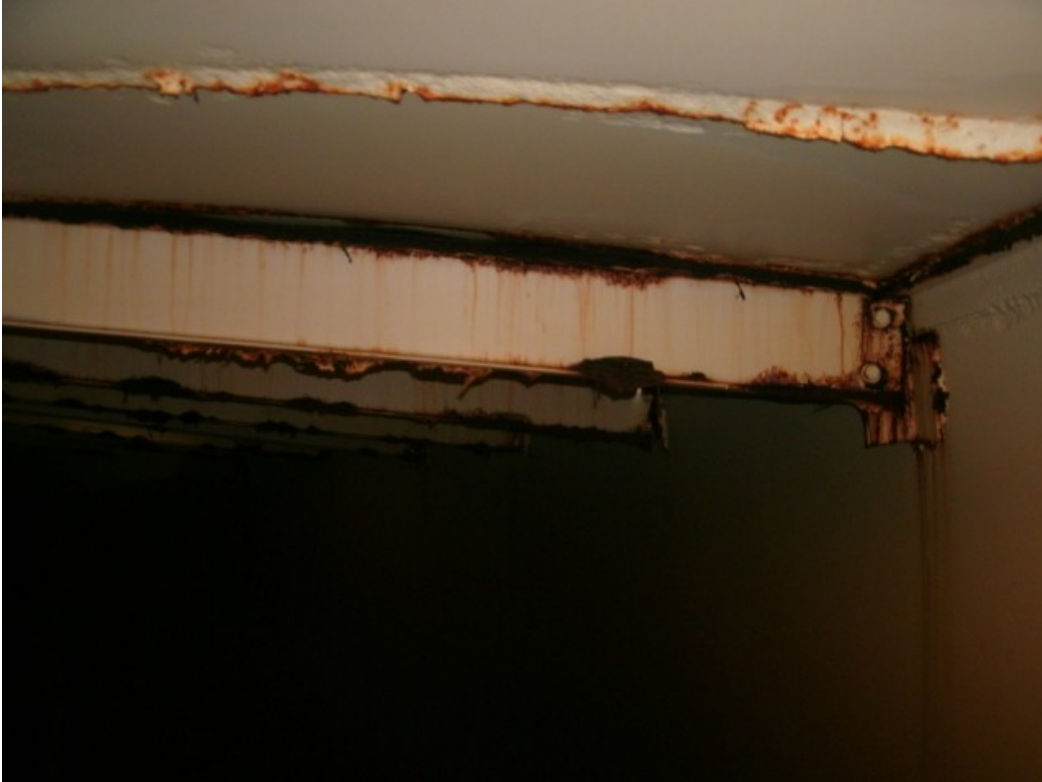
Roof beams show significant deterioration of the metal and coating, as well as corrosion.

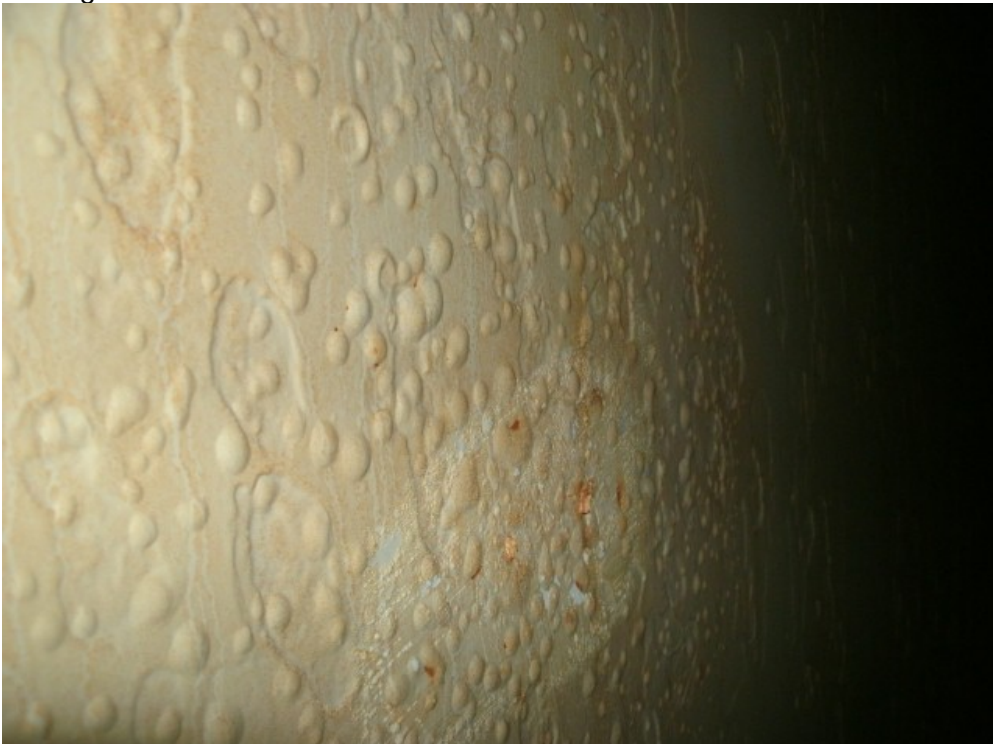
Coatings on the interior walls show severe blistering caused by moisture under the coating.

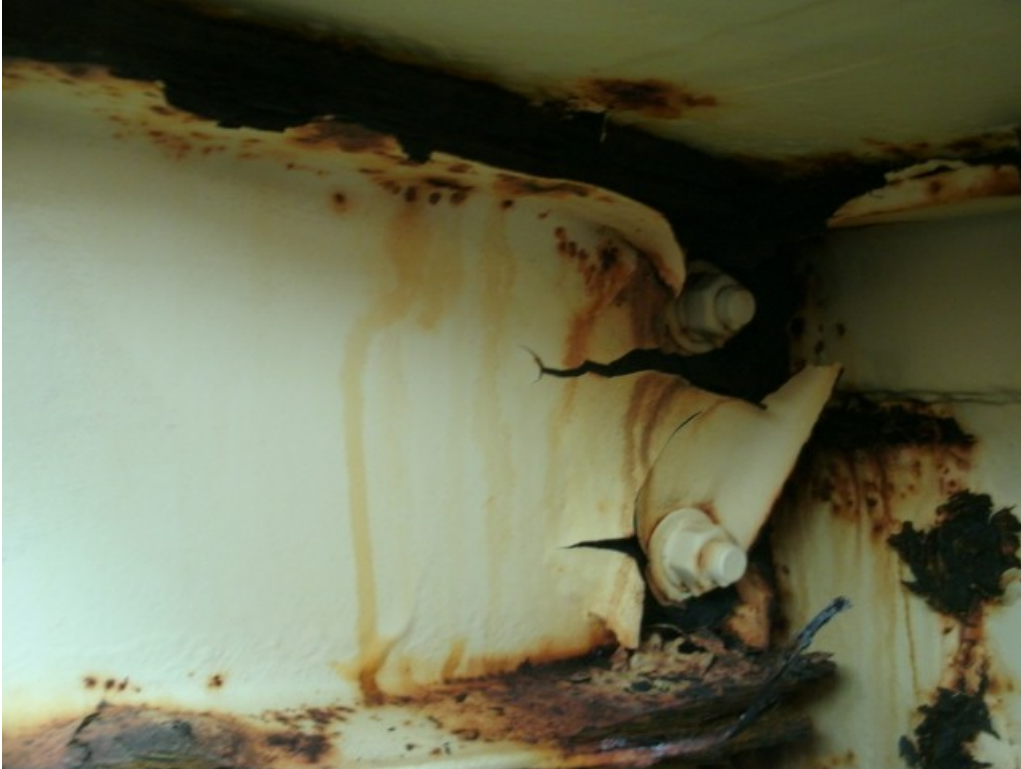
Severe corrosion and coating failure as seen on the below beam as it attaches to the roof and sidewall.

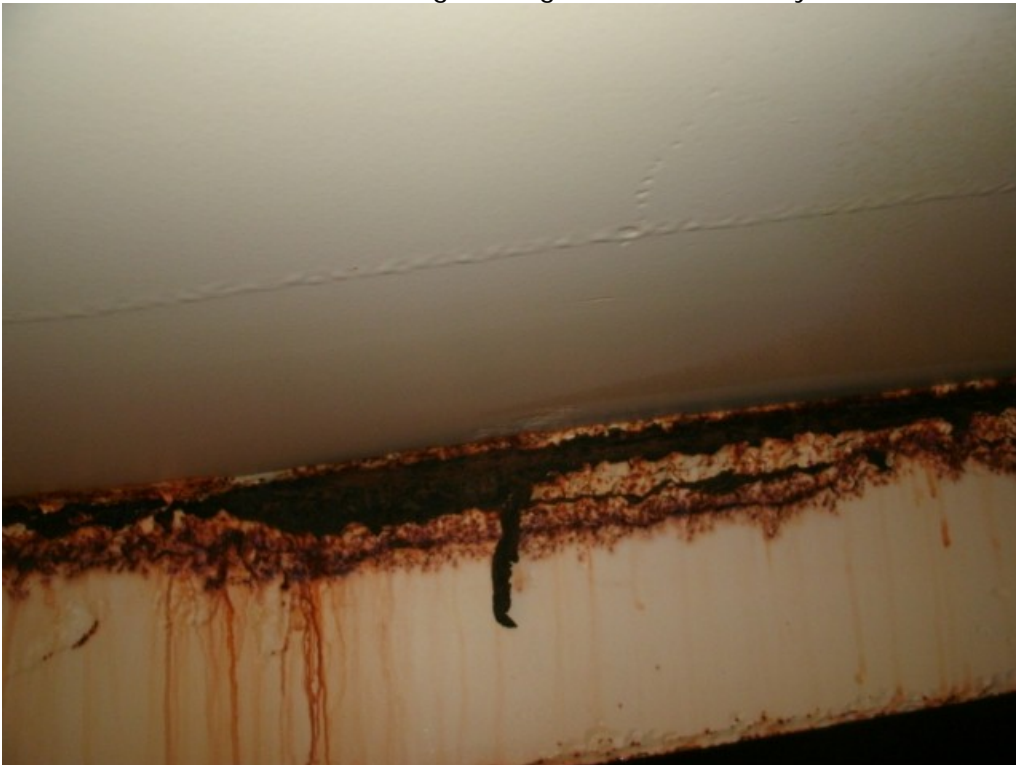
Corrosion has deteriorated coating causing metal loss of many of the roof beams.

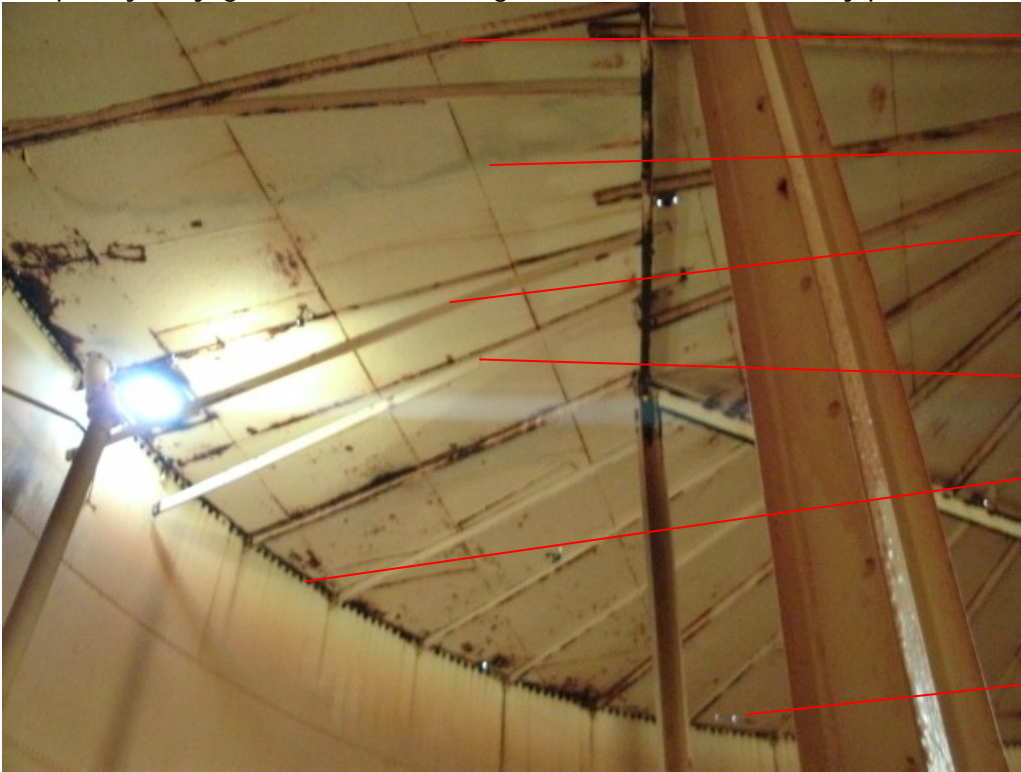
Several roof beams have come loose and hang from the roof, as well as one missing completely. Daylight also shows through holes in the roof in many places.

Beam loose and hanging.

Beam missing.

Beam loose and laying on brace.

Severe corrosion and missing rivets at sidewall/roof seam.

Two of the many holes in the roof.

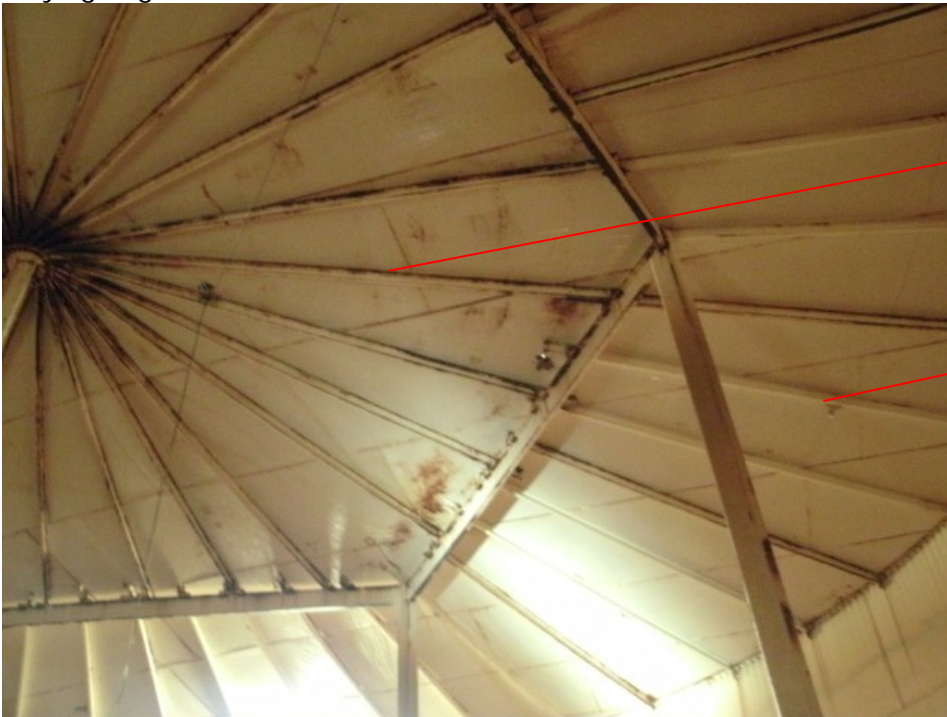
72 beams support the roof, 24 on the interior ring and 48 on the exterior ring. All have varying degrees of corrosion.

24 Interior Ring Beams.

48 Exterior Ring Beams.

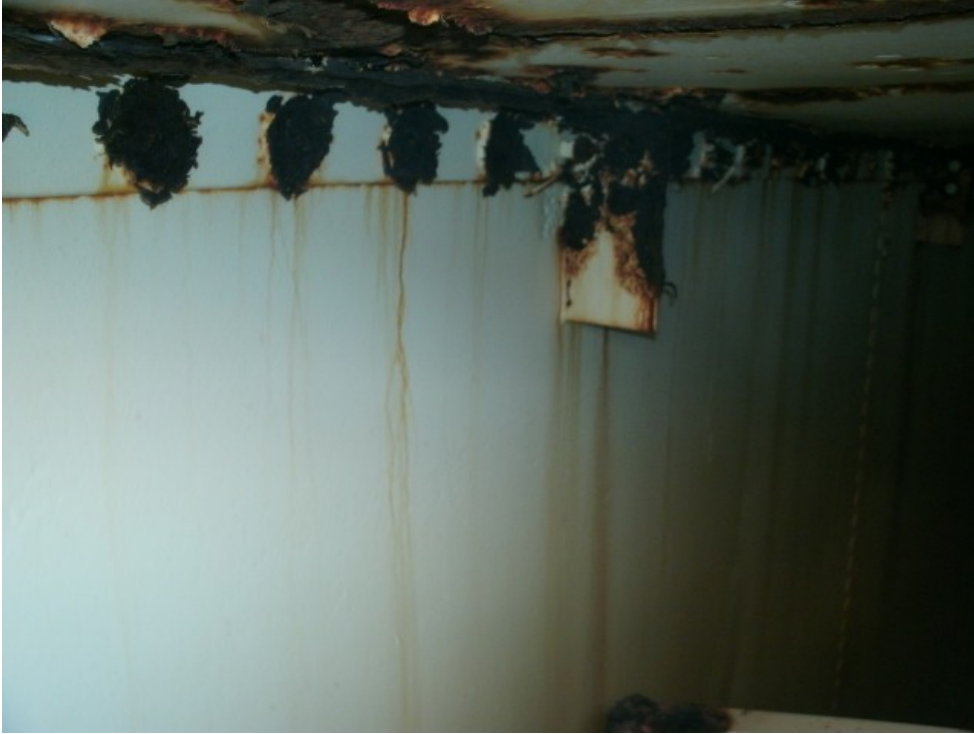
Corrosion of the rivets at the sidewall and roof seam has corroded into the metal.

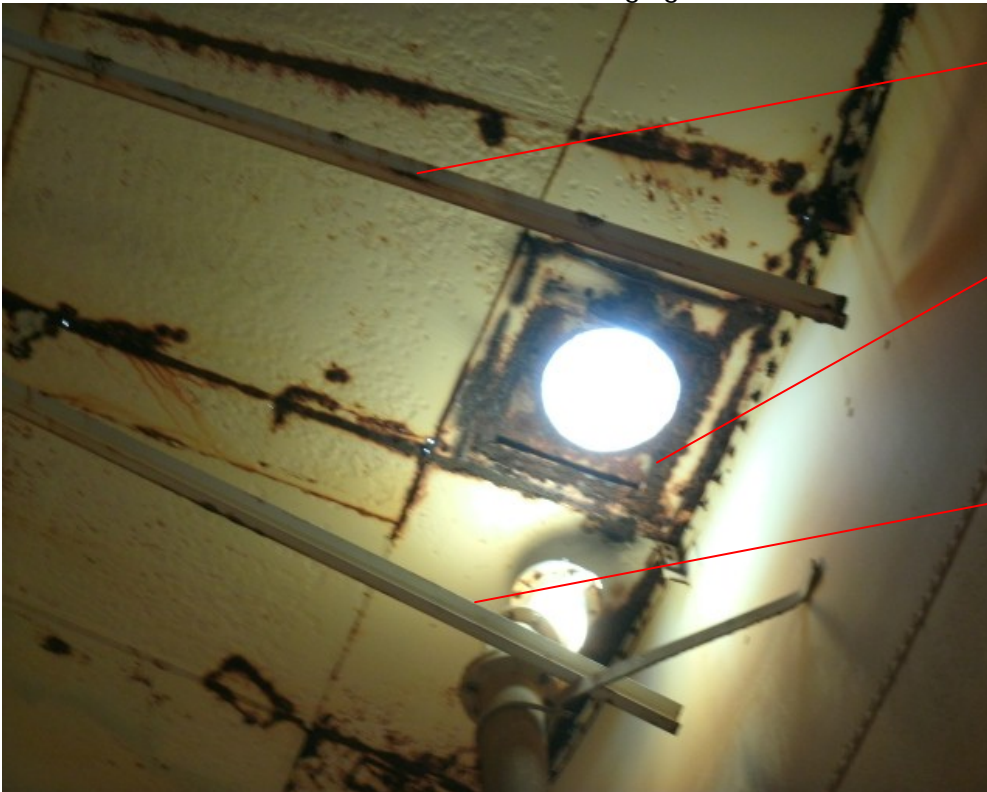
Severe corrosion around the roof hatch and hanging roof beams.

Beam loose and hanging.

Severe corrosion of roof hatch.

Beam loose and laying on brace.

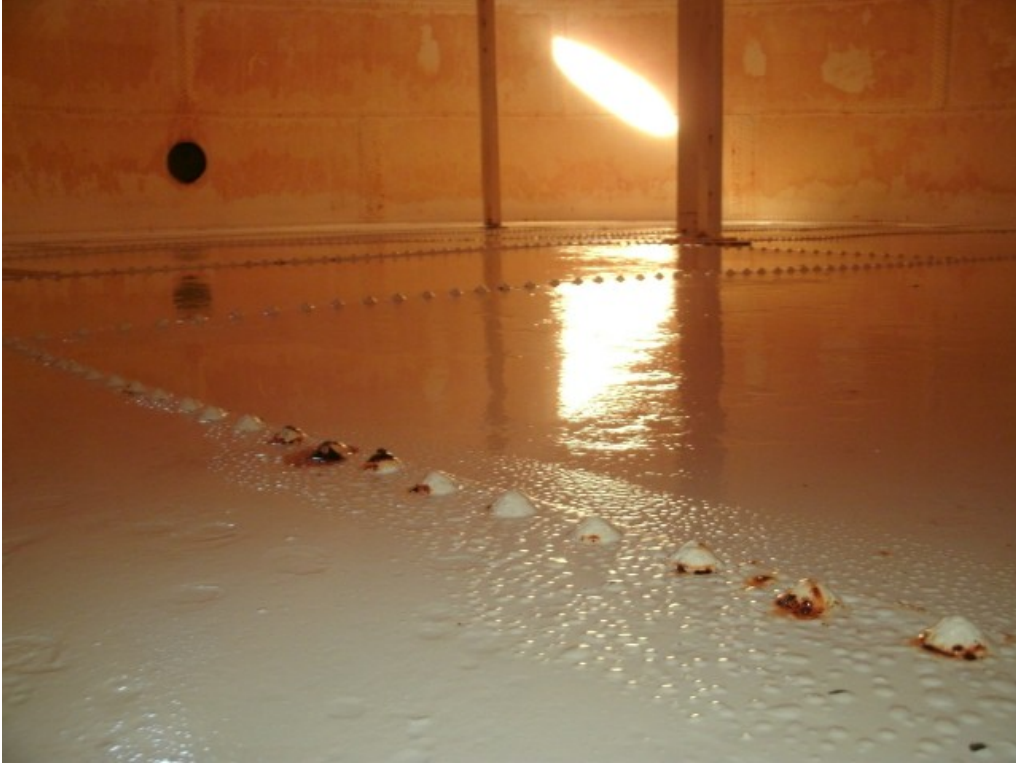
Blisters in the coating of the tank bottom, indicating moisture under the coating.

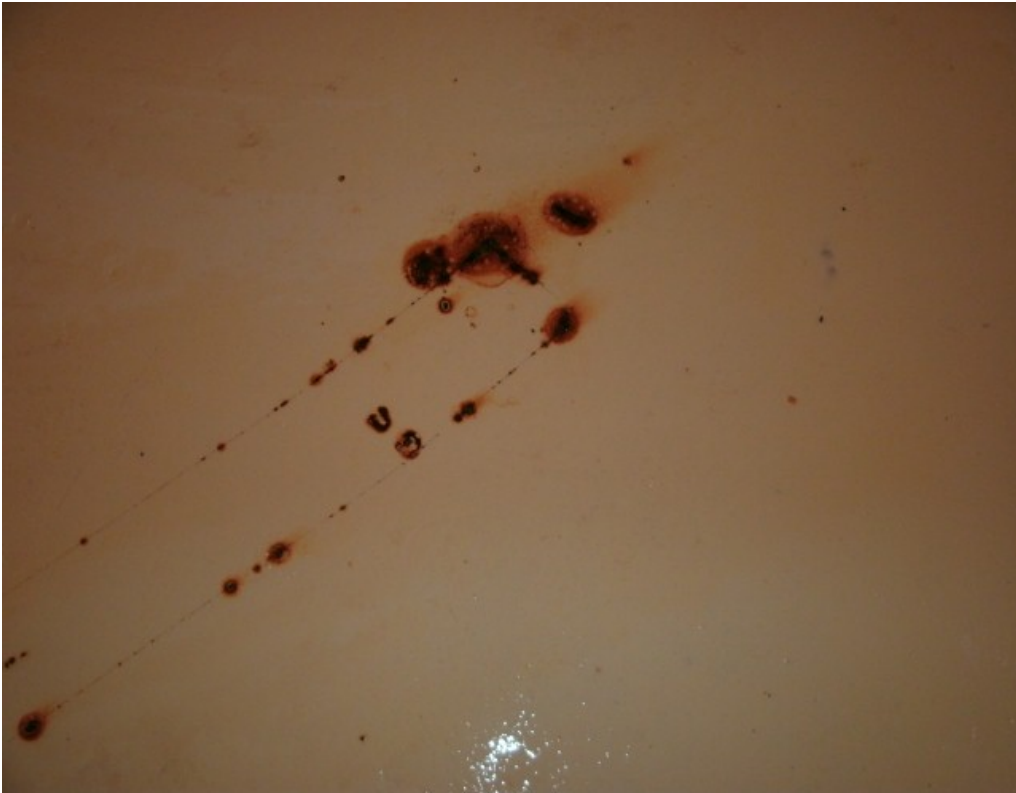
Corrosion caused by the missing roof beam that possibly fell and lay on the floor of the tank.

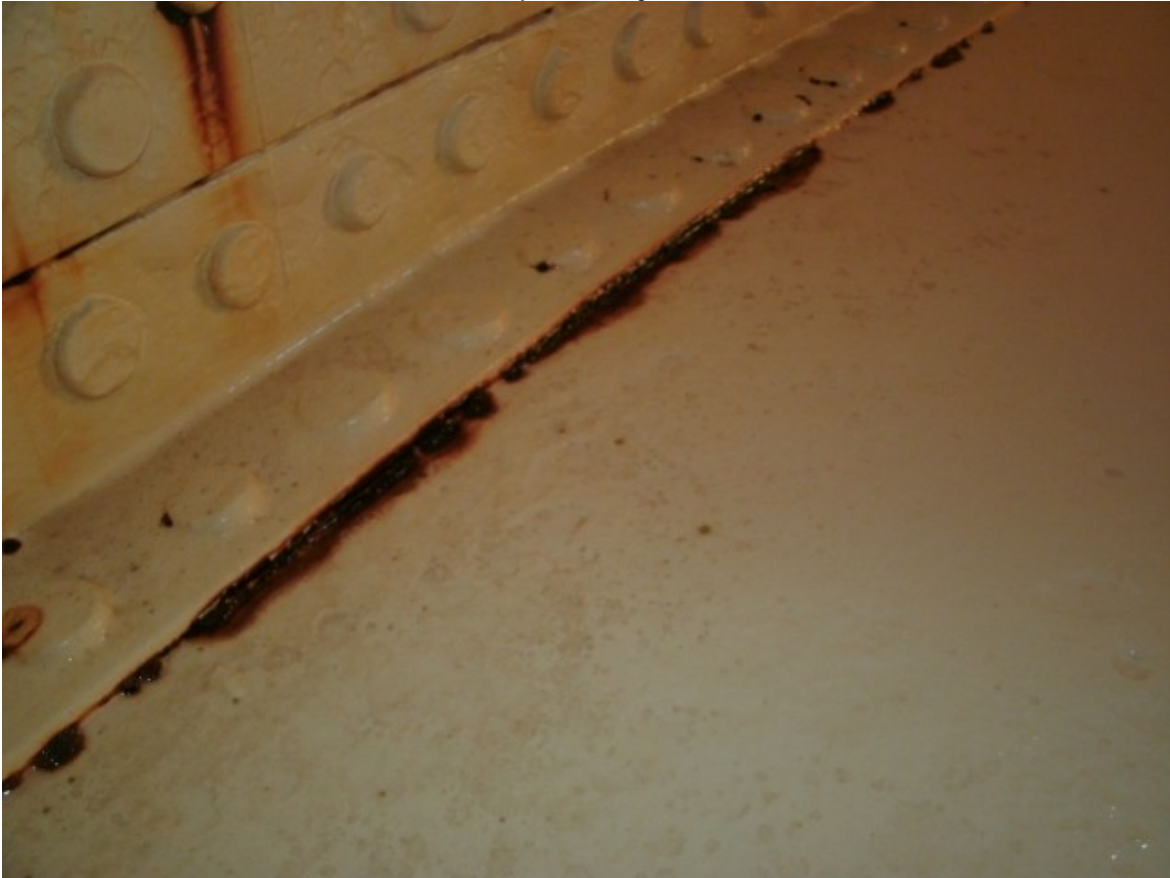
Corrosion near the sidewall/floor seam, potentially the cause of a leak in the tank.
