City of Lawrence, KS  
Stratford Elevated Water Storage Tank  
Preliminary Alternatives Evaluation Report (Phase 1) - FINAL

B&V Project 184715  
B&V File 50.1000  
December 17, 2014

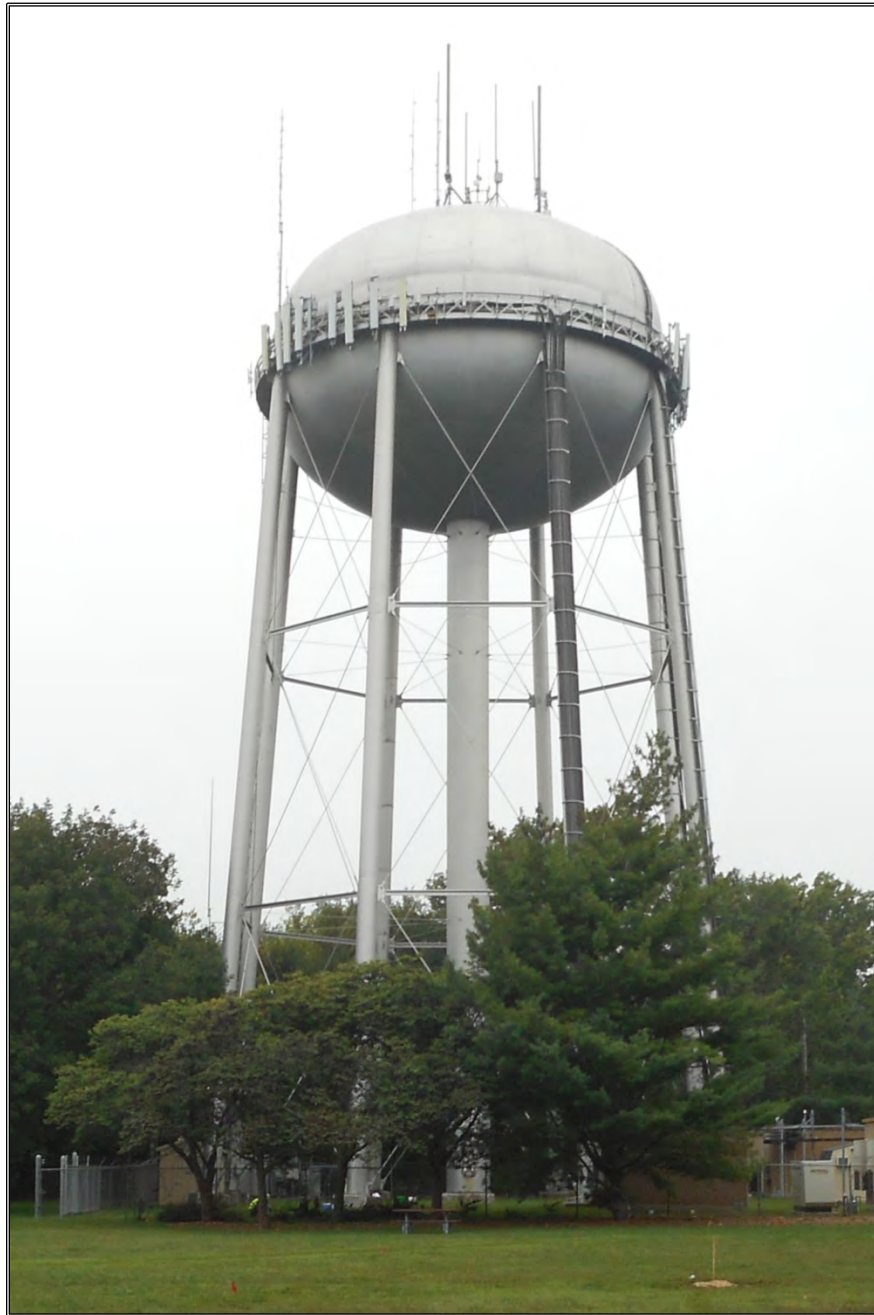
**Photo 1: Overall View of Stratford Elevated Storage Tank.**

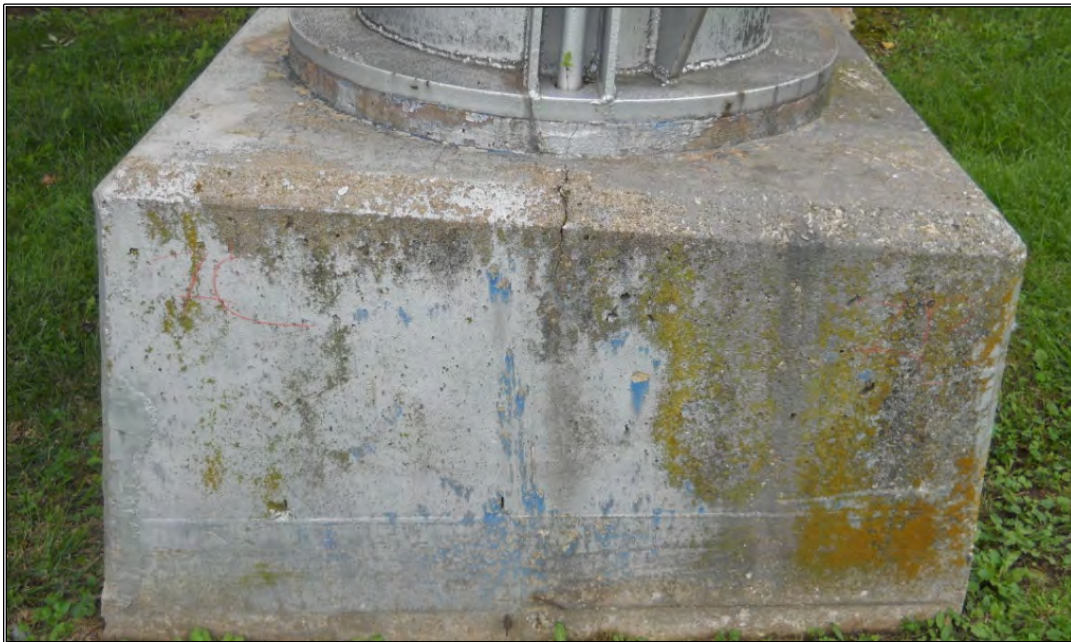
Generally the eight support leg foundations are sound but have minor isolated cracking. The isolated cracking occurs adjacent to each of the two anchor bolts at each of the eight foundations as shown in Photo 2 and Photo 3. The widths varied from hairline to 0.05 inch wide. These cracks appear to have been present for an extended time based on coloration and sediment in the openings.

**Photo 2: Overall View of Support Leg Footings.**

- Inject cracks with structural epoxy to prevent future deterioration.
- Patch and repair any spalled surfaces prior to structural epoxy injection. After spalls are repaired the structural epoxy will glue the surfaces of the crack together in order to return the footings monolithic behavior and prevent any loss in anchorage capacity.

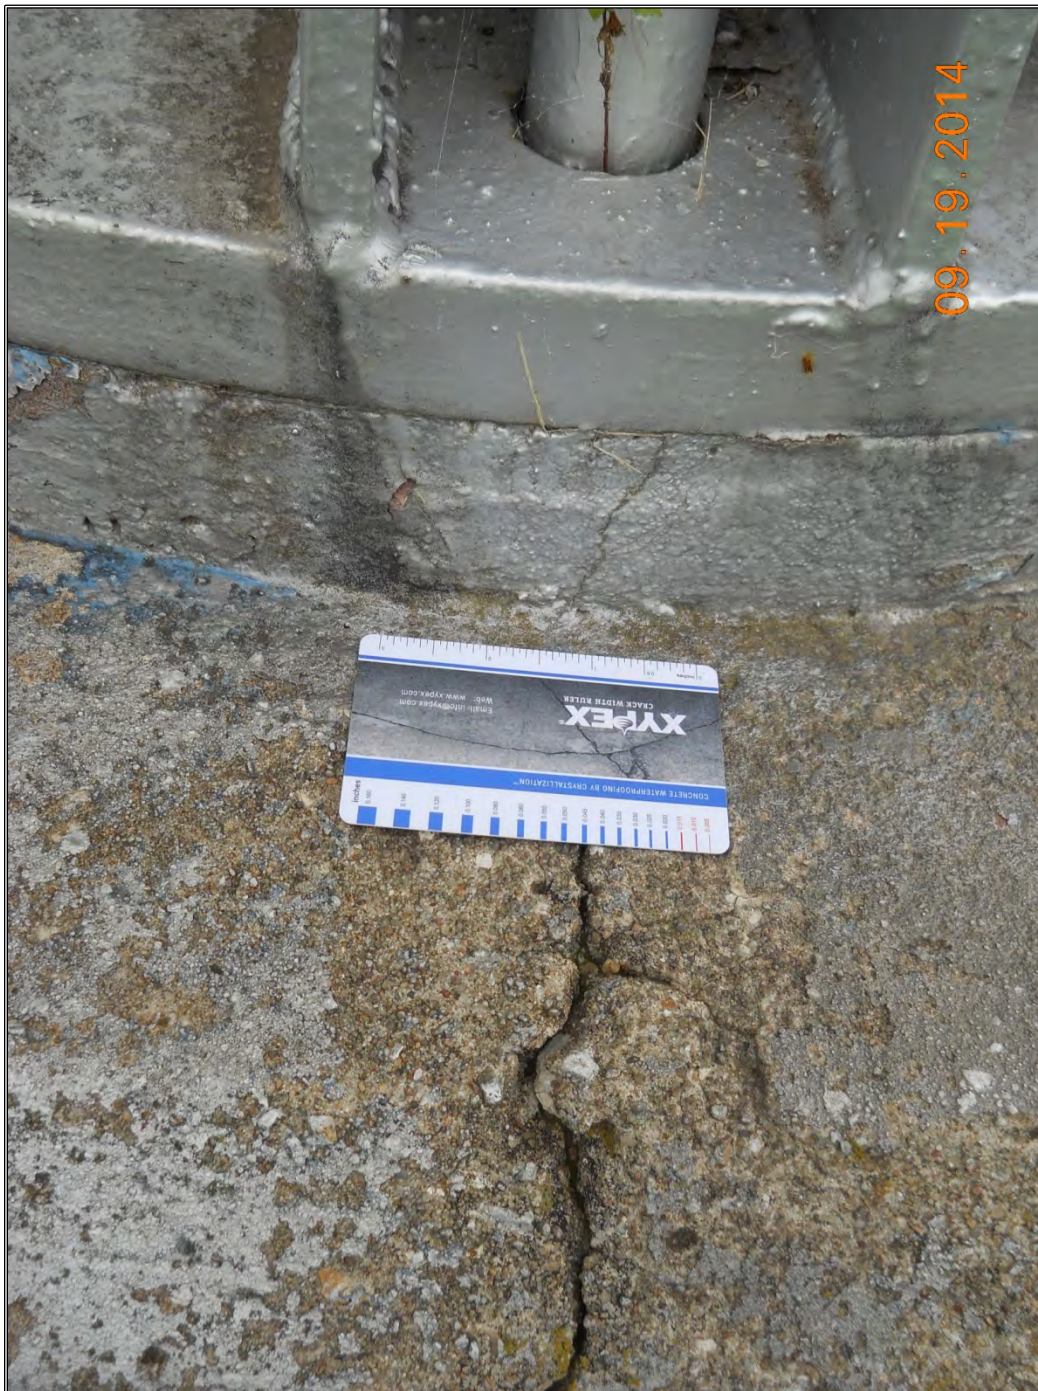
**Photo 3: Close up View of 0.05inch wide Crack with Spalling in Footing.**

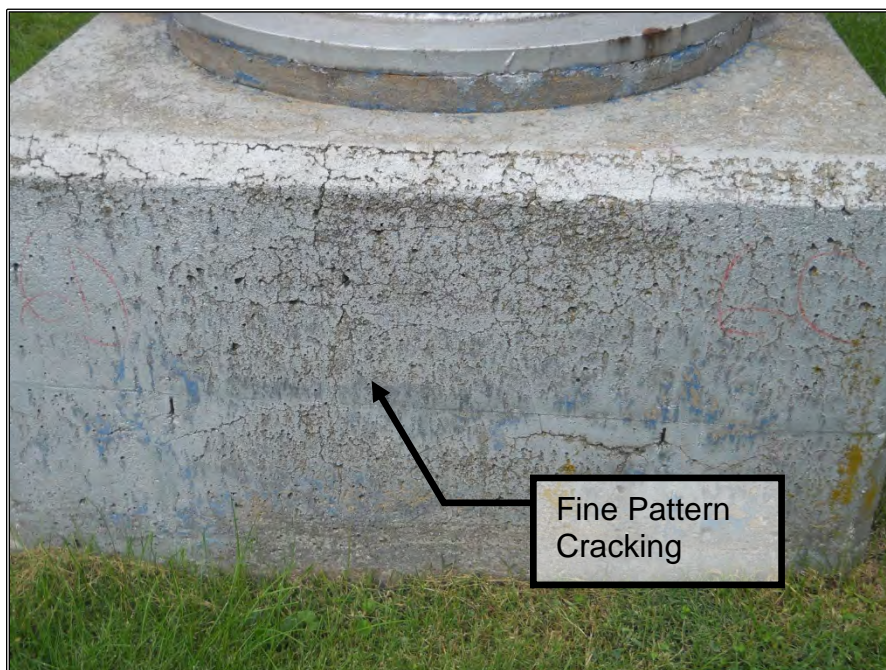
Throughout the eight support foundations and the riser foundation there is pattern cracking. The pattern cracking varies in severity from fine to severe. At the fine level the cracking is just apparent whereas at the severe level layers of aggregate are loose and as much as 2 inches of concrete has disintegrated. The worst case pattern cracking occurs at the riser foundation. At this location the concrete when hammer sounded was soft and friable. The respective pattern cracking is shown in Photo 4 and Photo 5. Additionally the grout under the riser bottom flange has spalled out reducing the bearing area of the riser bottom ring. The loss of grout is shown in Photo 6.

**Photo 4: Fine Pattern Cracking at Footing No. 6.**

Pattern cracking and areas of isolated cracking are present in the concrete foundations. Typically pattern cracking in concrete foundation is more concerning than isolated cracking, and may be due to a number of causes. One potential cause of the pattern cracking may be a chemical reaction within the concrete. Pattern cracking observed at the riser foundation resembles reactive aggregates or carbonation of the concrete. This pattern cracking was present at the riser foundation but not at the support leg foundations; however, this does not necessarily mean that reactive aggregates are not present in the support leg foundations. If reactive aggregates were present in the riser foundation, they would also likely be present in the support leg foundations but not yet exhibiting signs of degradation.

Another cause may be freeze thaw damage which occurs in concrete that was not air entrained. Air-entraining is essential because it creates optimum internal voids structure. If concrete is not air-entrained the expansion of water in the internal voids destroys the concrete matrix. The center riser foundation is the most likely foundation to be susceptible to this damage because the flat top surface would allow ponding and saturation, whereas the perimeter support leg foundations have a sloped top surface.

All of these possible causes of deterioration require unique solutions ranging from a simple patch of the exposed concrete surfaces to removal and replacement of the concrete footings. Petrographic testing of core drilled samples is required to better determine the cause of the deterioration and to determine the most appropriate long term fix. Petrographic testing would provide an estimated remaining life expectancy of the concrete footings. Petrographic testing would range in cost from \$40,000 to \$60,000 and testing results can take six months, from the time samples are received at the lab, to receive results. The cost provided for petrographic testing would cover testing of all concrete foundations.

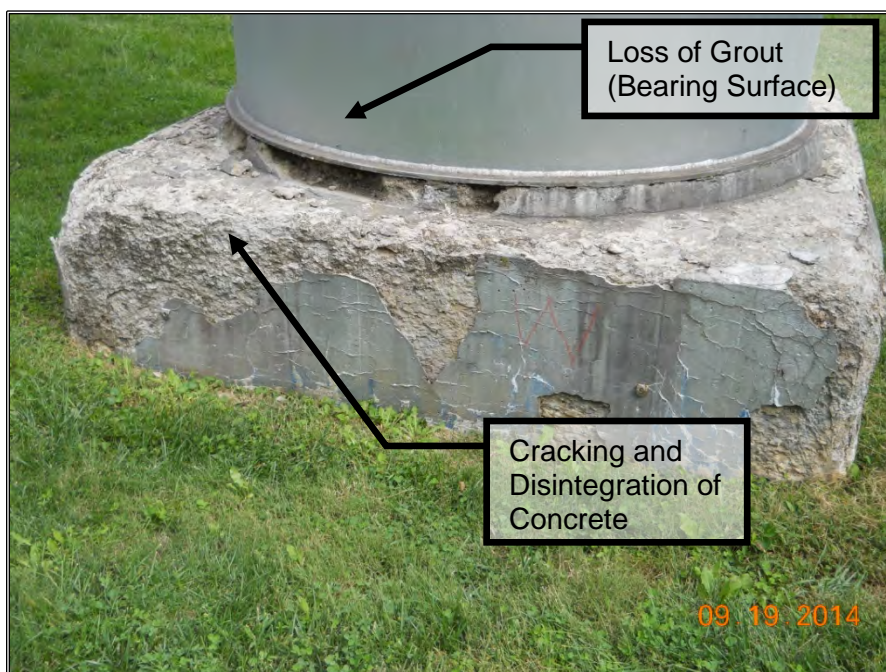
**Photo 5: Severe Pattern Cracking and Disintegration of Concrete at Riser Footing.**

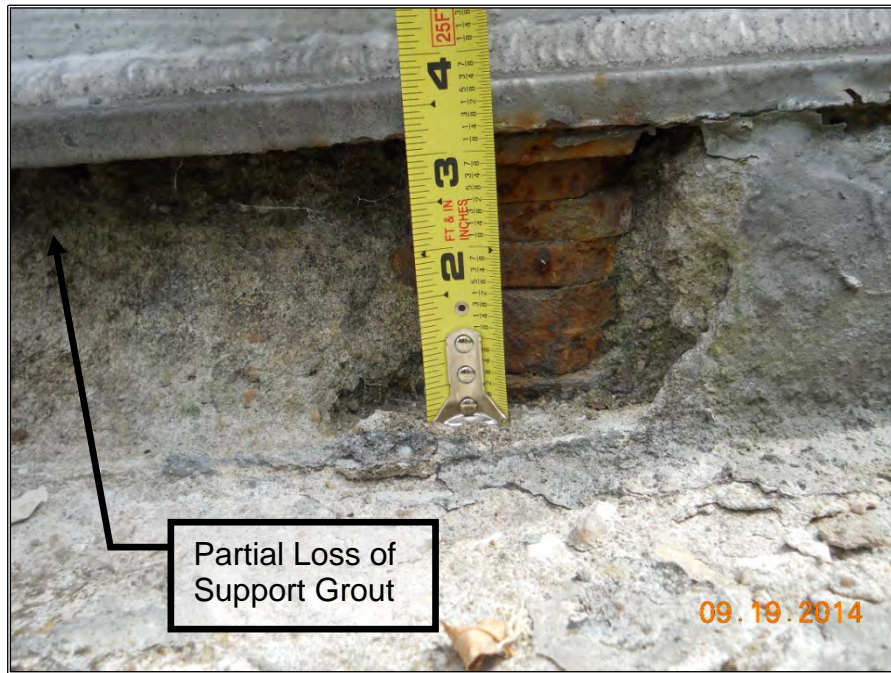
**Photo 6: Close Up View of Grout Loss. Original Steel Construction Shims are Exposed.**

- Patch the spalled grout at the riser bearing ring. This can be done with standard non-shrink grout following the manufacturer's recommendations for surface preparation, mixing, placement and curing. Of particular importance is to remove all loose materials prior to

cleaning and surface preparation. We recommend using a scrub coat for bonding preparation versus options utilizing bonding agents.

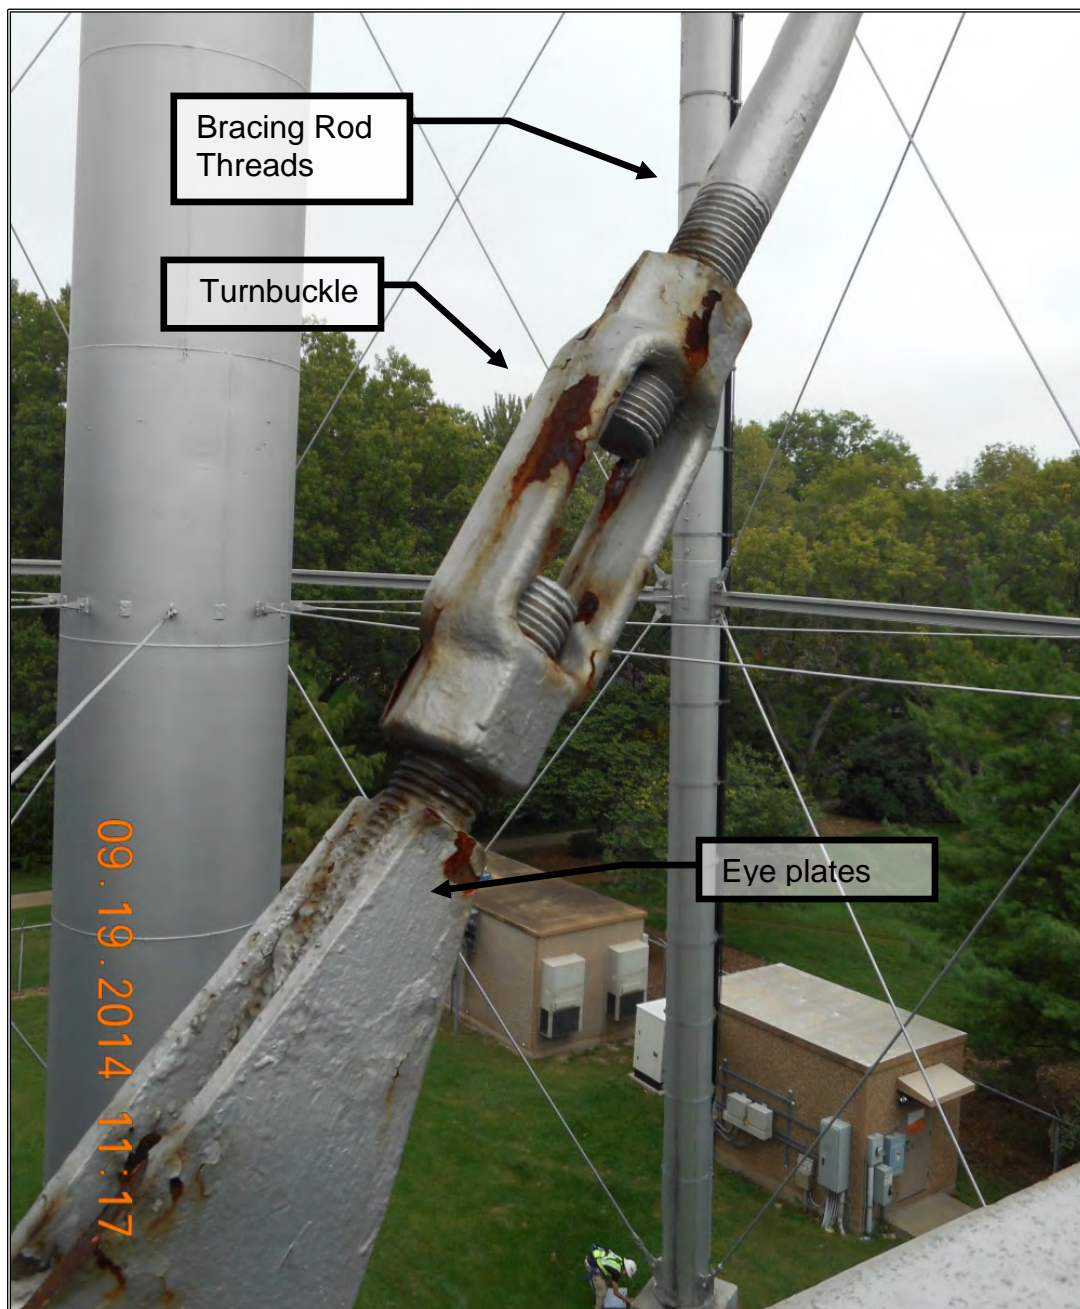
The elevated tank support legs and bracing appear to be in adequate structural condition. Only one brace rod appeared to have a slight kink. This kink is indistinguishable in photos. All other items appeared to be in alignment and have only sporadic surface corrosion at failures in the coating system. The existing coating system showed signs of deterioration throughout. In particular most edges, threads, and points of metal to metal contact are chipped, pitting, or worn. These failures are most prevalent on the rod bracing threaded ends, turnbuckles, eye plates, and gusset plates as shown in Photo 7 and Photo 8.

**Photo 7: Surface Corrosion at Chipped, Cracked, and Pitted Coating.**

Finally of significant note regarding the elevated tank superstructure are the coating failures. These failures are all currently small in nature but are numerous on the exterior and appear to be more significant at the visible portions of the interior. It is apparent that the coating has reached the end of its useable life. If this tank is to remain in long term service it will need to be recoated. Patching of the isolated chips, cracks and pitting will not provide a long term solution. The entire tank should be coated. Specifically we recommend coating both the interior and exterior of the tank.

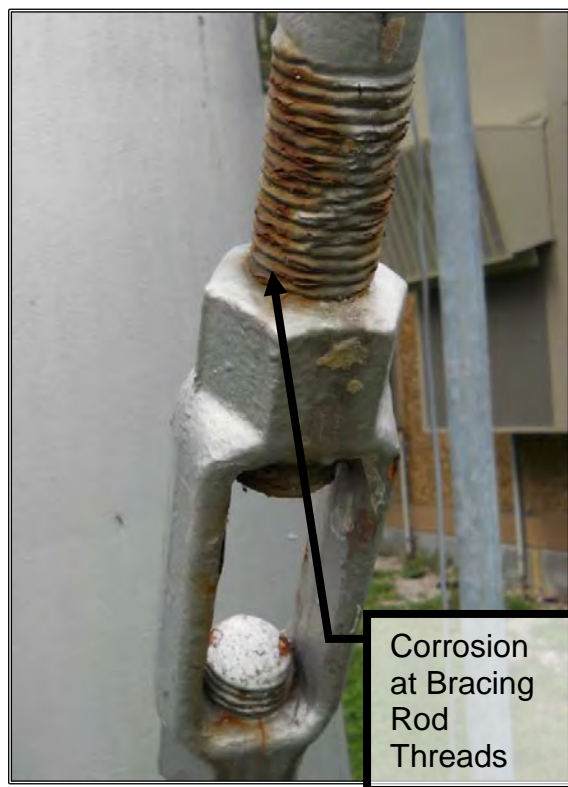
**Photo 8: Surface Corrosion on Threaded Bracing Rods.**

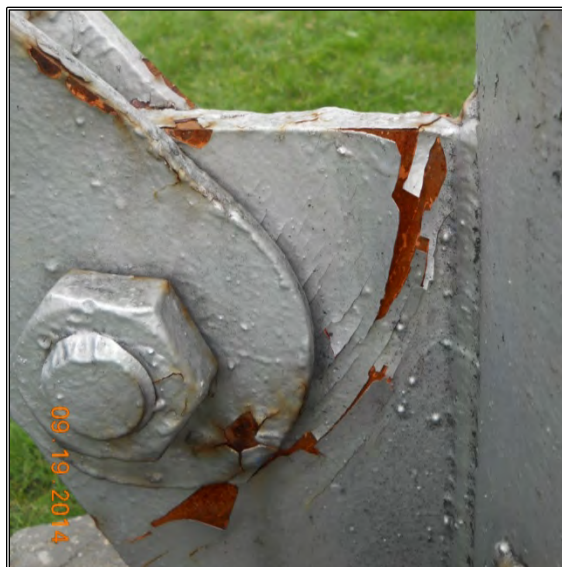
Surface corrosion was also commonly found at the gusset to support leg weld. Photo 9 and Photo 10 show samples of this corrosion. Additionally the support legs have isolated small areas that are pitting with occasional areas of chipping. One location of pitting is shown in Photo 11. Further coating system failures were found at joints and edges of the support legs. Photo 12 illustrates coating failures at the top of support legs.

**Photo 9: Cracking and Chipping of Coating on Gussets.**

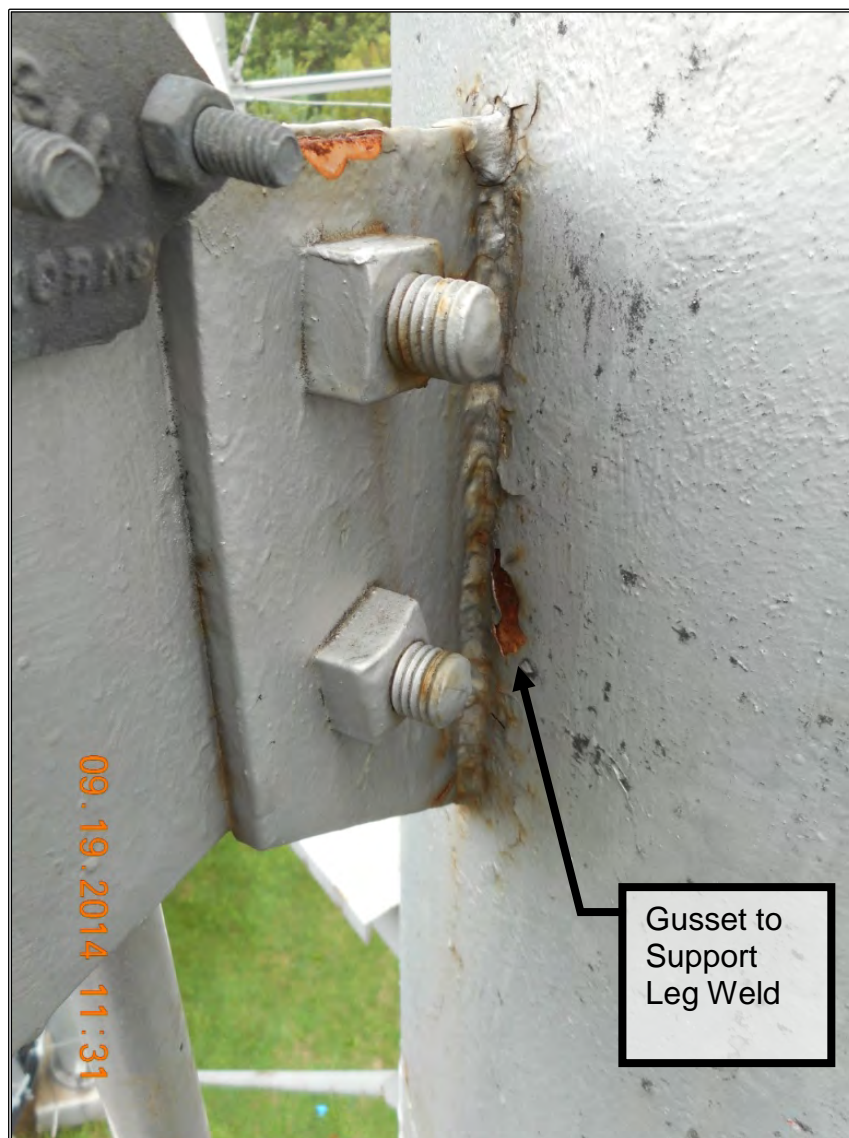
**Photo 10: Surface Corrosion and Cracked Coating at Gusset to Support Leg Connections.**

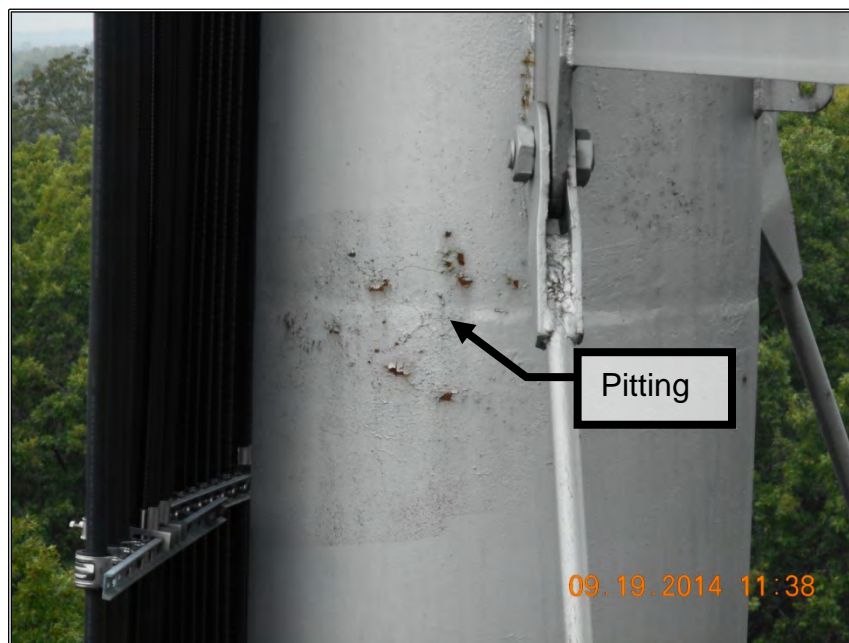
**Photo 11: Pitting on Support Legs.**

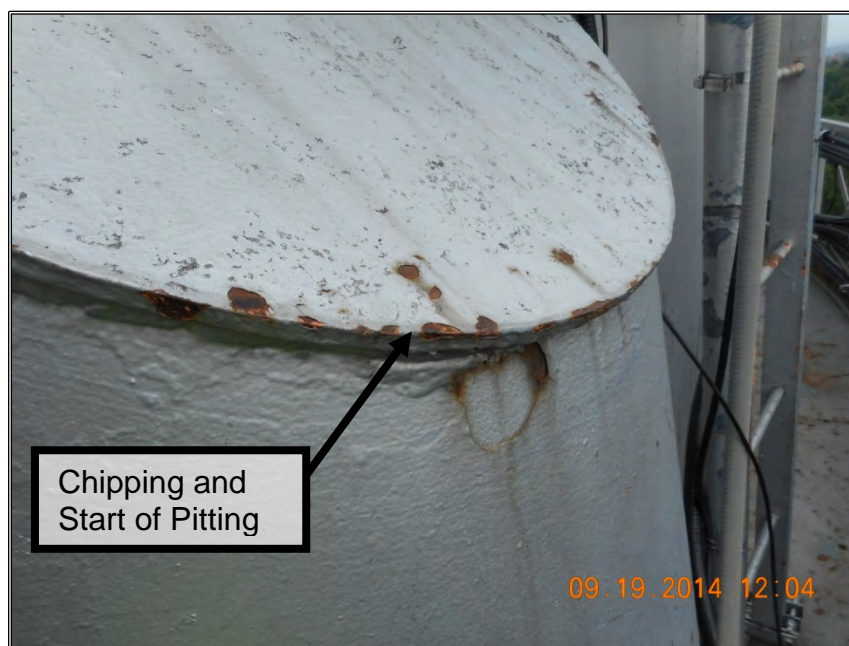
**Photo 12: Coating Failures at the Top of Tank Support Legs.**

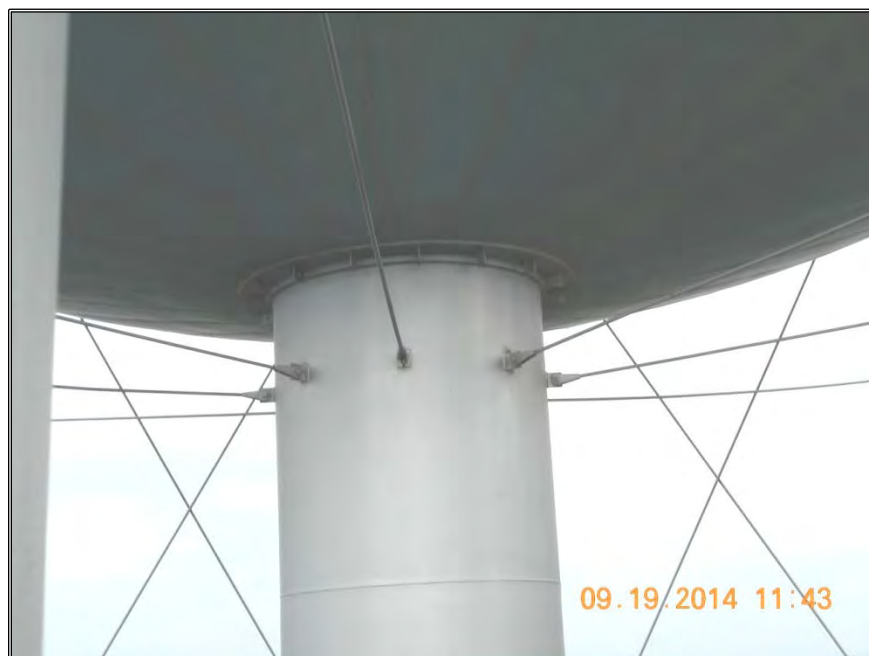
**Photo 13: Butt Welded Bottom Shell at Connection to Riser.**

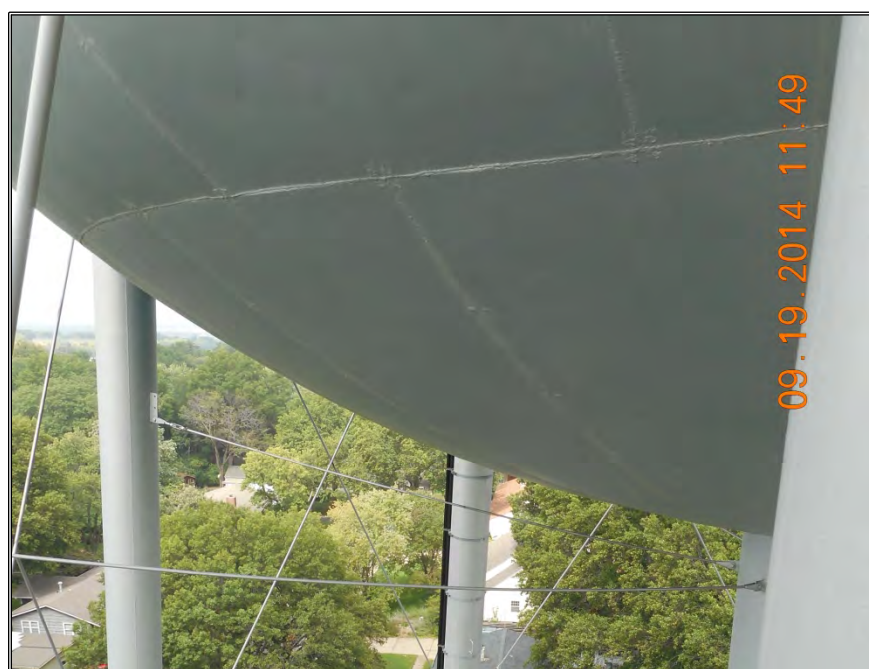
**Photo 14: Butt Welded Bottom Shell.**

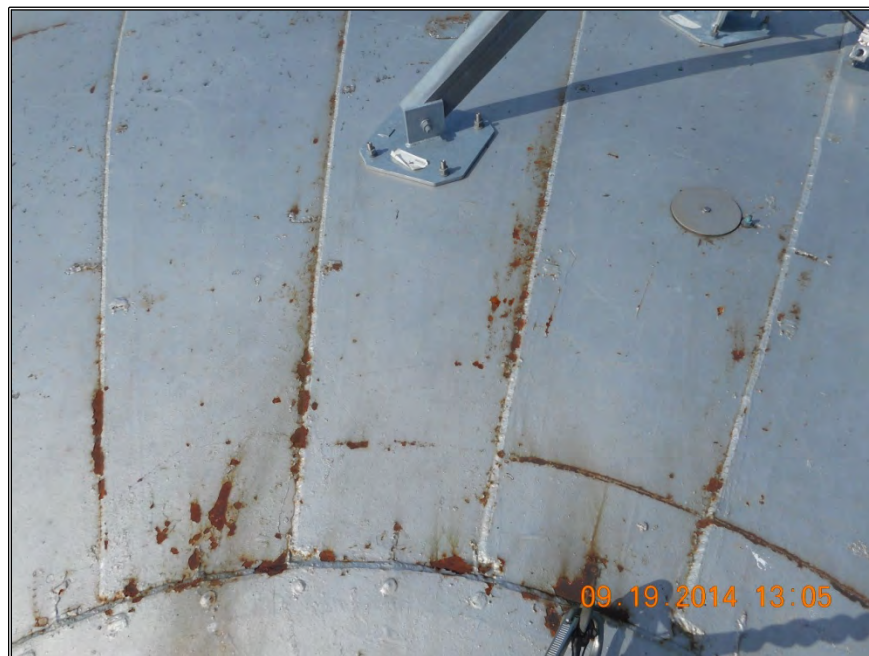
The elevated tank dome shell generally appears to be in good structural condition. The bottom shell has very little pitting, chipping, or areas of cracking on the exterior. The exterior of the top shell has consistent surface corrosion at the lap welds and significant amounts of chips in the coating in the body of the plates. Photo 13, Photo 14, Photo 15, and Photo 16 show representative views of the respective dome surfaces. The interior of the top shell has radial stiffeners with corrosion consistently present at the welds. The interior also has a platform with significant corrosion. For the platform at least one ladder rung is missing and many of the braces are corroded through. The interior of the dome and the platform are shown in Photo 17, Photo 18, Photo 19, and Photo 20.

**Photo 15: Exterior of Lap Welded Top Shell.**

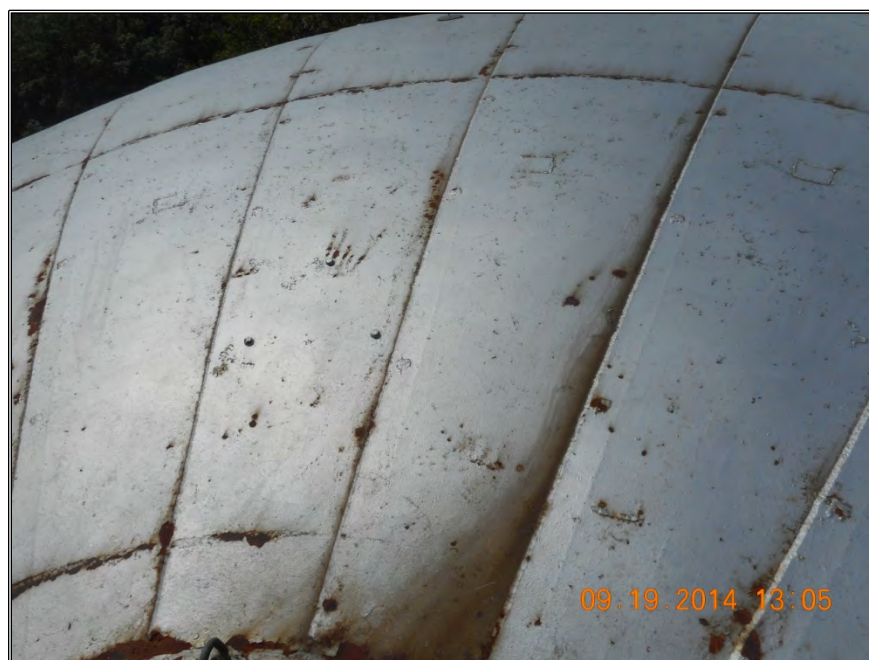
**Photo 16: Exterior of Lap Welded Top Shell.**

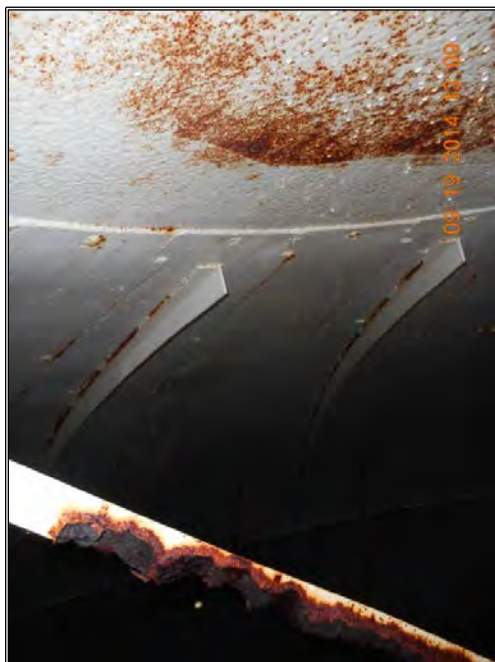
**Photo 17: Interior View of Top Shell and Platform.**

The internal platform is significantly deteriorated and is not in a useable condition. If the elevated tank is selected to remain in long term service the interior platform should be removed and a new OSHA approved internal ladder and/or platform should be installed. Final configuration of this would be based on anticipated needs of the City.

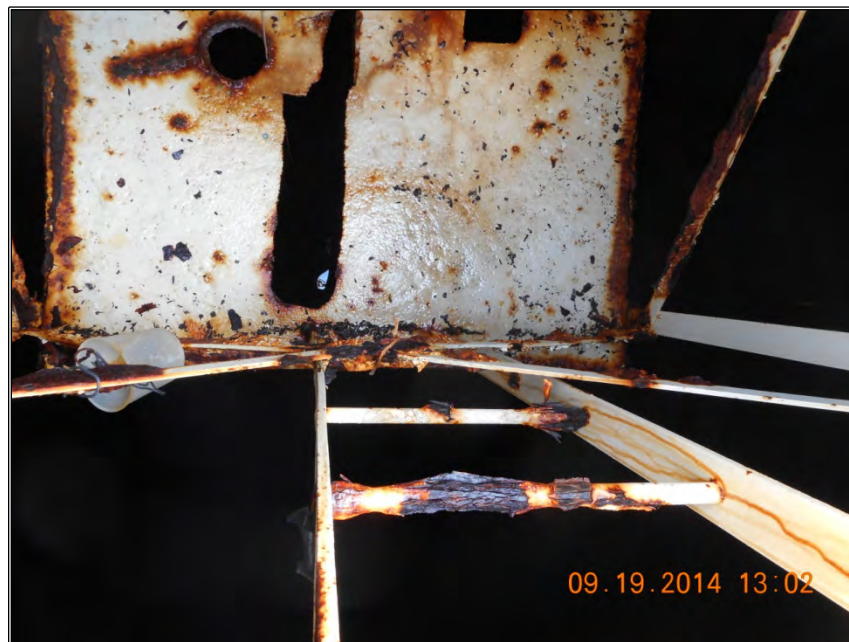
**Photo 18: View of Platform Looking Down from Top Hatch.**

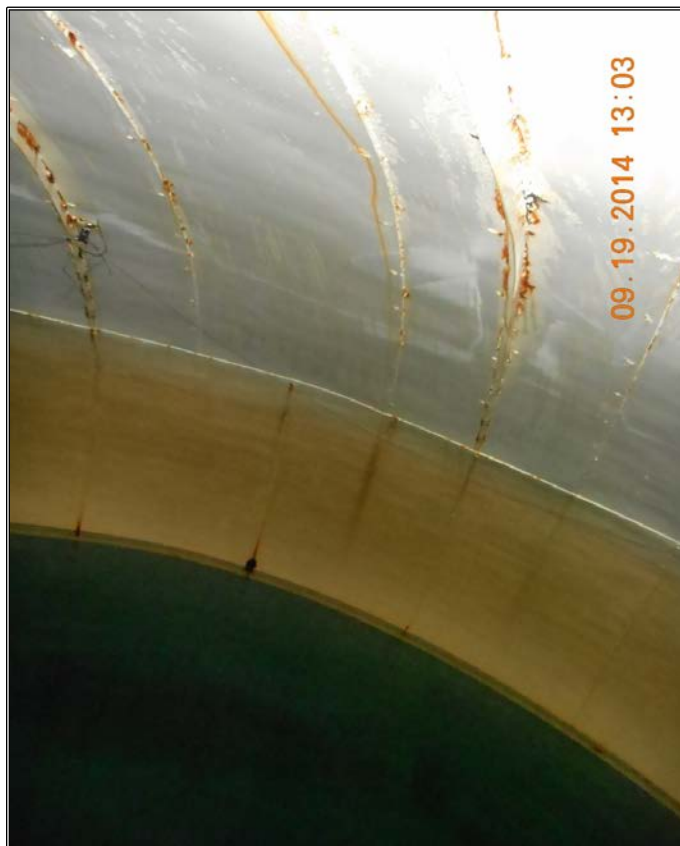
**Photo 19: Interior View of Tank Top Shell**

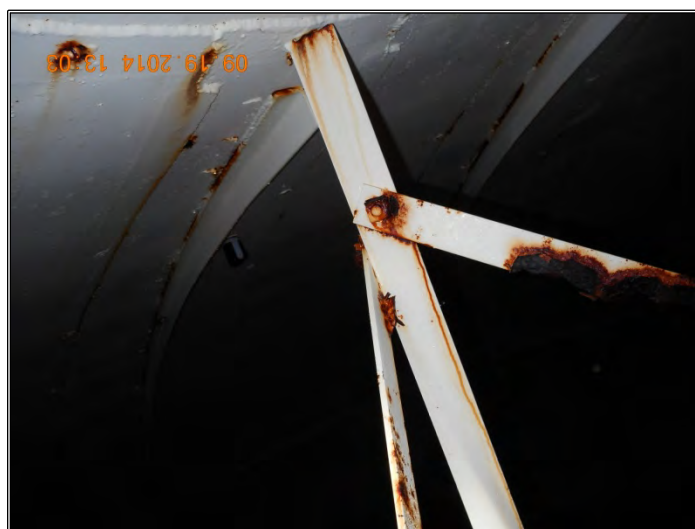
**Photo 20: Interior View of Platform and Spot Corrosion of Top Shell Plates**

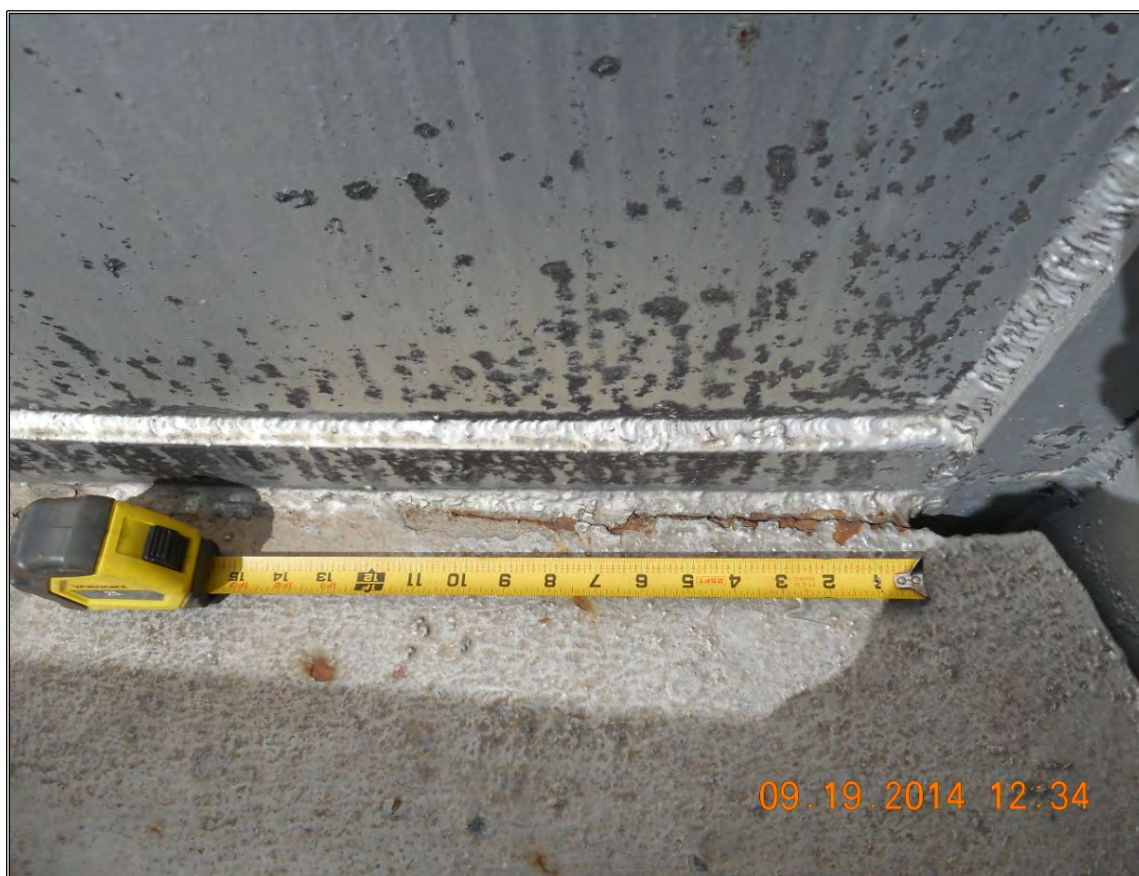
The exterior circumferential balcony is generally in good condition however there are three locations of significant cracks in the balcony checker plate to tank shell weld. The cracks are full width through the balcony checker plate and vary in length from approximately 10 inches long to 3 inches long. These cracks are shown in Photos 21, Photo 22, and Photo 23. Additionally there is significant pitting over the balcony support brackets. When measured with a pit gauge there was as much as 3/16" pitting in the plate over the bracket.

**Photo 21: Crack in Balcony Checker Plate.**

The cracking of the balcony connection to the tank shell most likely formed due to a stress concentration at the end of the circumferential weld. Stresses due to temperature differential between the tank shell and the balcony steel are the most likely repetitive source and will continue to be a factor in crack propagation. This crack will only get larger if it is not arrested. If allowed to grow it may cause local excessive deflection of the balcony checker plate walking surface and eventual destabilization of the checker plate walking surface. This can be prevented by drilling out the end of the crack to stop future propagation.

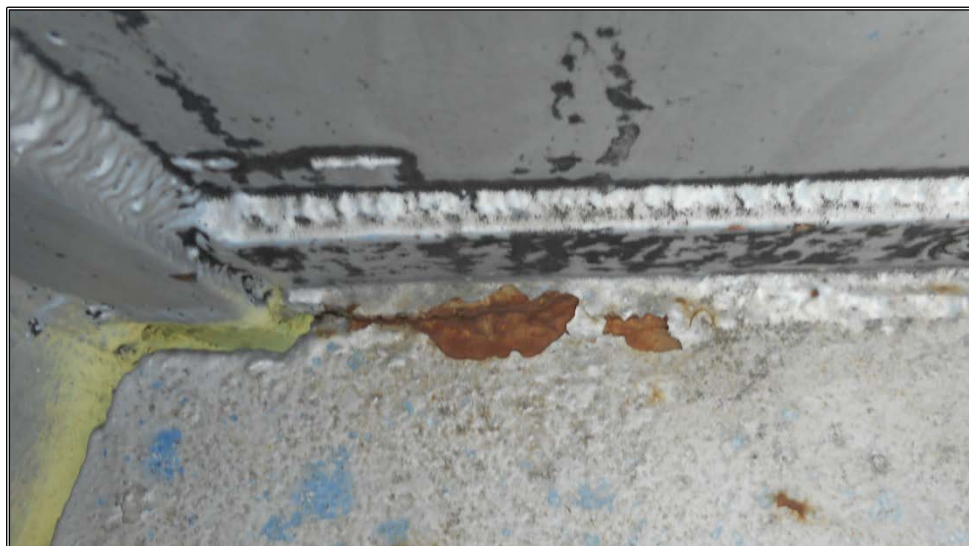
**Photo 22: Smaller Crack in Balcony Checker Plate.**

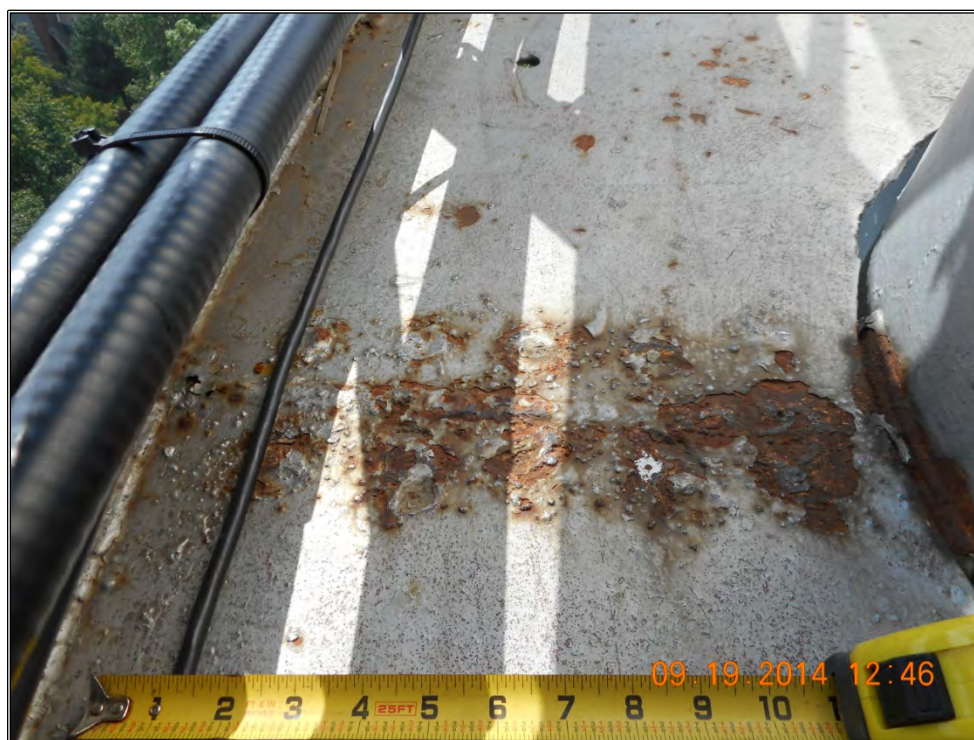
**Photo 23: Deep Pitting of Checker Plate Over Support Bracket.**
