Choosing an Appropriate Treatment
for the Historic Building

preserving

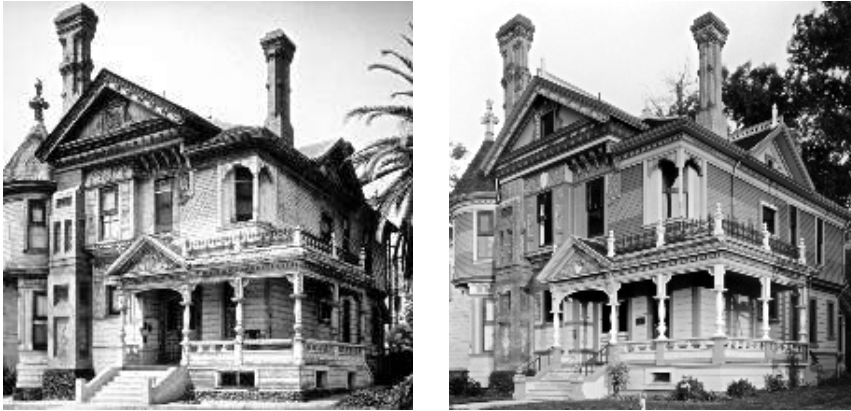
Preservation of the exterior of the Hale House, Los Angeles, California, involved repainting the exterior walls and decorative features in historically appropriate colors. In excellent example of the Preservation treatment focused upon the ongoing maintenance of historic materials and features. Photo: Before, NPS files; After: Bruce Boehner.

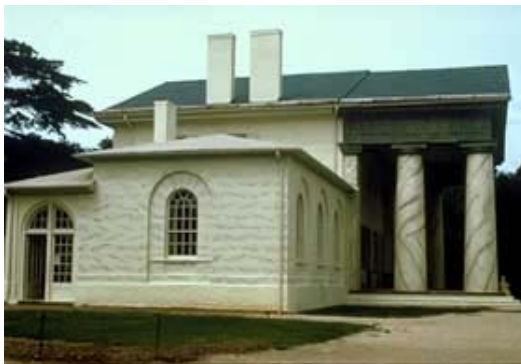
The stucco finish on Arlington House, Arlington, Virginia, was marbled in the 1850s, approximately 30 years after it was built, but because it is a character-defining finish that has gained significance over time, it should be retained and preserved. Photo: NPS files.

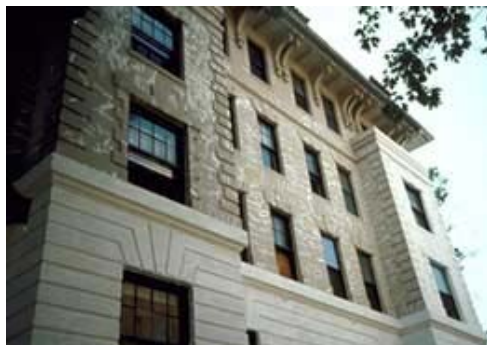
*The caulking shown here is not an appropriate method for repairing cracks in historic stucco.
Photo: NPS files.*

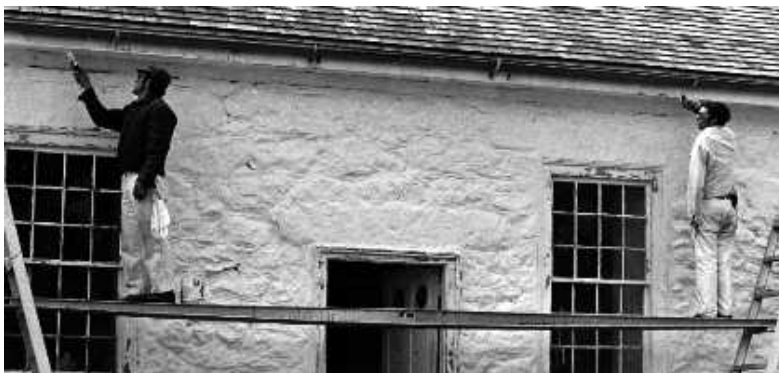
Adequate protection and maintenance of a historic building is an ongoing commitment. Here, two workers are priming and repainting exterior stone and wood trim. If surface treatments are neglected, more extensive repair and replacement will be required. Each loss further undermines a building's historic integrity. Photo: NPS files.

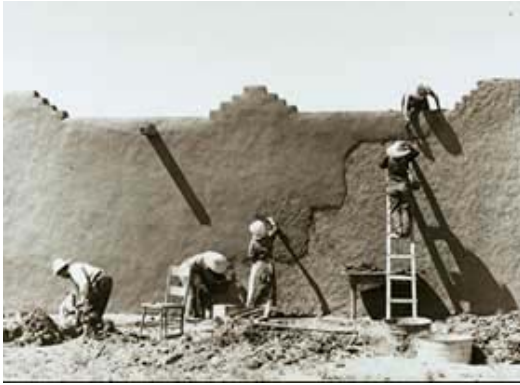
Traditionally, adobe surface coatings that protected the fragile adobe building fabric were renewed every few years. Women are seen here recoating an adobe wall with mud plaster mixed with straw at Chamisal, New Mexico. Photo: Russell Lee, Farm Security Administration Collection, Library of Congress.

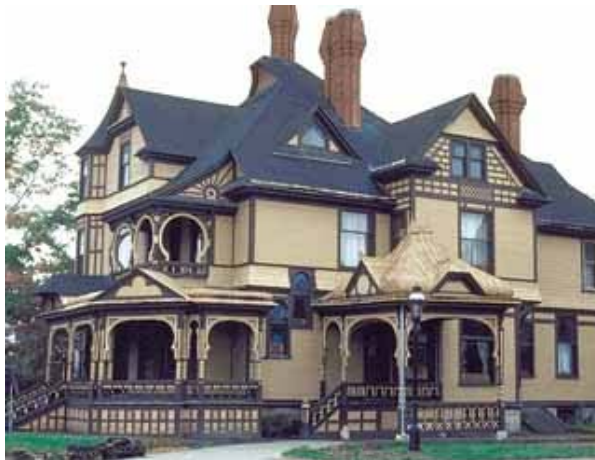
Whether it is used for exterior cladding, roofing, interior finishes, decorative features, or structural members, wood is frequently an essential component of historic and older buildings which should be retained and preserved. Photo: NPS files.

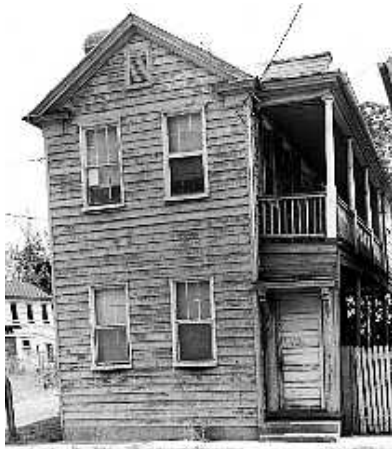
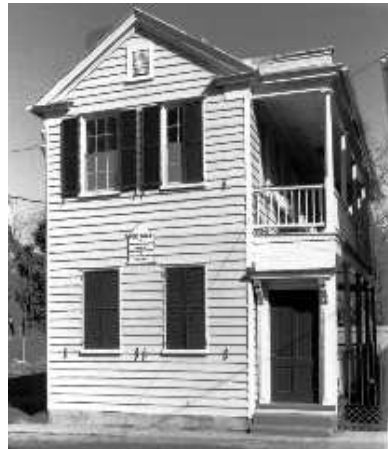
Maximizing retention of historic materials and features is the primary goal of Preservation, as demonstrated here in these "before" and "after" photographs. Aside from some minor repairs and limited replacement of deteriorated material, work on this house consisted primarily of repainting the wood exterior. Photos: Historic Charleston Foundation.

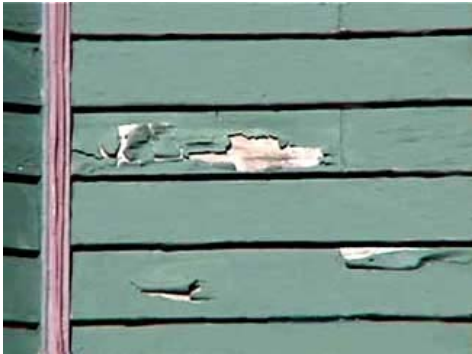
As shown, the paint on this house is failing in isolated spots, while most of it is in good condition. On older buildings heavy paint buildup is common. The thick paint film traps moisture in the wood. As the moisture escapes from the wood it pushes the paint off the wall, leaving spots of bare wood. Photo: © John Leeke.

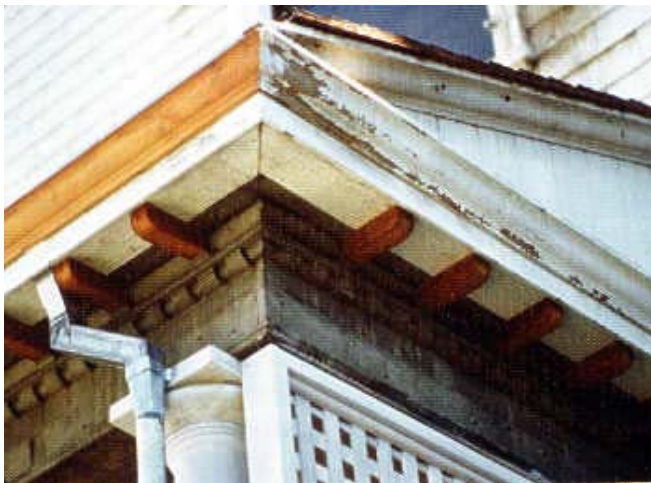
An example of "limited replacement in kind" points out an appropriate scope of work within the treatment, Preservation. Targeted repairs to deteriorated wood cornice elements (fascia board and modillions) meant that most of the historic materials were retained in the work. Photo: NPS files.

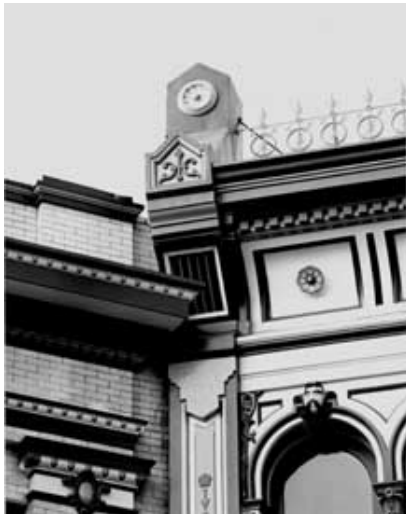
The ongoing maintenance and repair of historic architectural metals is emphasized in the treatment, Preservation. This shows a detail of a well-maintained polychromed cast-iron facade in Petaluma, California, 1886 (O'Connell and Lewis, Architectural Iron Works, San Francisco). Photo: Don Meacham.

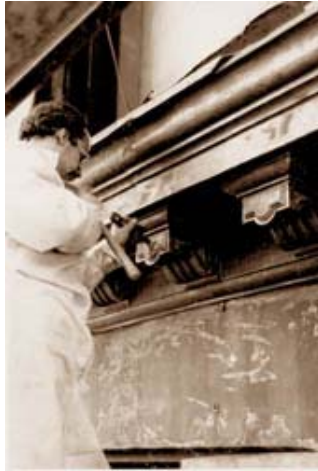
Where chemical paint stripping is involved, careful planning of the sequence of work and inspection by an architect or conservator to ensure strict compliance with the contract documents is important to minimize the risk of problems. Photo: Raymond M. Pepi, Building Conservation Associates.

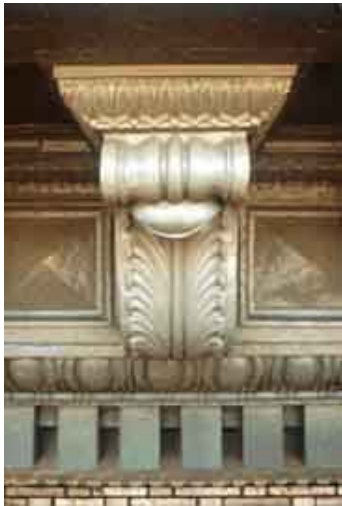
This detail of a repaired historic cornice shows the zinc modillion and the leaf and egg and dart

*moldings after Preservation work, including repainting of the elements, has been completed.
Photo: Michael Devonshire.*

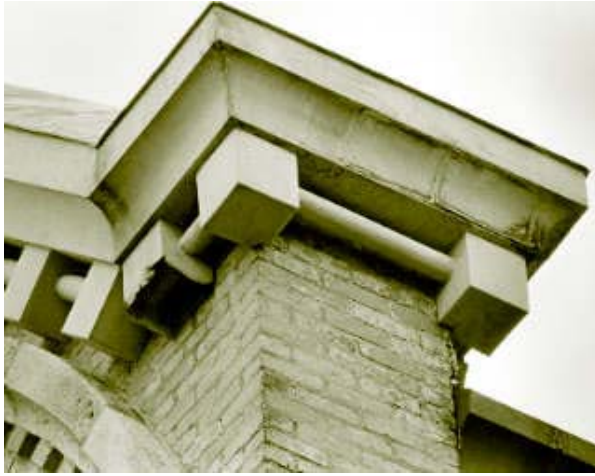
Another example shows one metal modillion (left side of cornice) that has sustained damage from a faulty gutter. The damaged modillion will be

replaced in kind during the Preservation work, while the intact elements of the historic cornice will be maintained and preserved.

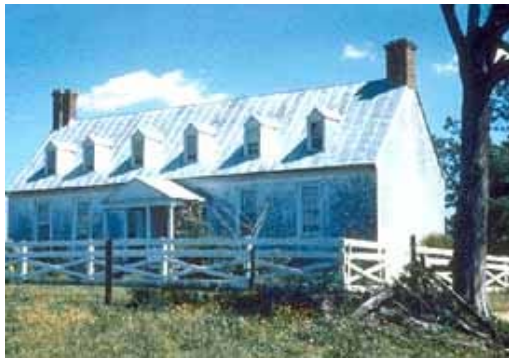
The steepness of this standing seam metal roof, along with its multiple dormers and double chimneys, characterizes this historic building. In Preservation, materials and features are carefully retained during a work project. Photo: NPS files.

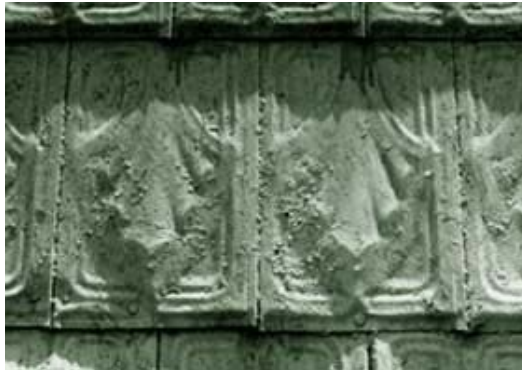
Pressed metal shingles, whose surfaces created interesting patterns, were popular throughout the country in the late 19th century. Tin roofs were kept well-painted, usually red; or, as shown here, in a color that imitates the green patina of copper. Photo: NPS files.

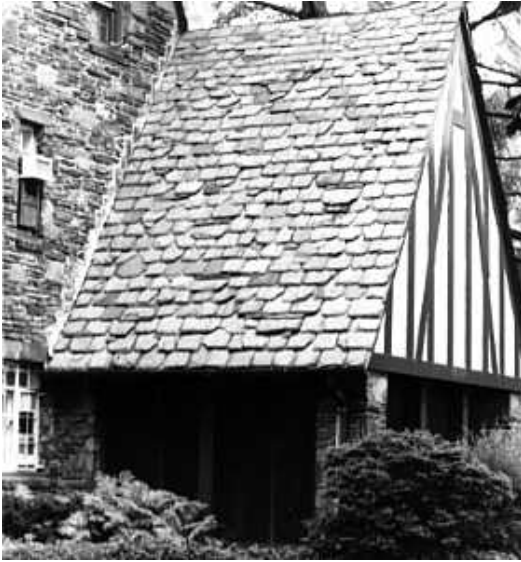
It is particularly important to preserve materials that contribute to a building's historic character, such as this highly visible slate roof. In the event that repair and limited replacement are necessary, all new slate would need to match the old exactly. Photo: Jeffrey S. Levine.

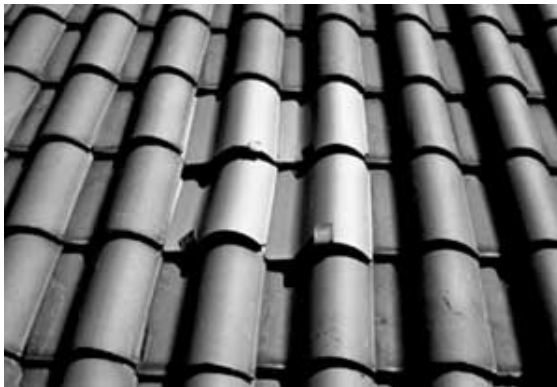
Repairs on this pantile roof were made with new tiles held in place with metal hangers. Photo: NPS files.

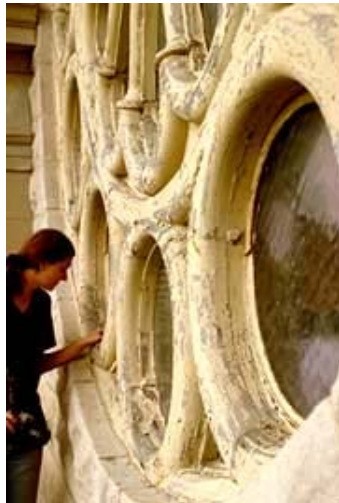
A condition assessment of the frame supporting the stained glass window is as important as evaluating the stained glass itself. Photo: Neal A. Vogel.

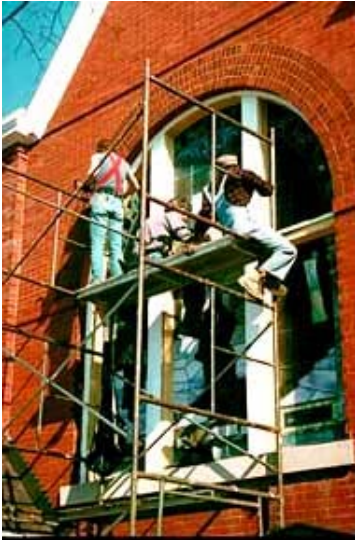
These workmen are performing exterior window maintenance after the protective glazing--which had prevented maintenance--was removed. Photo: Neal A. Vogel.

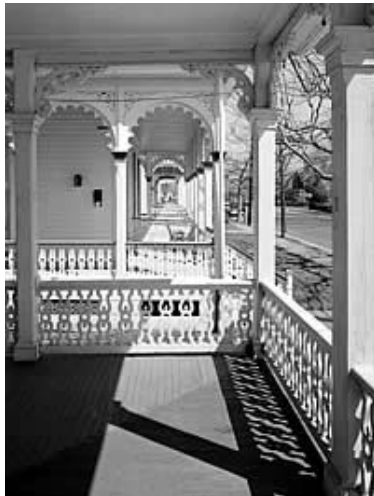
*As significant features in the Cape May Historic District, New Jersey, these decorative exterior porches have been carefully maintained and preserved.
Photo: HABS Collection, NPS.*

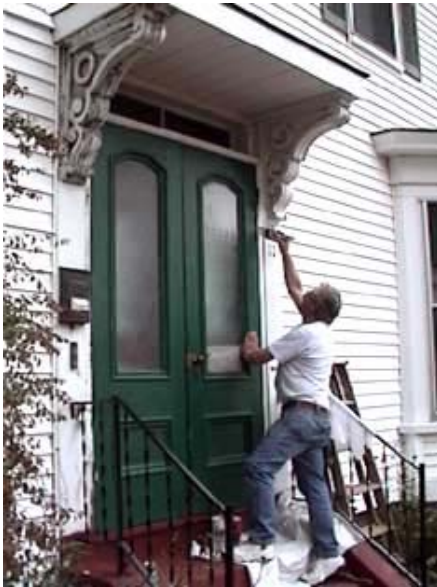
One of the major principles of the treatment, "Preservation," is the ongoing maintenance of existing historic materials and features. The entrance of this historic house is receiving a protective coat of paint, which will help preserve wood from long-term effects of weathering. Photo: © John Leeke.

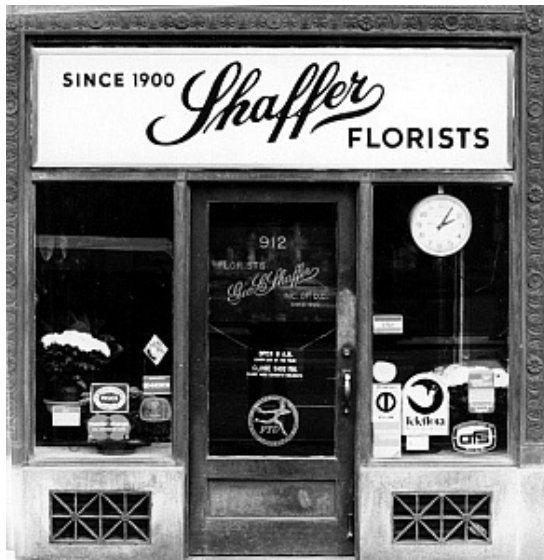
The original form and features of this 1920s storefront have been retained through Preservation. Photo: David W. Look, AIA.

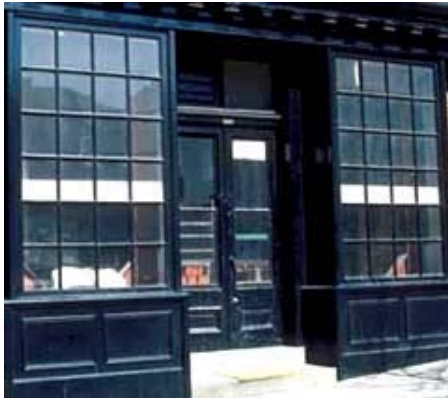
This cast iron storefront from the late 19th century has been well maintained over the years. Photo: NPS files.

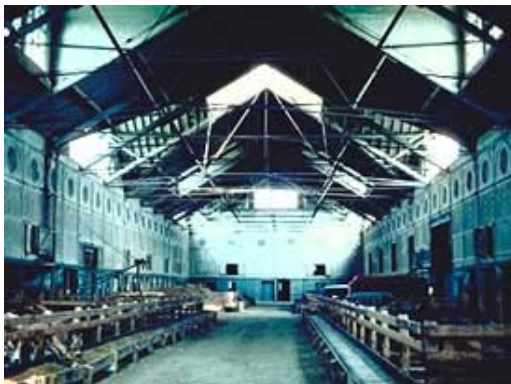
The interior of this barn in Shelburne, Vermont, is a magnificent space that included an overhead hay loft with tracks that allowed workers to drop hay to the floor below. Photo: NPS files.

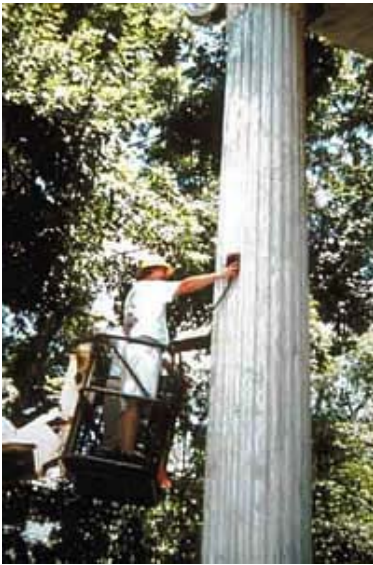
Non-destructive evaluation techniques can be of significant value in historic preservation projects. Impulse radar is being used to evaluate both the orientation and depth of the cracks visible on the surface of the column shaft. Photo: Edmund P. Meade, P.E.

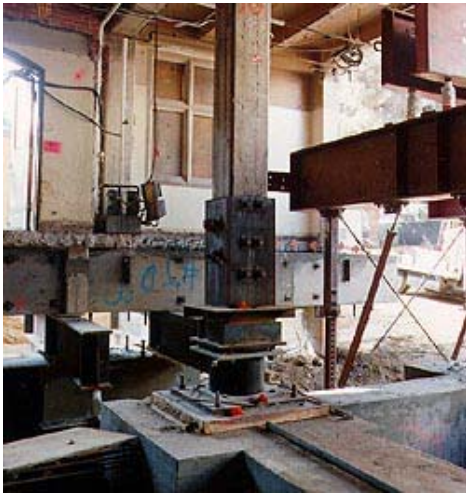
The new base isolator allows the structural support member at the foundation to move horizontally as it absorbs the earthquake forces. Photo: ©Jonathan Farrer.

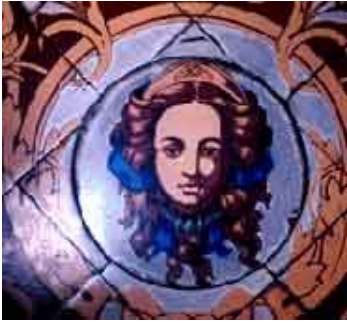
This Minton encaustic floor tile was installed in the U.S. Capitol in the 1850s. Before undertaking any work more complicated than regular maintenance or a very simple repair on a significant historic ceramic tile floor, it is recommended that a professional conservator of ceramics, an historical architect, an architectural historian, or a chemist with particular knowledge and experience in this field be consulted. Photo: NPS files.

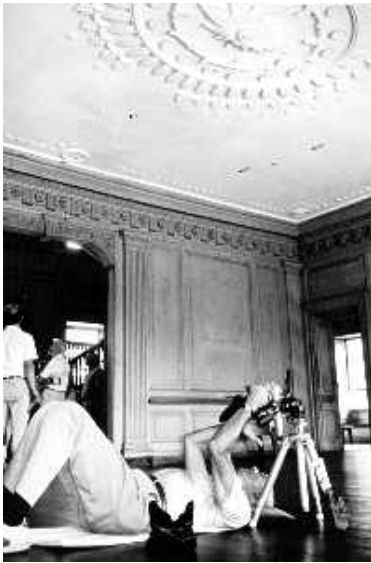
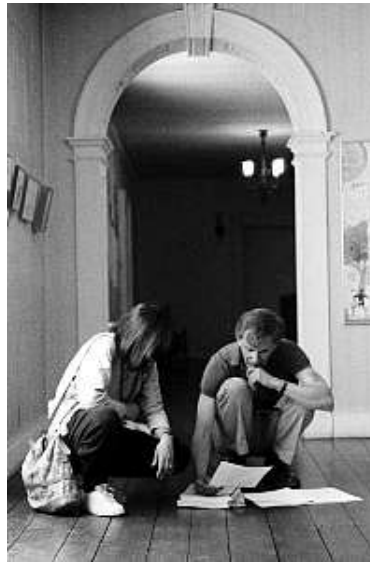
Careful documentation of a building's physical condition is the critical first step in determining an appropriate level of intervention. This may include documenting a particular problem, such as this cracked ceiling (left); or relating the historical research to existing materials and features (right). Photos: NPS files.

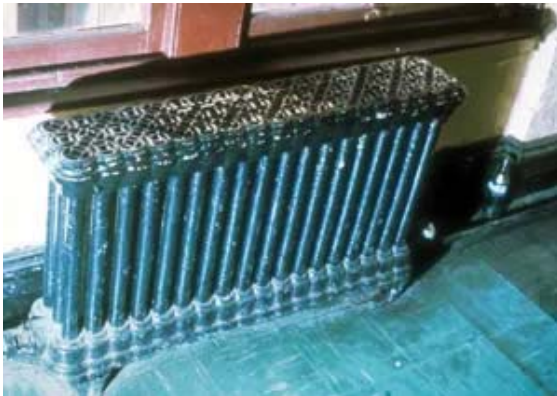
Modern heating or cooling devices usually add little to the interior character of a building; but historically, radiators, for instance, may have contributed to the interior character by virtue of their size or shape, or because of their specially designed bases, piping, and decorative grillage or enclosures.

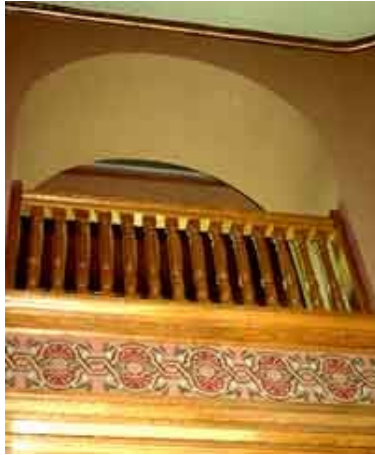
existing systems are suitably upgraded--while preserving the historic integrity of the building. Here, a return grille is successfully screened behind the arch.

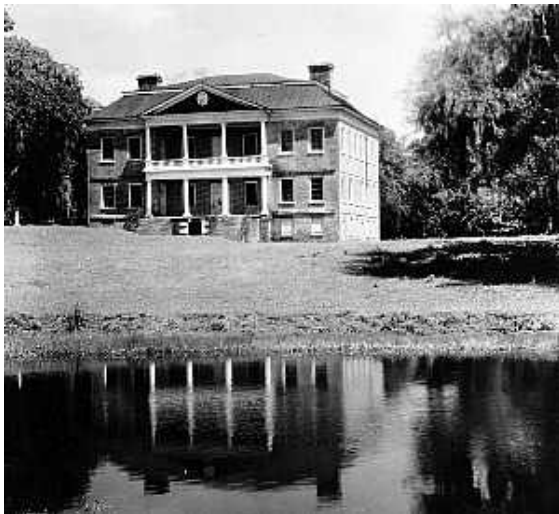
Drayton Hall, near Charleston, South Carolina, is an excellent example of an evolved 18th century plantation. Of particular note in this photograph are the landscape features added in the late 19th century--a reflecting pond and rose mound. With an overall Preservation treatment plan, these later features have been retained and protected. If a Restoration treatment had been selected, later features of the landscape as well as changes to the house would have been removed. Photo: Courtesy, National Trust for Historic Preservation.

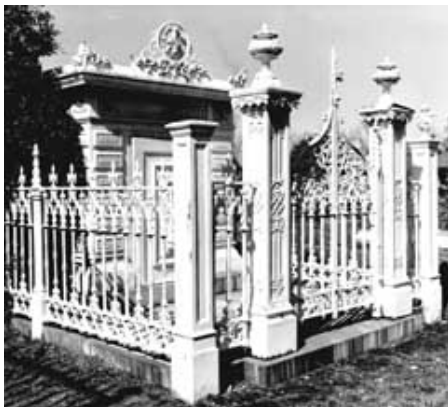
The Slatter Family Tomb in Mobile, Alabama, consisting of a cast-iron mausoleum and fence, exhibits the wide range of uses of the material in the 19th century. These historic materials should be carefully maintained and repaired. Photo: Jack E. Boucher, HABS Collection.

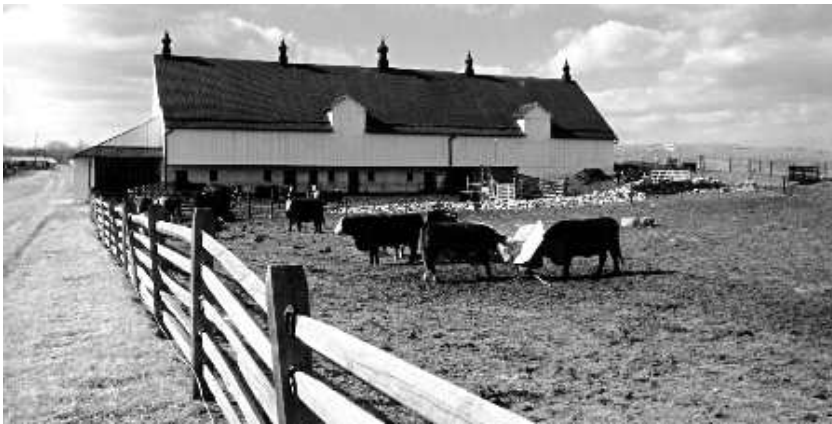
The goal of Preservation is to retain the historic form, materials, and features of the building and its setting as they have changed--or evolved--over time. This bank barn was built in the 1820s, then enlarged in 1898 and again in 1914. Today, it continues its role as a working farm structure as a result of sensitive preservation work. This included foundation re-grading; a new gutter system; structural strengthening; and replacement of a severely deteriorated metal roof. Photo: Jack E. Boucher, HABS.

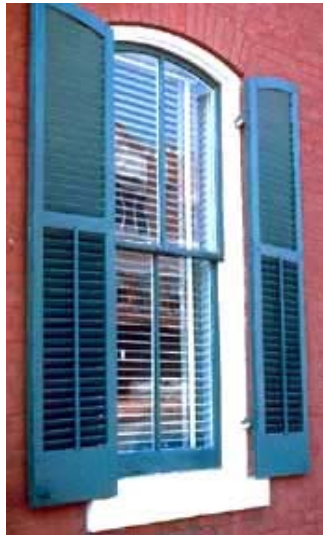
interior or exterior shutters, interior venetian blinds, curtains and drapes, or exterior awnings. Photo: NPS files.

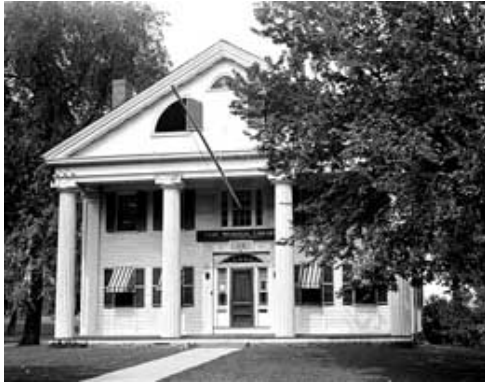
This 19th c. building in Massachusetts employed several energy-conserving features in its historic design, including shade trees, roof overhangs, awnings and

shutters. Photo: HABS collection, NPS.

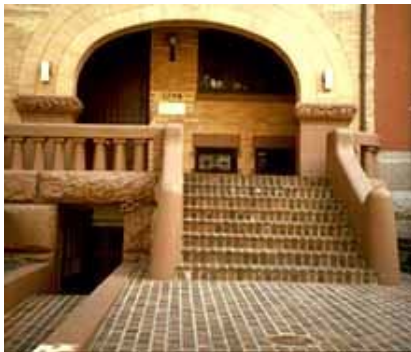
A significant entrance may be difficult to modify. Although a special challenge, sensitive changes can almost always be made to provide access while preserving the unique historic character. Photo: NPS files.

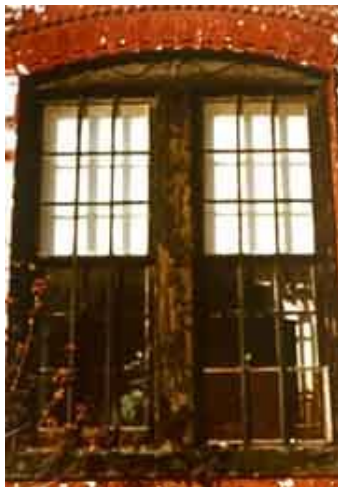
Deteriorating operable windows often contribute to lead dust in a house. In homes with small children, floors and other surfaces should be kept as clean as possible to avoid lead contamination.
