# Multimodal Planning Studies

## FIXED ROUTE TRANSIT and PEDESTRIAN ACCESSIBILITY STUDY

December 2013

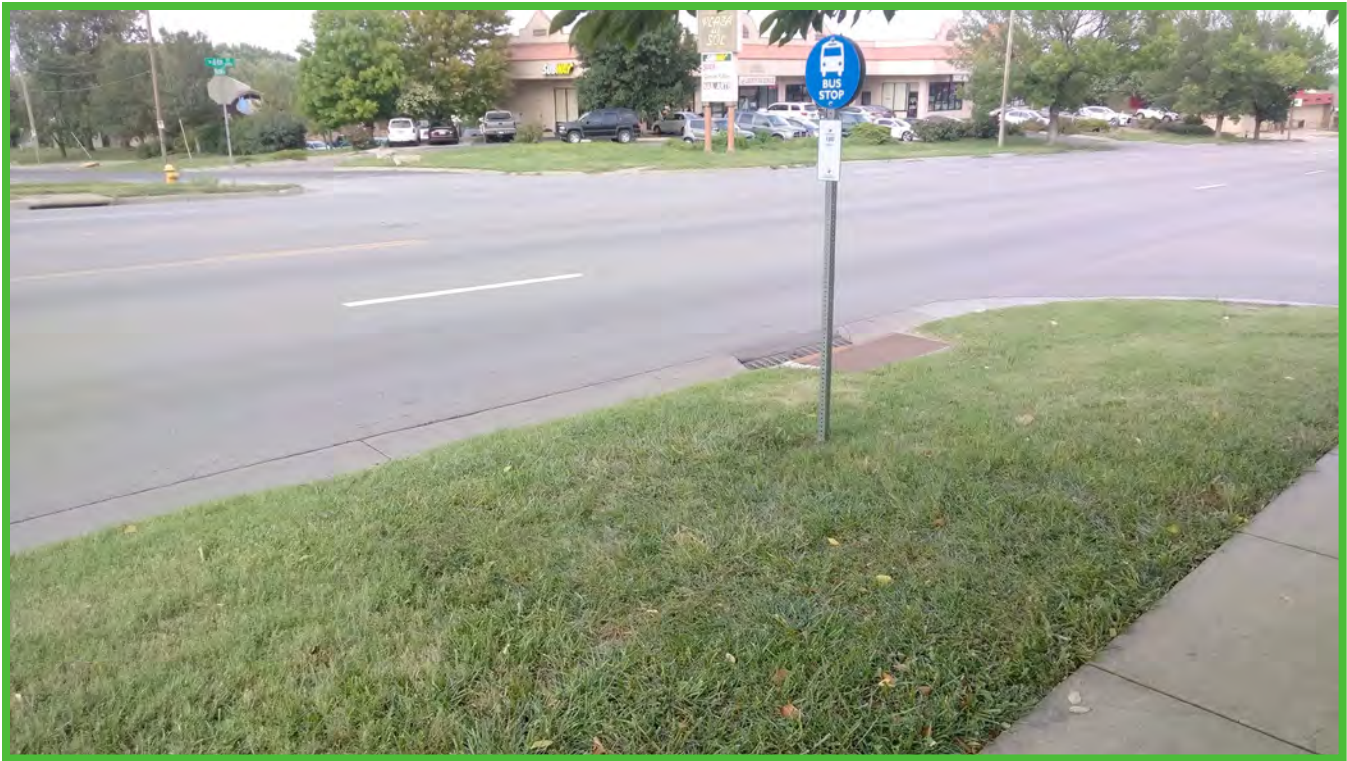
Example of a Typical Bus Stop Location Along 6th Street

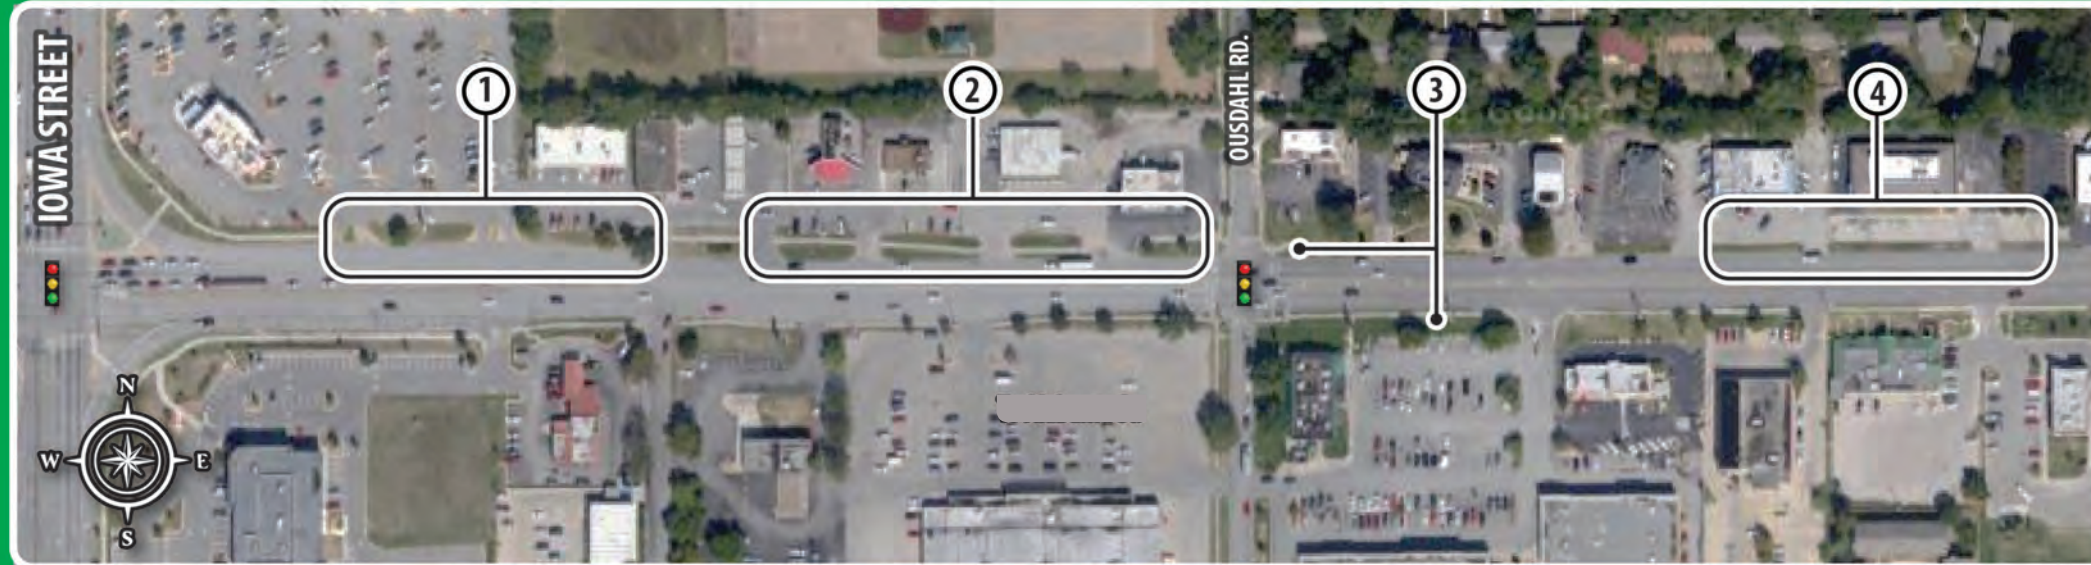
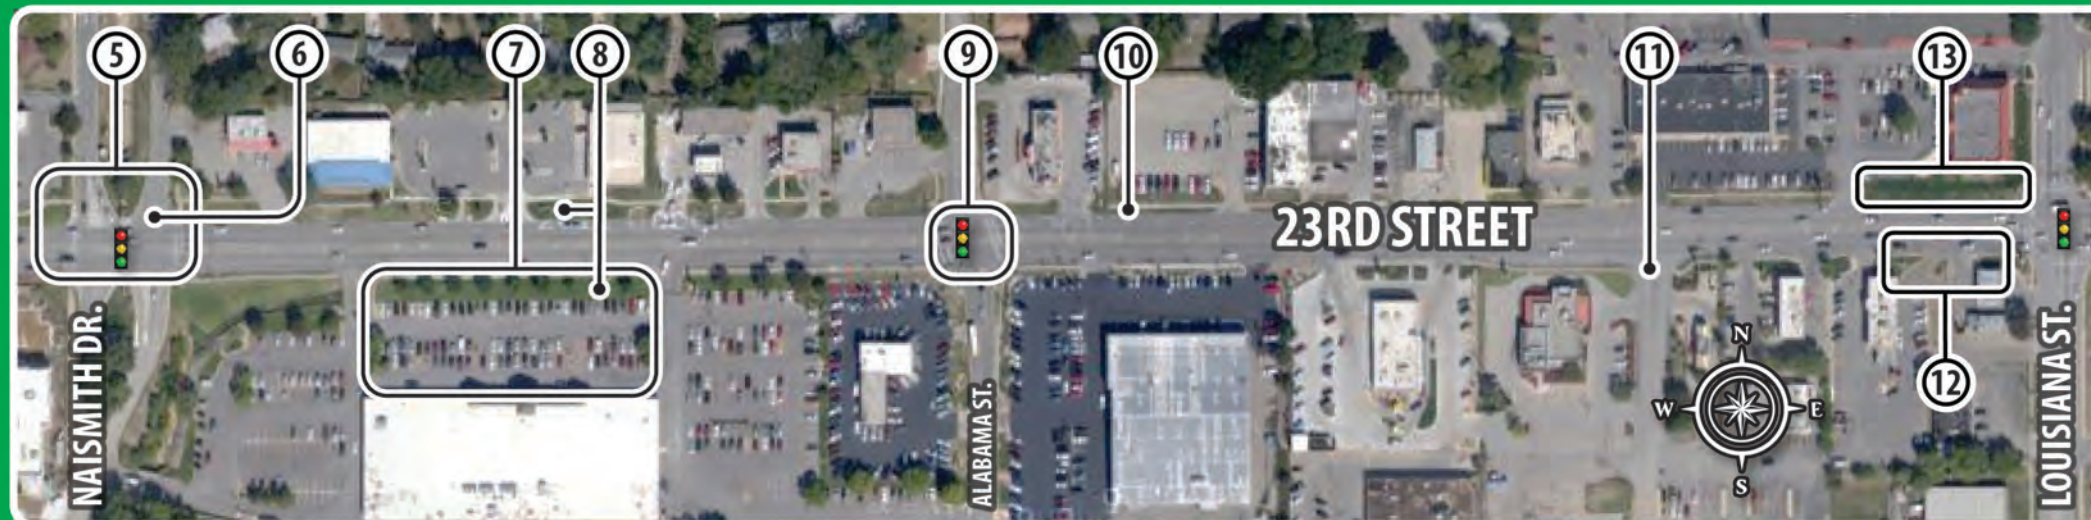
- ① Gaps in the sidewalk network.
- ② Several access points; potential vehicle / pedestrian conflicts.
- ③ Bus stops with no amenities.
- ④ Gap in sidewalk network; sidewalks located near store front and not adjacent to the street.
- ⑤ NE / NW corners have odd configuration; difficult for pedestrians to navigate.
- ⑥ Missing crosswalk paint.
- ⑦ Poor access to commercial area; direct access to store requires pedestrians to walk across 30' of grass.

- ⑧ Pedestrians / transit users crossing mid-block unprotected.
- ⑨ Poor crosswalk striping at some crossings.
- ⑩ Bus stop with no amenities.
- ⑪ Raised median / sign supports in path of sidewalk. Also, curb ramps in disrepair.
- ⑫ Wide driveway access and sidewalk with poor slope.
- ⑬ Missing sidewalk segment.

- 1 Construct missing sidewalk segments.
- 2 Review potential access management strategies to improve pedestrian safety and enhanced connectivity.
- 3 Identify appropriate bus stop amenities to include at these stops.
- 4 Construct sidewalk adjacent to roadway to provide a continuous sidewalk connection that would be utilized by fixed-route transit riders.
- 5 Reconstruct sidewalk connections to provide direct connections to curb ramps – improve sidewalk configuration.
- 6 Repaint crosswalk.
- 7 Provide direct access from bus stop to commercial building entrances.

- 8 Explore potential mid-block crossing to provide safer crossing between bus stops, or consider alternative improvement to direct pedestrians to cross at Naismith or Alabama. Explore possibility of relocating bus stop closer to a signalized intersection with marked cross walks.
- 9 Repaint crosswalks; explore possibility of better aligning marked pedestrian crosswalks.
- 10 Identify appropriate bus stop amenities to include at this stop.
- 11 Reconstruct SW corner curb ramp and remove all or parts of raised median to enhance pedestrian movement.
- 12 Implement access management strategies and improve sidewalk cross slope to provide for enhanced pedestrian movements.
- 13 Install sidewalk that connects to the NW corner of the intersection at Louisiana Street.

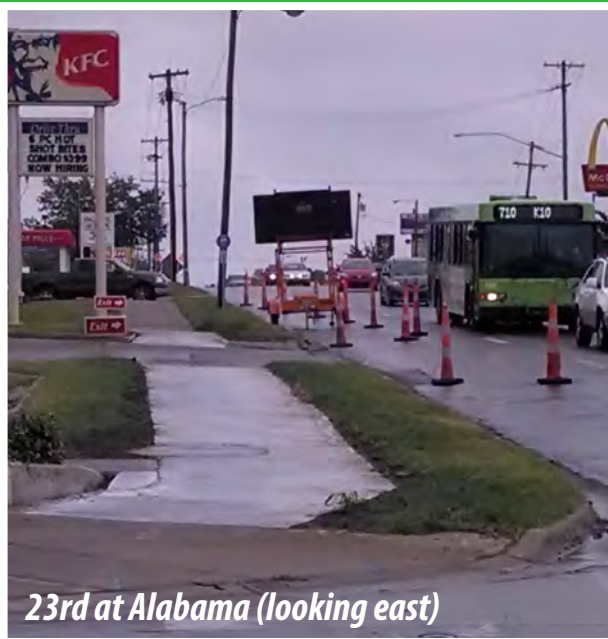
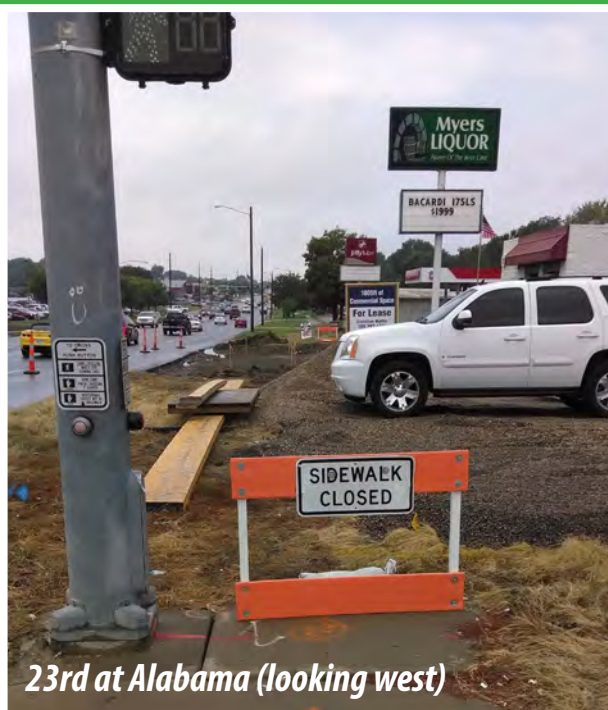
**Figure 5-4: Examples of Key Sidewalk Segments along 23rd Street**

Generally speaking, this targeted corridor segment provides several examples of issues that make transit-pedestrian access difficult. The corridor segment includes sidewalk gaps along key stretches of the roadway. Figure 5-4 displays examples of the missing sidewalk segments, including a key segment that was recently replaced near the intersection of 23rd Street and Alabama Street. In some cases, sidewalks may be present but are located directly near the store front and not adjacent to the roadway. While this design may be compliant with site development requirements requiring sidewalks, a sidewalk adjacent to a store front does not facilitate pedestrian access to transit and in fact creates an obstacle that makes riding fixed-route transit more difficult.

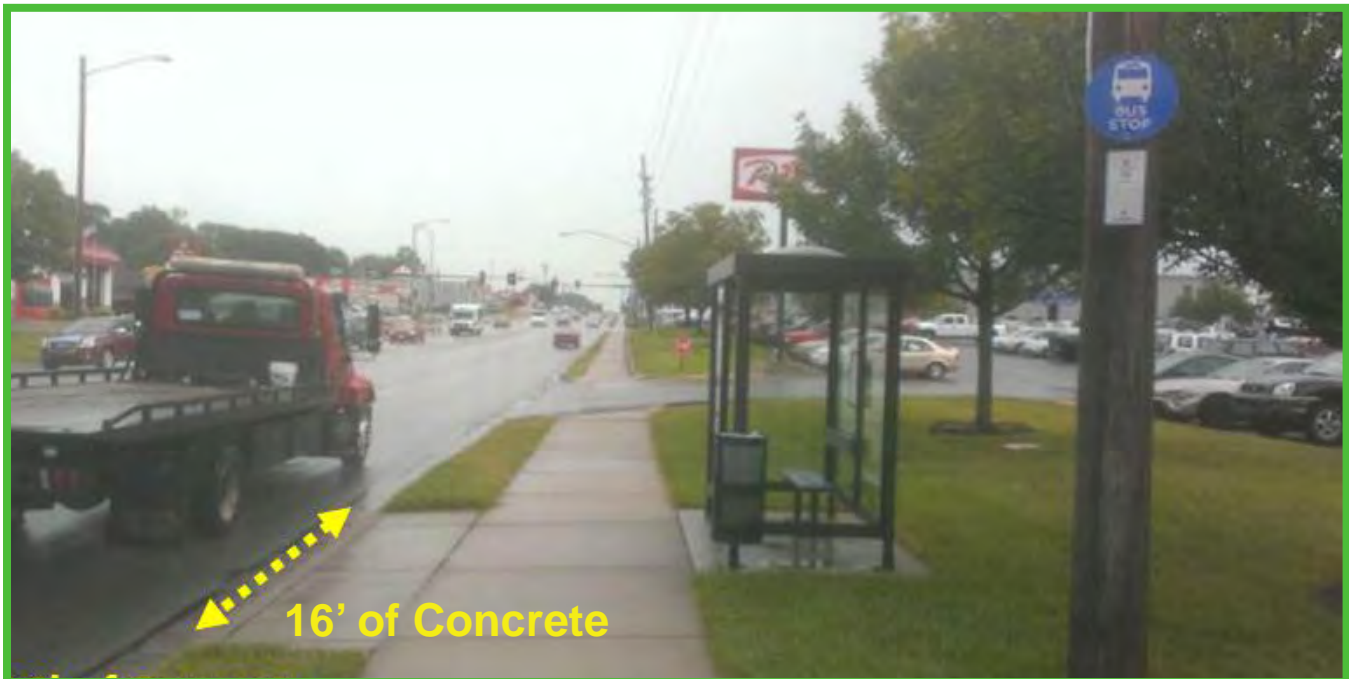
Finally, the actual bus stop design provides a good example of what other stops throughout the area should be included. For example, this particular stop has a wide concrete boarding area that makes it easy for pedestrians to access the bus from the sidewalk/waiting area. During fieldwork, this concrete section between the roadway and sidewalk was measured at 16 feet wide (see Figure 5-7). Having this width allows bus drivers to easily pull up to the stop and passengers to board and alight the bus. The extra width also provides a larger area for accessing the bus during bad weather, especially important if large amounts of snow that could easily narrow or close the boarding location accumulate in the corridor.

**Figure 5-7:** Example of Wide Concrete Boarding Area

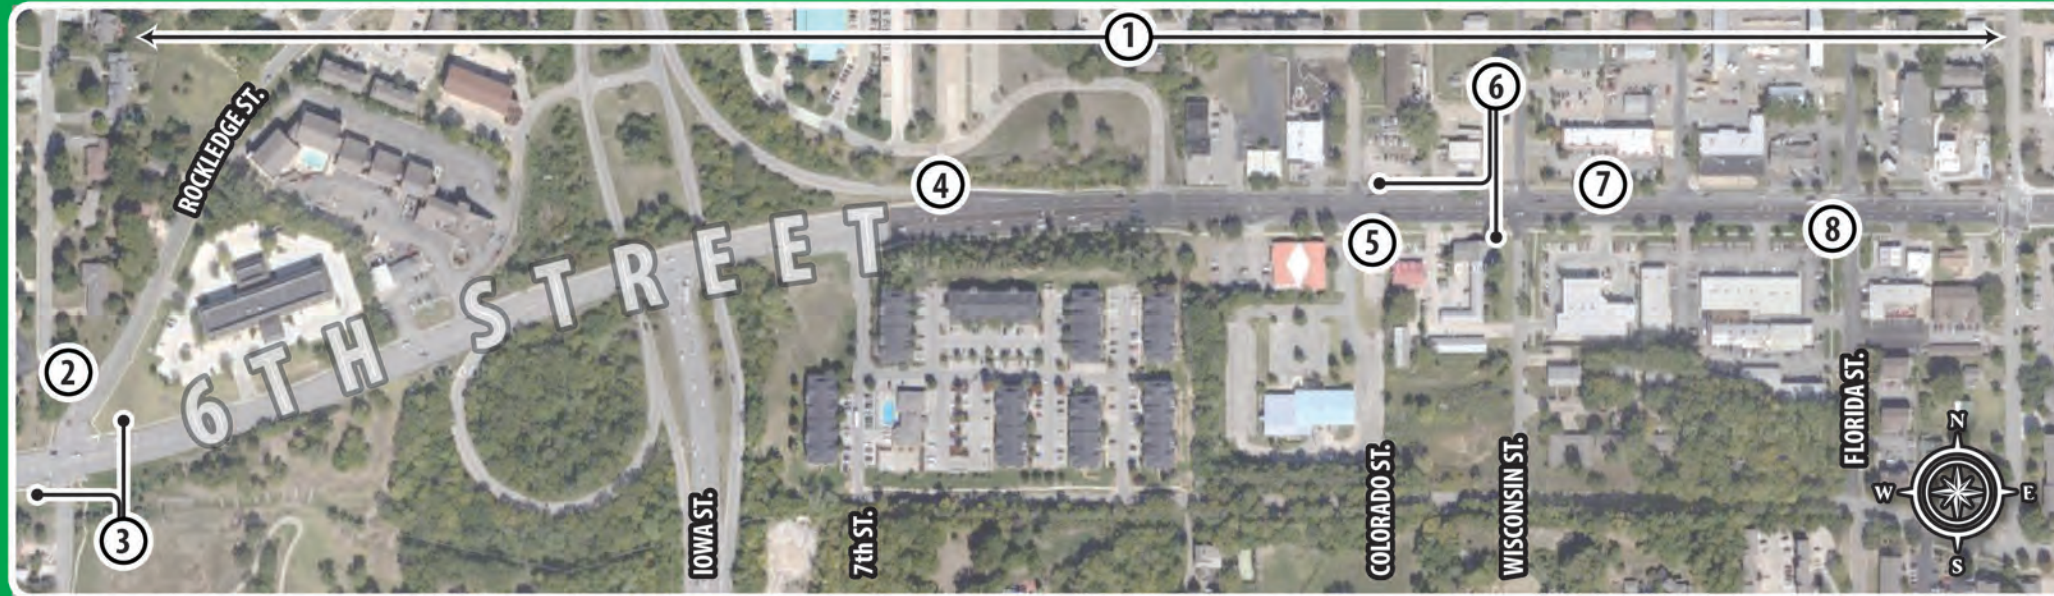
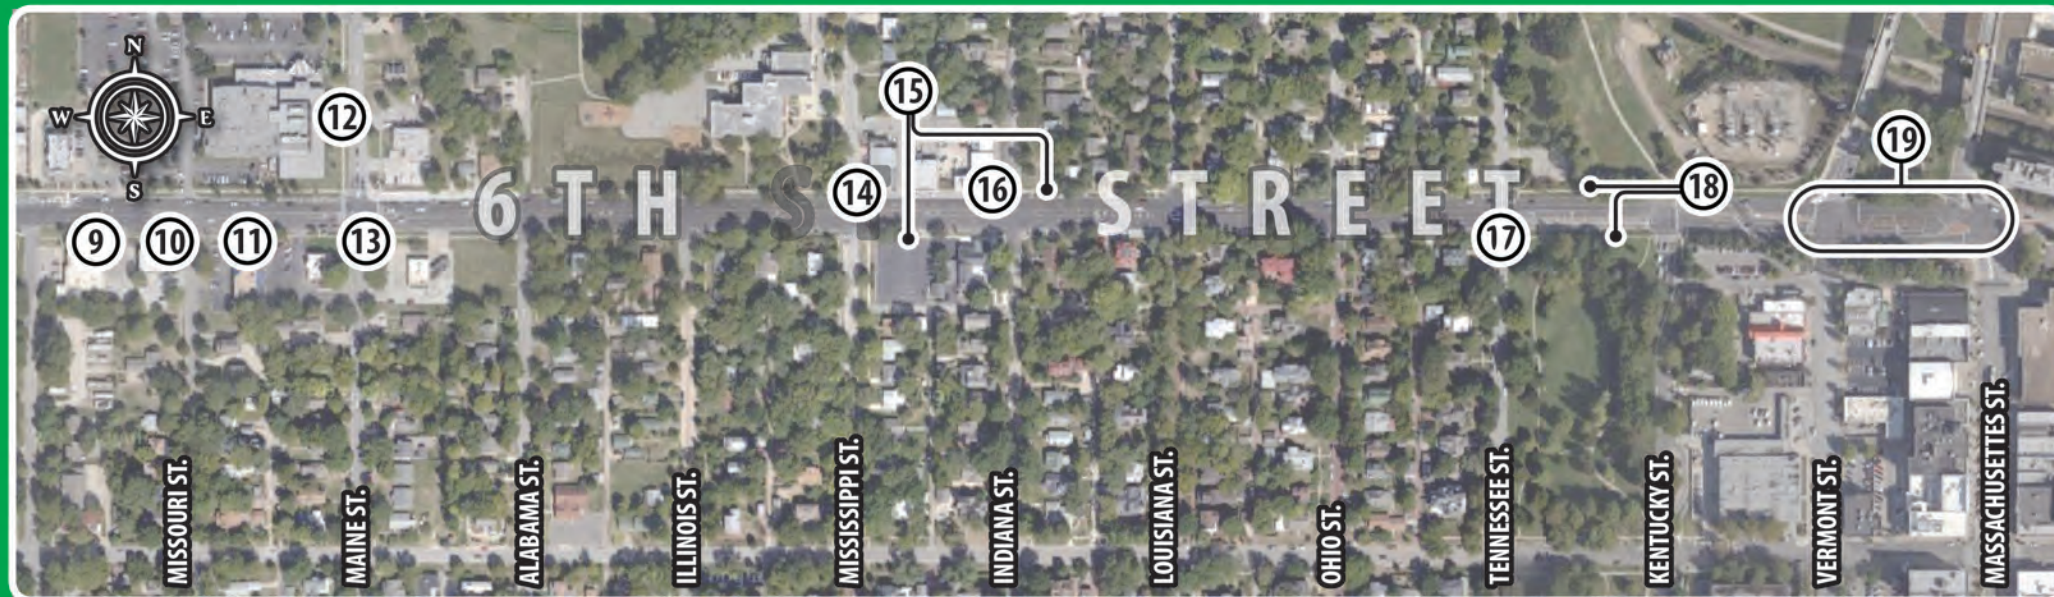
**Figure 5-10: 6th Street Transit-Pedestrian Accessibility Issues**

- ① ¾-miles with no north-south marked pedestrian crossings; frequent mid-block crossings by pedestrian and bicyclists.
- ② Curb ramps and pedestrian push buttons need improvement.
- ③ Bus stops with no amenities.
- ④ Missing crosswalk paint on high speed crossing.
- ⑤ Access management concern and segment of sidewalk in disrepair and steep slope.
- ⑥ Bus stops with no amenities.
- ⑦ Sidewalk in disrepair.
- ⑧ Connecting walkway on south but not north side.
- ⑨ Good example of sidewalk connection to commercial building.
- ⑩ Severe grade at curb ramp (southwest corner).
- ⑪ Sidewalk deficiencies - site presently in redevelopment.
- ⑫ Bus stop on Maine Street – currently no amenities (bus stop was recently relocated).

- ⑬ Accessibility issue at curb ramp needs improvement (southeast corner).
- ⑭ Missing crosswalk paint; priority crossing near school.
- ⑮ Bus stops with no amenities.
- ⑯ Accessibility issue at curb ramp needs improvement (northwest corner).
- ⑰ Curb ramps in severe disrepair and steep grades; heavy traffic and priority crossing near park grades.
- ⑱ Bus stops with no amenities.
- ⑲ No north-south crosswalks to Robinson Park.

- 1 Provide marked and/or pedestrian actuated crossing(s) between Rockledge Road and Michigan Street.
- 2 Upgrade curb ramps and improve accessibility to pedestrian push buttons.
- 3 Provide typical bus stop amenities
- 4 Paint highly visible crosswalk; consider potential signage to highlight pedestrian crossing.
- 5 Close driveway access from 6th Street and provide access from Colorado Street. Repair sidewalk, improve alignment.
- 6 Provide typical bus stop amenities.
- 7 Replace sidewalk that is currently in disrepair.
- 8 Provide north side connection (accessible courtesy walk).
- 9 Good example of sidewalk connection to commercial area.
- 10 Reconstruct sidewalk and curb ramp to mitigate grade issue.
- 11 Incorporate sidewalk reconstruction with redevelopment to create flatter, more consistent sidewalk connection.

- 12 Provide typical bus stop amenities.
- 13 Reconstruct curb ramp to make more accessible/navigable
- 14 Paint new crosswalk
- 15 Provide typical bus stop amenities
- 16 Reconstruct NW corner curb ramp to 6th Street – potential location for N/S painted and/or controlled crossing.
- 17 Replace curb ramps and reconstruct sidewalk to make more accessible/navigable.
- 18 Provide typical bus stop amenities; Explore moving bus stop (bus pull out) in conjunction with bikeway improvements at the Vermont Intersection.
- 19 Investigate alternatives to provide improved accessibility to Robinson Park area (coordinate with Bikeway Plan).

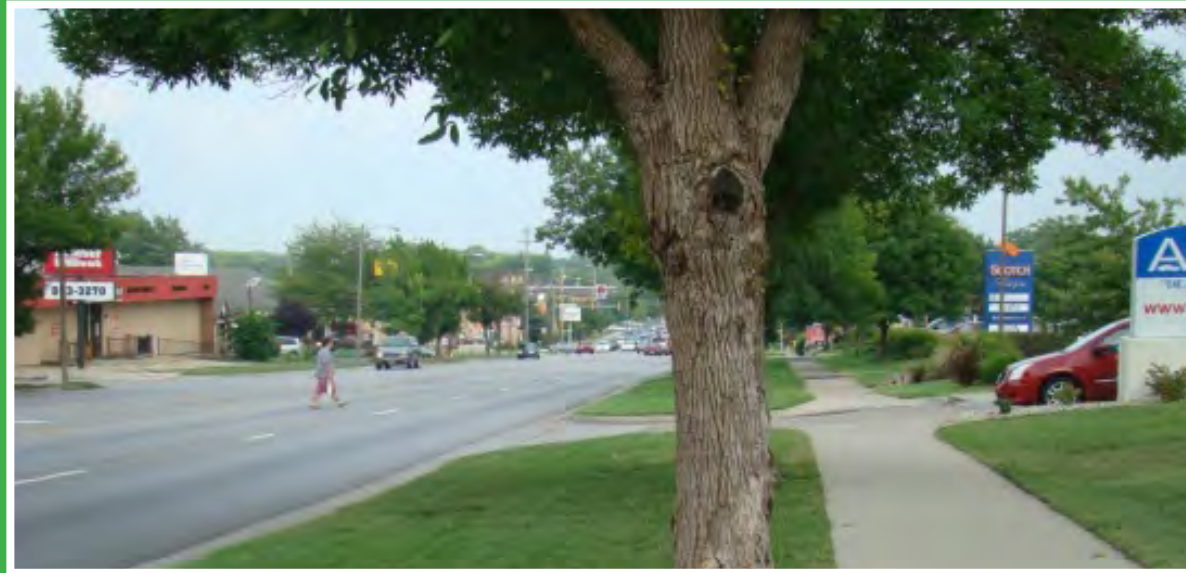
*Mid-block crossings were frequently observed along the corridor.*

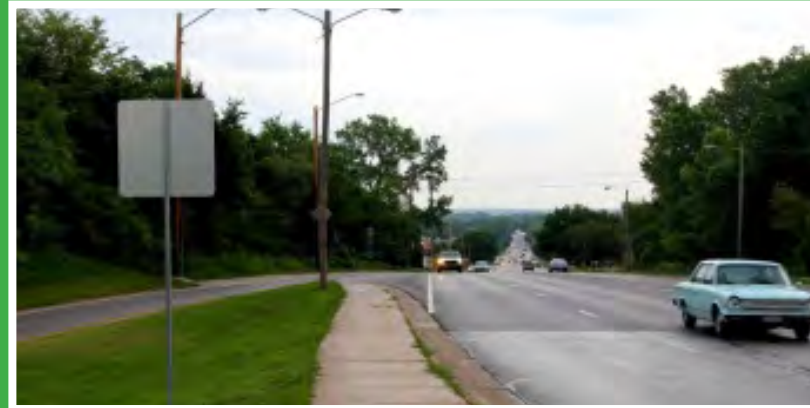
*A high speed pedestrian crossing on 6th near the ramp to northbound McDonald Drive heading to I-70.*

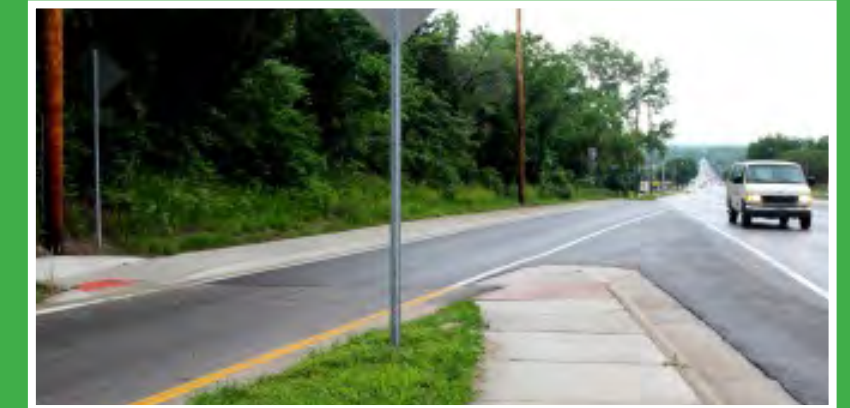
*Steep slopes on some sidewalk segments, and poor drainage, make pedestrian travel difficult.*

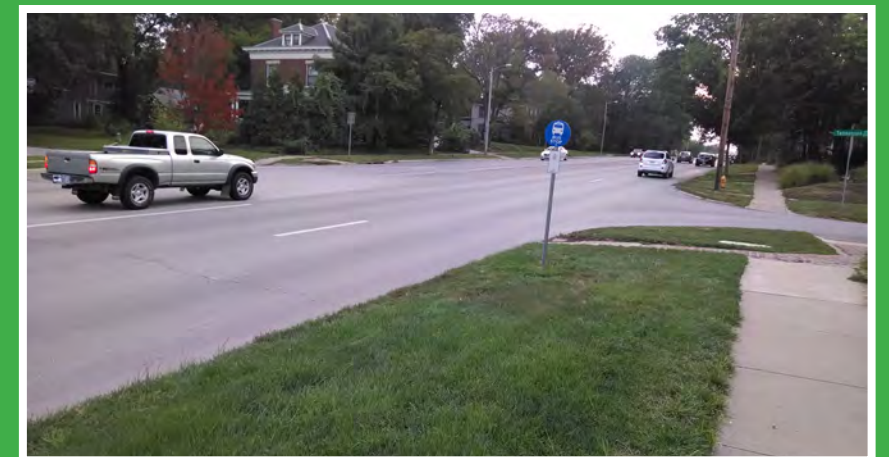
*Typical bus stops along 6th Street do not have concrete pads or other amenities.*

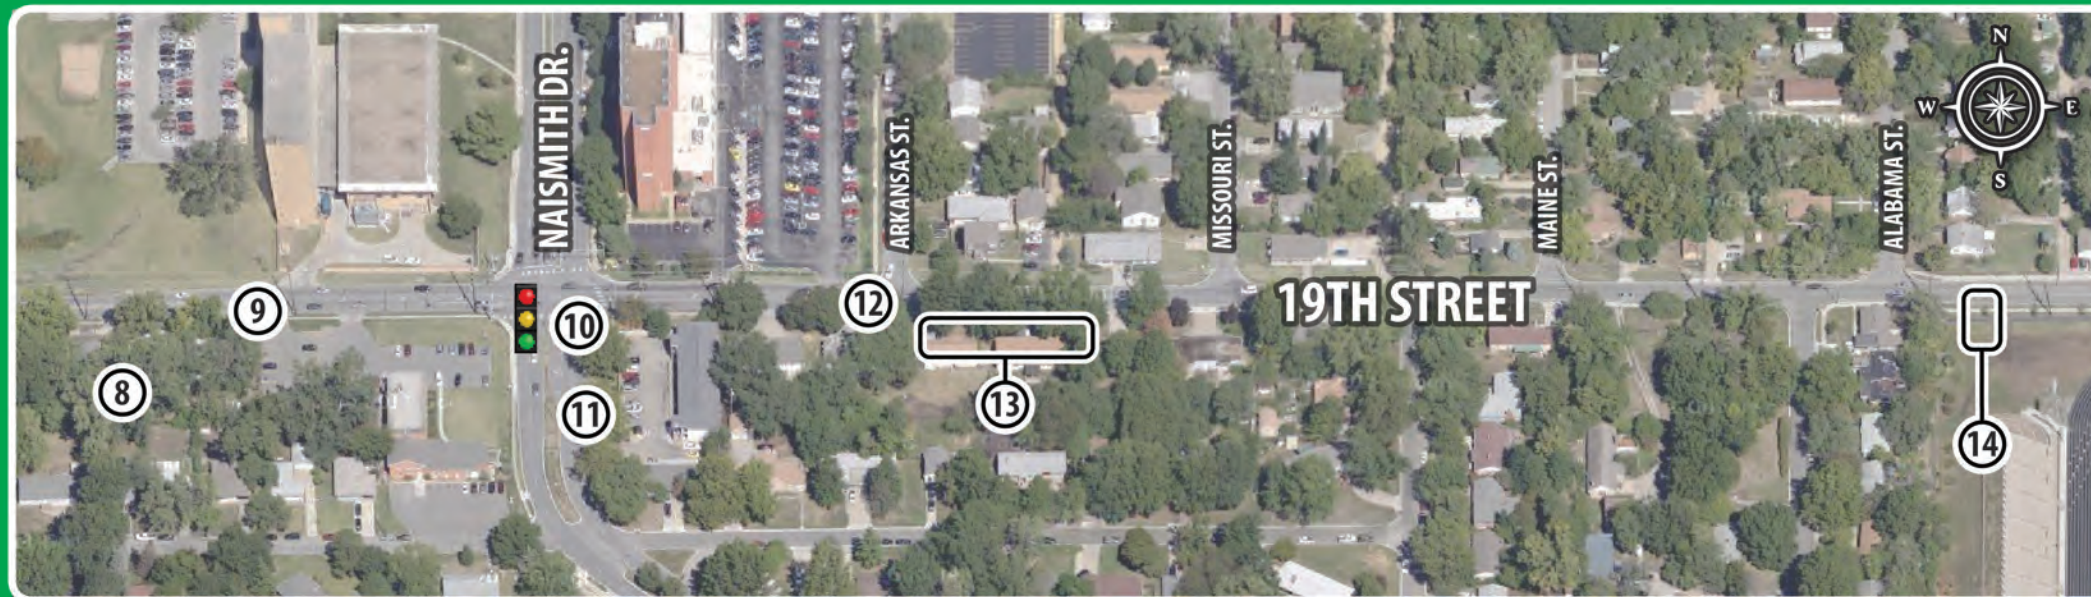
- ① Bus stop with no amenities; no connection to nearby sidewalk.
- ② Ped push button inaccessible - on back of pole.
- ③ 50% of sidewalk in disrepair - Ellis to Ousdahl; obstacles in sidewalk and overgrown landscaping.
- ④ No sidewalk connection to student housing.
- ⑤ No crosswalk between bus stops (East of Anna).
- ⑥ Bus stops with no amenities; steep slope on north side.
- ⑦ No sidewalk on north side of 19th (Iowa to Alabama).

- ⑧ Multiple sidewalk segments need replacement; some obstacles in sidewalk path.
- ⑨ Bus stop with no amenities; no sidewalk connection.
- ⑩ Missing crosswalk paint (included in Naismith Drive improvements).
- ⑪ Inaccessible pedestrian push buttons (included in Naismith Drive improvements).
- ⑫ Sidewalk ends 8' north of 19th Street.
- ⑬ Problem with untrimmed trees (~4' off sidewalk).
- ⑭ Possible location for a marked crossing

- 1 Provide typical bus stop amenities and sidewalk connection.
- 2 Reposition pedestrian push button.
- 3 Replace sidewalk that is in disrepair.
- 4 Install sidewalk from 19th to student housing.
- 5 Install painted crosswalk between bus stops; consider possible pedestrian crossing signs.
- 6 Provide typical bus stop amenities; improve waiting area on north side of 19th Street.
- 7 Install sidewalk on north side of 19th Street; coordinate with KU Master Plan. As part of implementing this facility, a 300' retaining wall will likely need to be constructed.

- 8 Replace sidewalk that is in disrepair.
- 9 Provide typical bus stop amenities.
- 10 Repaint crosswalk.
- 11 Upgrade curb ramp/push button accessibility.
- 12 Connect sidewalk to future 19th Street sidewalk.
- 13 Trim trees to provide adequate overhead clearance for pedestrians.
- 14 Install painted crosswalk near school; consider pedestrian crossing signage.

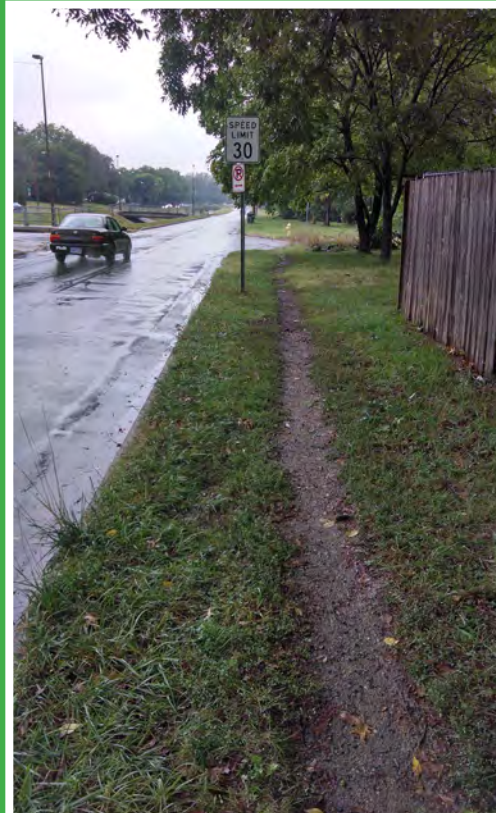
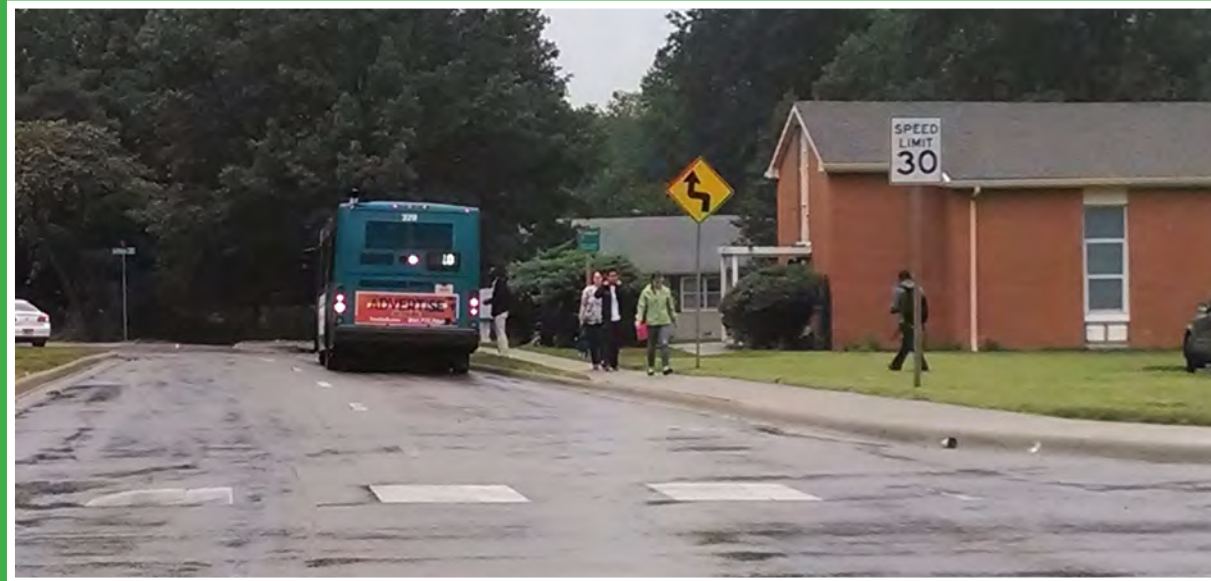
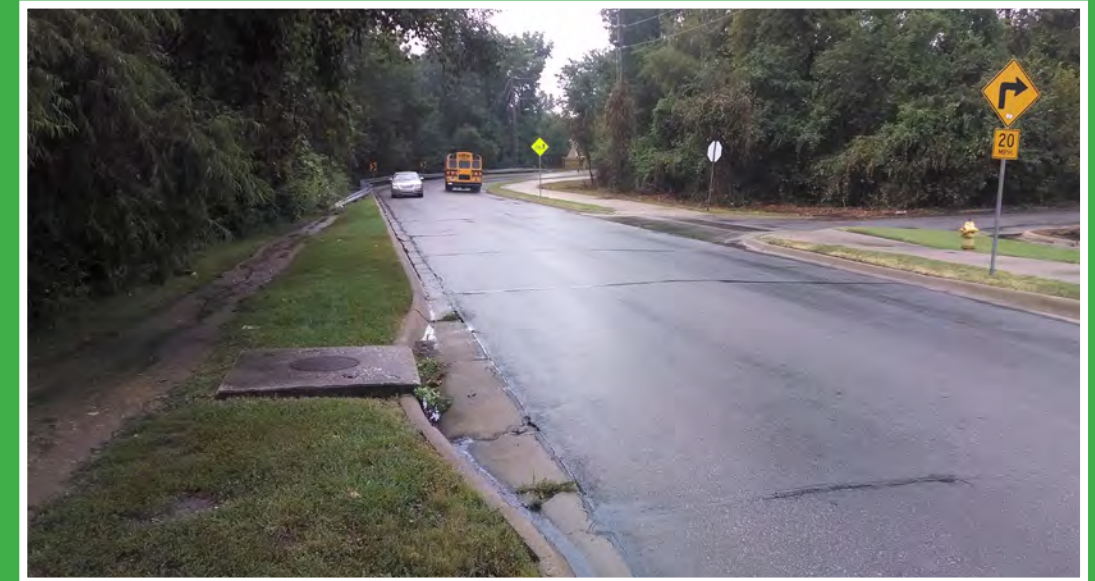
Figures 5-14 through 5-17: Naismith Drive (see sub-headings for more information)

**Figure 5-14:**  
 (Bottom- and Top-left)  
 Naismith Drive - No sidewalks on  
 East Side of the Roadway.

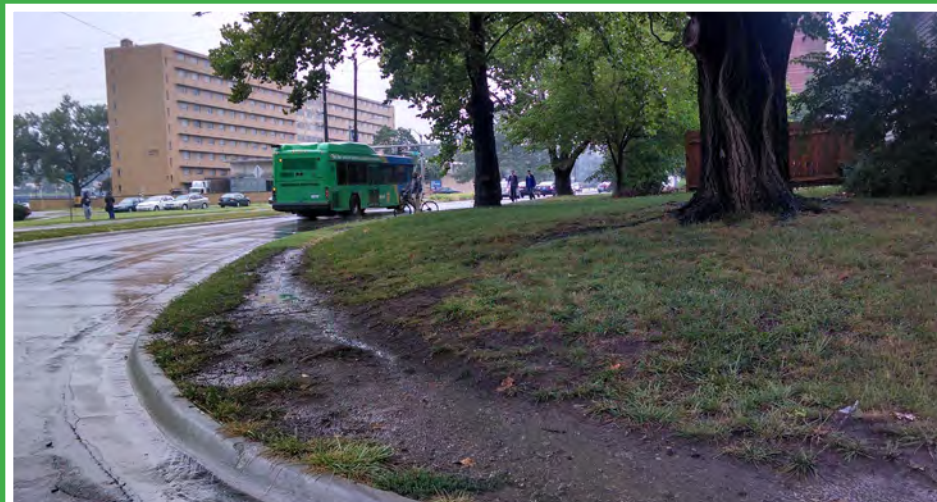
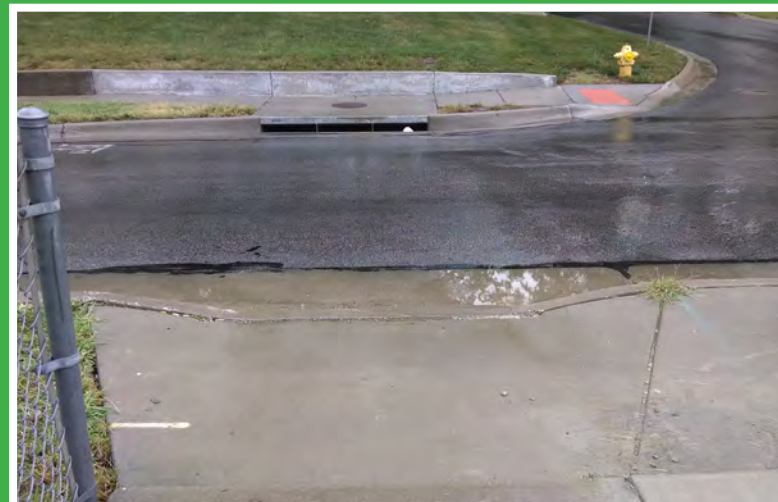
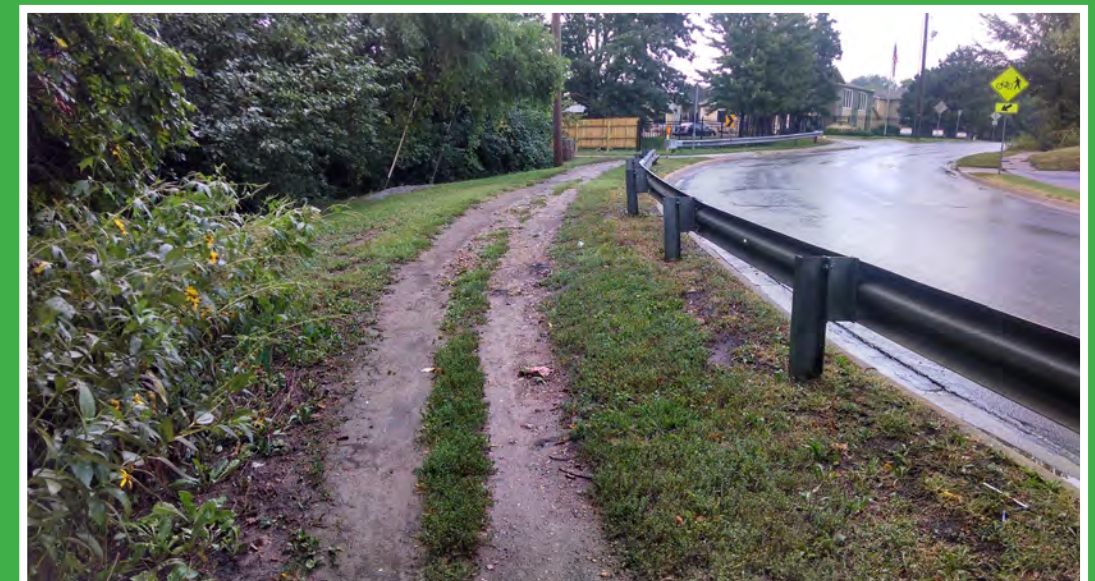
**Figure 5-17:**  
 (Above and Below) Naismith Drive – No Sidewalks South of 23rd Street.

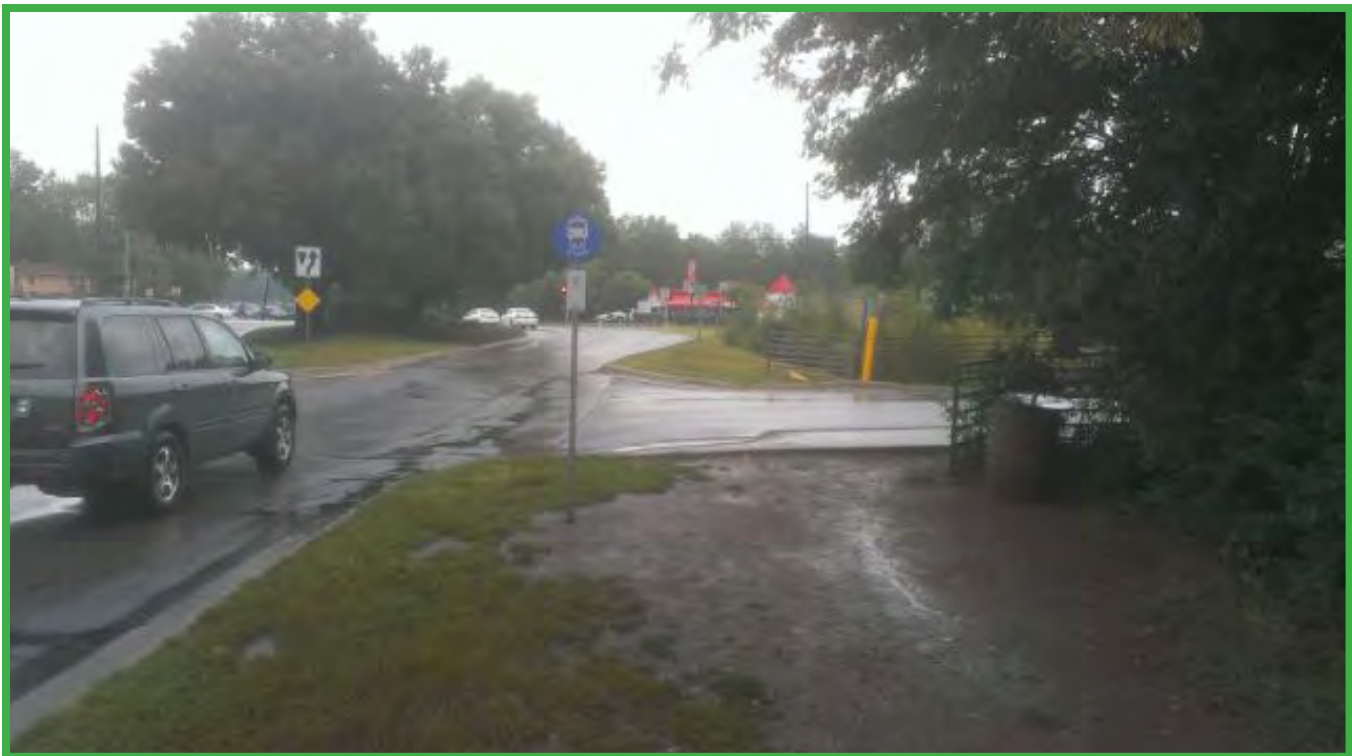
**Figure 5-18:** Naismith Drive – Bus Stop with No Concrete Pad.

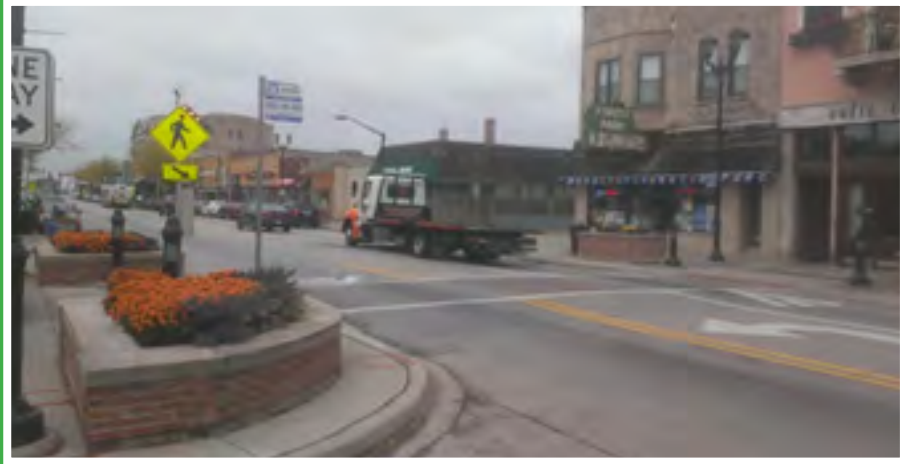
**Figure 6-9: Examples of Sidewalk Enhancements**

*(Above) This pedestrian crosswalk includes a slightly raised crossing to enhance accessibility. There is also a pedestrian button that activates a flashing pedestrian sign to alert motorists.*
