Multimodal Planning Studies

FIXED ROUTE TRANSIT and PEDESTRIAN ACCESSIBILITY STUDY

December 2013

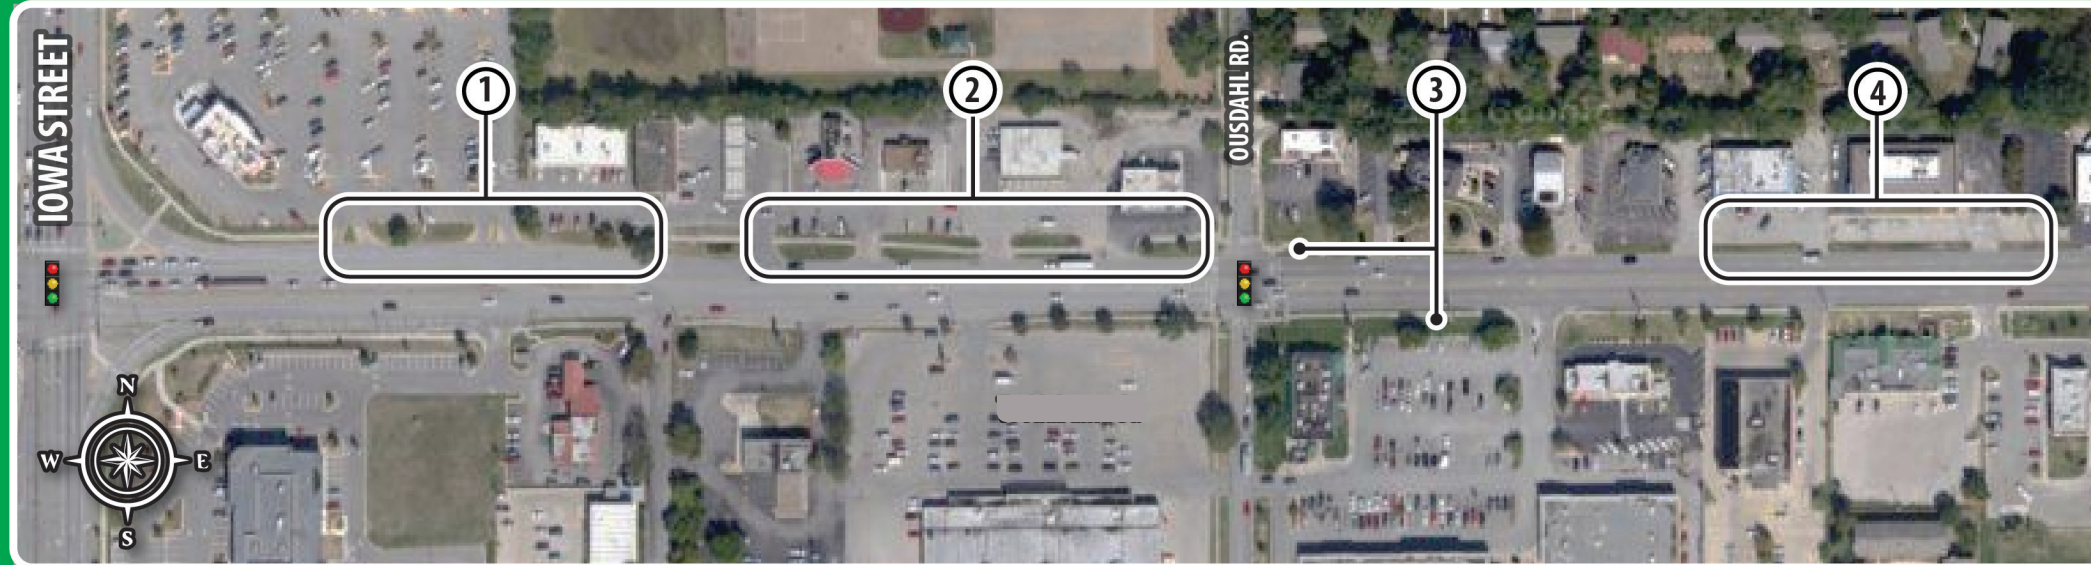
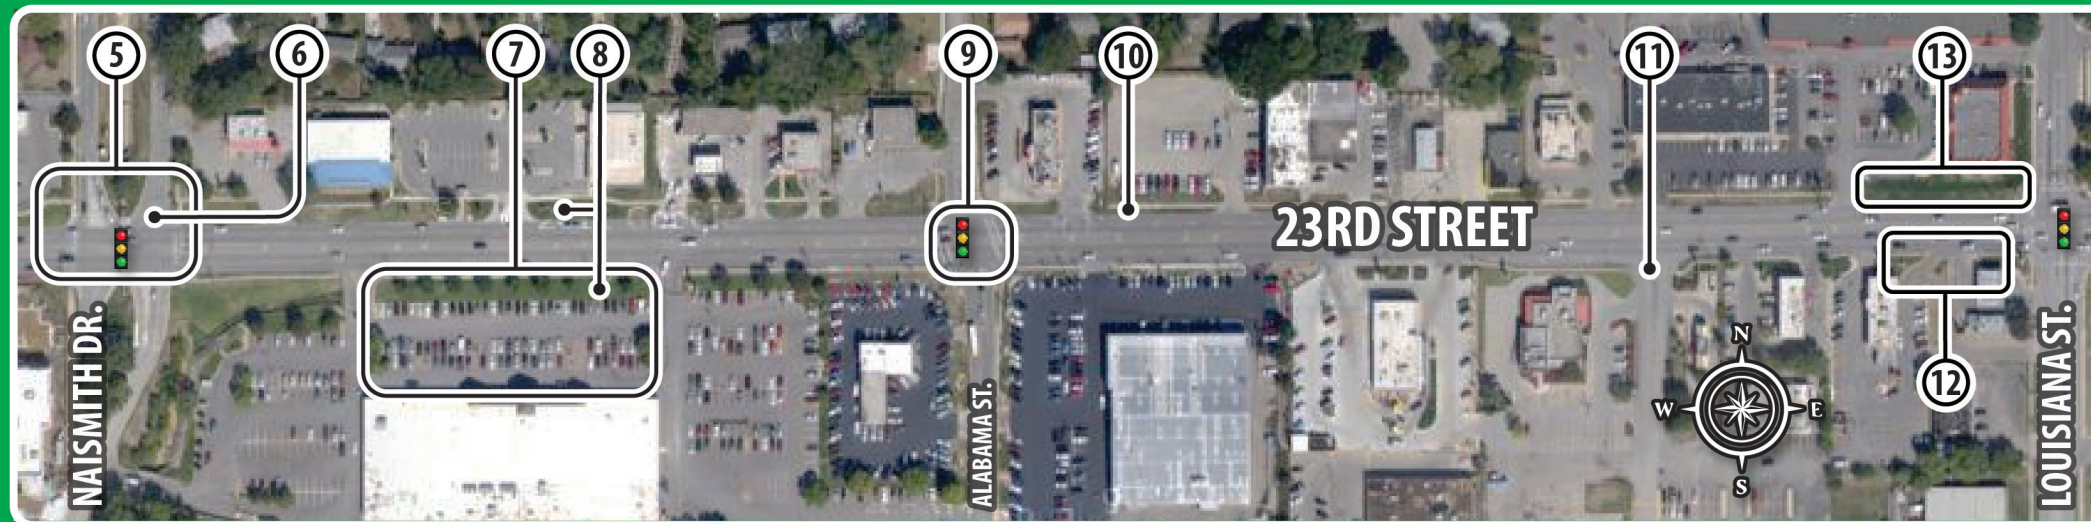
Figure 5-4: Examples of Key Sidewalk Segments along 23rd Street

- ① Gaps in the sidewalk network.
- ② Several access points; potential vehicle / pedestrian conflicts.
- ③ Bus stops with no amenities.
- ④ Gap in sidewalk network; sidewalks located near store front and not adjacent to the street.
- ⑤ NE / NW corners have odd configuration; difficult for pedestrians to navigate.
- ⑥ Missing crosswalk paint.
- ⑦ Poor access to commercial area; direct access to store requires pedestrians to walk across 30' of grass.

- ⑧ Pedestrians / transit users crossing mid-block unprotected.
- ⑨ Poor crosswalk striping at some crossings.
- ⑩ Bus stop with no amenities.
- ⑪ Raised median / sign supports in path of sidewalk. Also, curb ramps in disrepair.
- ⑫ Wide driveway access and sidewalk with poor slope.
- ⑬ Missing sidewalk segment.

- 1 Construct missing sidewalk segments.
- 2 Review potential access management strategies to improve pedestrian safety and enhanced connectivity.
- 3 Identify appropriate bus stop amenities to include at these stops.
- 4 Construct sidewalk adjacent to roadway to provide a continuous sidewalk connection that would be utilized by fixed-route transit riders.
- 5 Reconstruct sidewalk connections to provide direct connections to curb ramps – improve sidewalk configuration.
- 6 Repaint crosswalk.
- 7 Provide direct access from bus stop to commercial building entrances.

- 8 Explore potential mid-block crossing to provide safer crossing between bus stops, or consider alternative improvement to direct pedestrians to cross at Naismith or Alabama. Explore possibility of relocating bus stop closer to a signalized intersection with marked cross walks.
- 9 Repaint crosswalks; explore possibility of better aligning marked pedestrian crosswalks.
- 10 Identify appropriate bus stop amenities to include at this stop.
- 11 Reconstruct SW corner curb ramp and remove all or parts of raised median to enhance pedestrian movement.
- 12 Implement access management strategies and improve sidewalk cross slope to provide for enhanced pedestrian movements.
- 13 Install sidewalk that connects to the NW corner of the intersection at Louisiana Street.

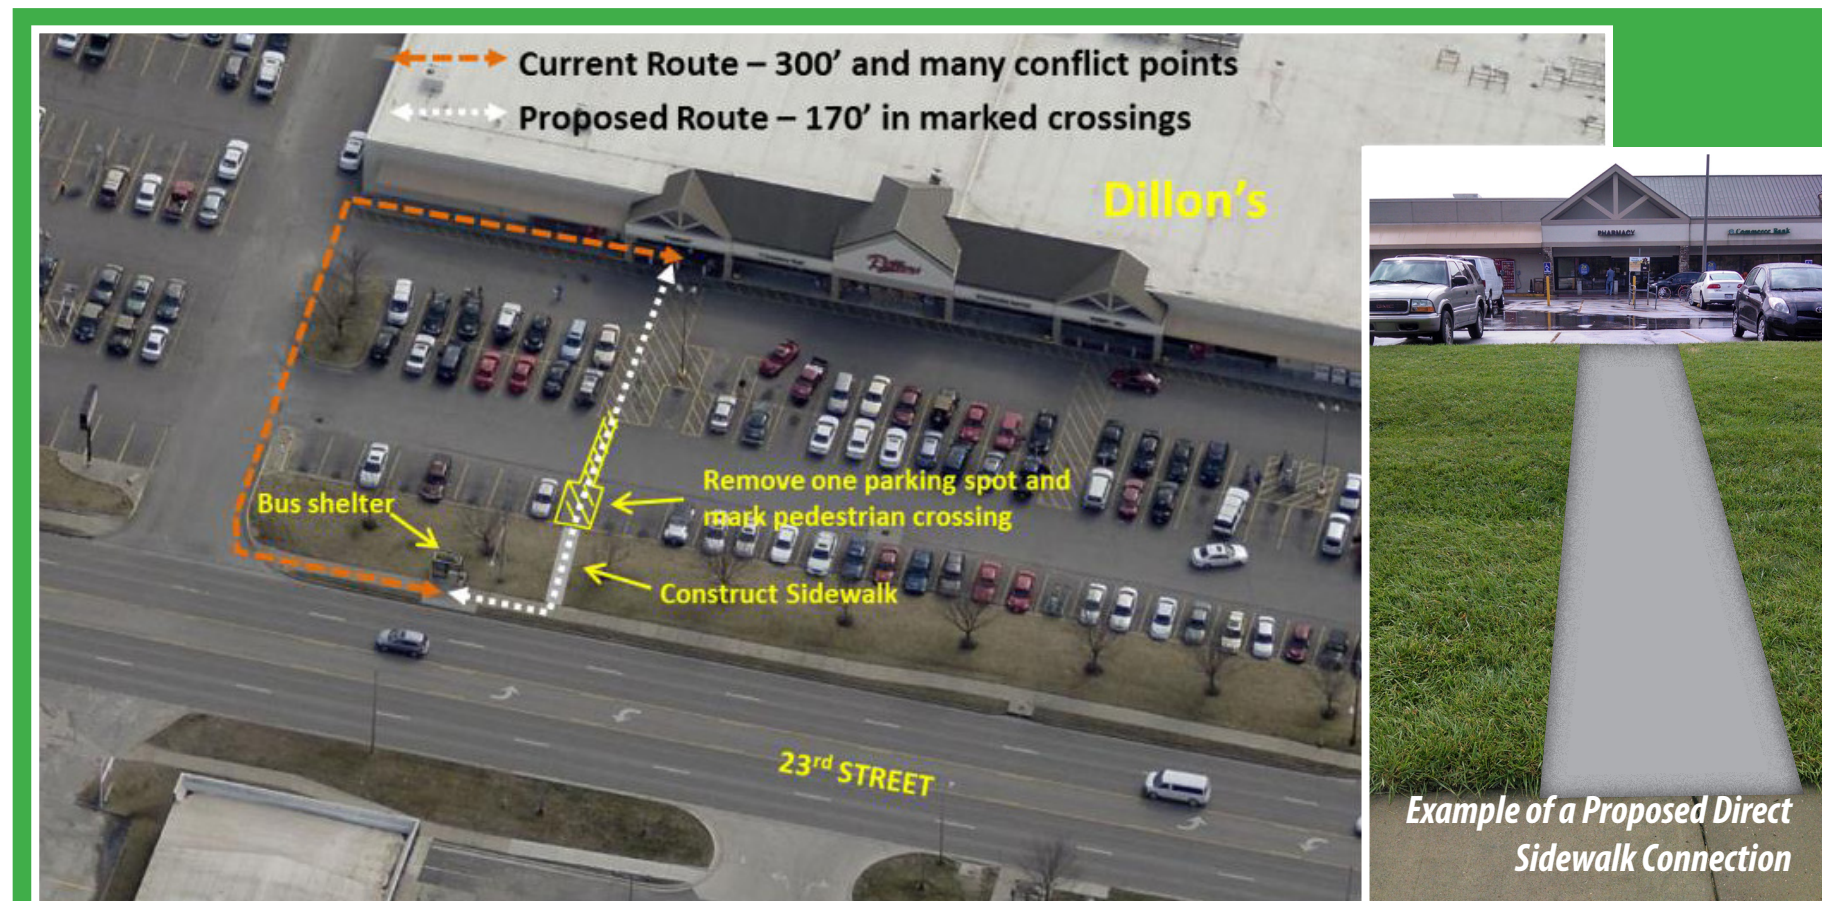
Figure 5-5: Examples of Pedestrian Connectivity Issues between Bus Stop and Development

Generally speaking, this targeted corridor segment provides several examples of issues that make transit-pedestrian access difficult. The corridor segment includes sidewalk gaps along key stretches of the roadway. Figure 5-4 displays examples of the missing sidewalk segments, including a key segment that was recently replaced near the intersection of 23rd Street and Alabama Street. In some cases, sidewalks may be present but are located directly near the store front and not adjacent to the roadway. While this design may be compliant with site development requirements requiring sidewalks, a sidewalk adjacent to a store front does not facilitate pedestrian access to transit and in fact creates an obstacle that makes riding fixed-route transit more difficult.

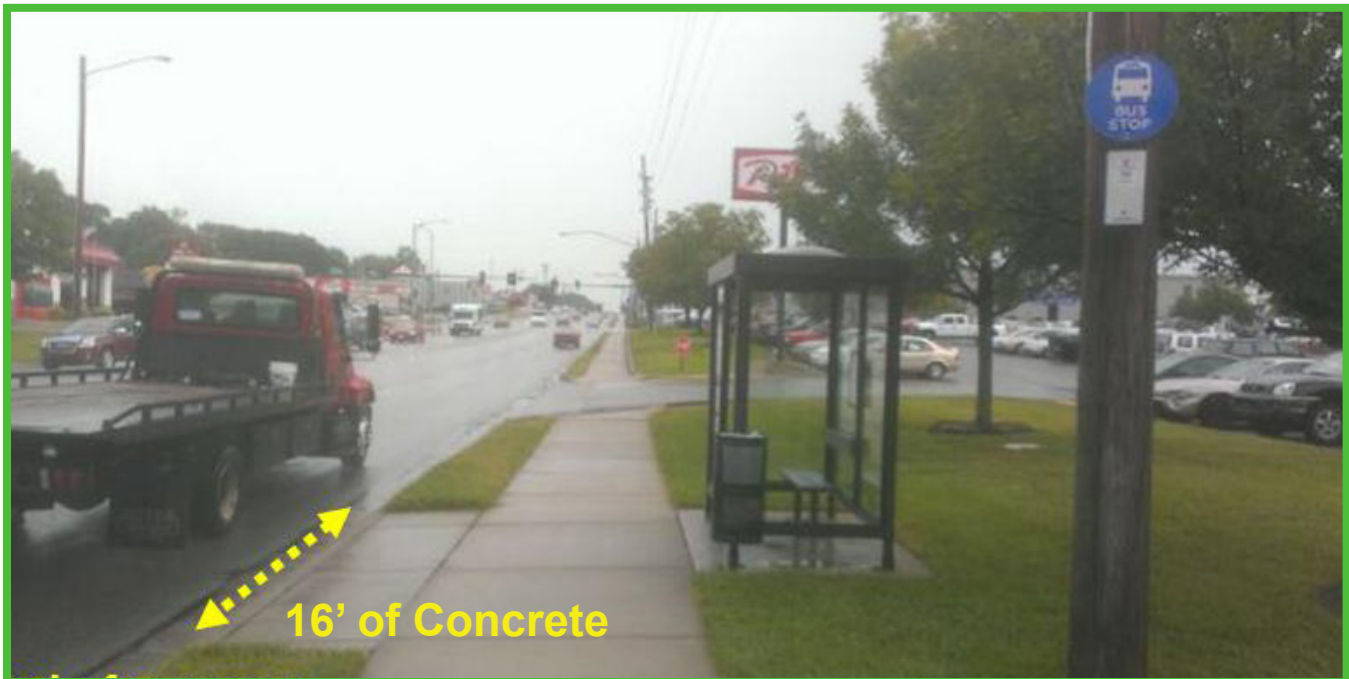
Figure 5-7: Example of Wide Concrete Boarding Area

Finally, the actual bus stop design provides a good example of what other stops throughout the area should be included. For example, this particular stop has a wide concrete boarding area that makes it easy for pedestrians to access the bus from the sidewalk/waiting area. During fieldwork, this concrete section between the roadway and sidewalk was measured at 16 feet wide (see Figure 5-7). Having this width allows bus drivers to easily pull up to the stop and passengers to board and alight the bus. The extra width also provides a larger area for accessing the bus during bad weather, especially important if large amounts of snow that could easily narrow or close the boarding location accumulate in the corridor.

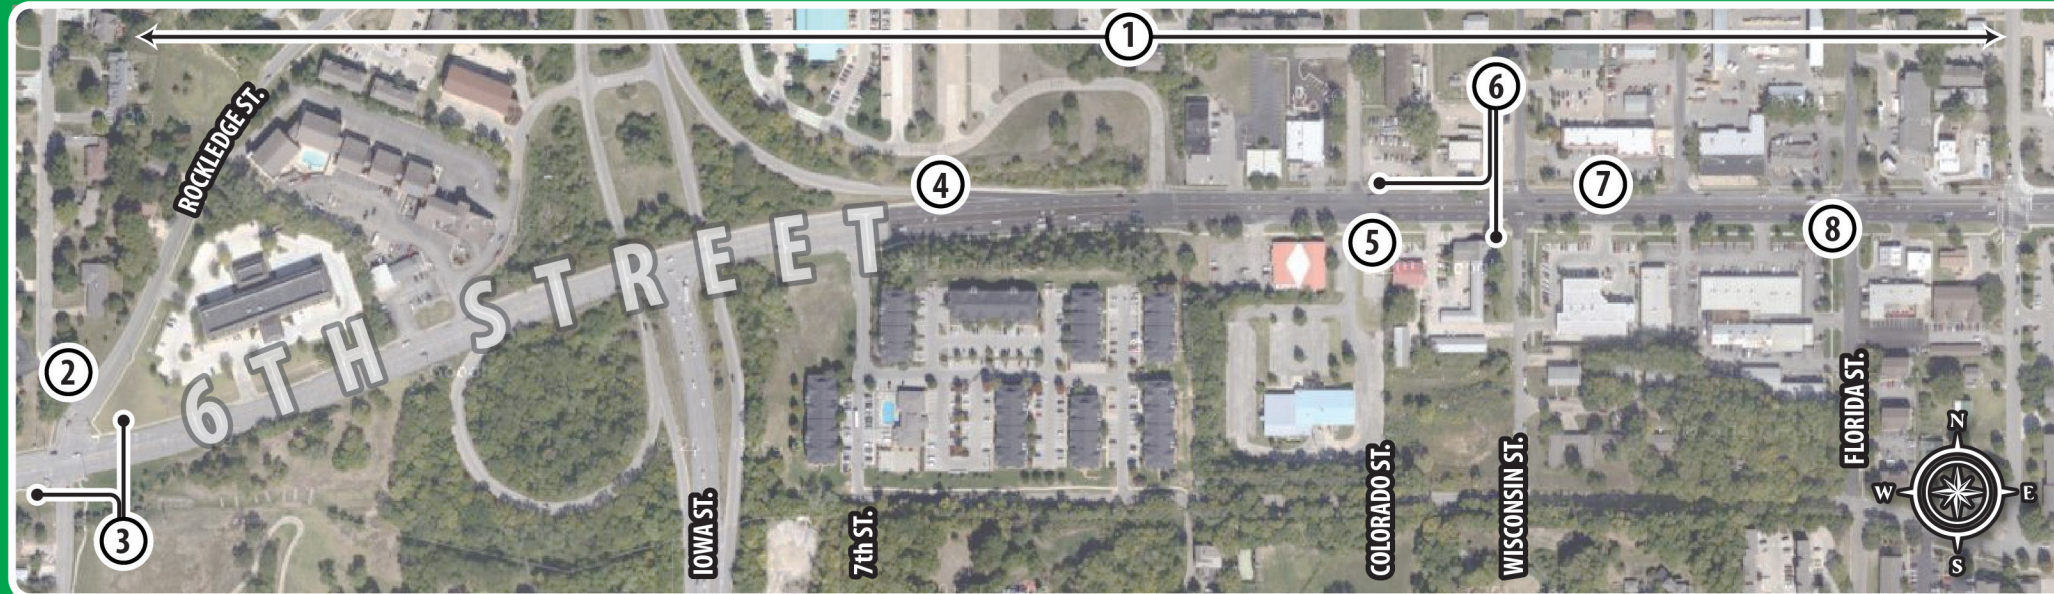
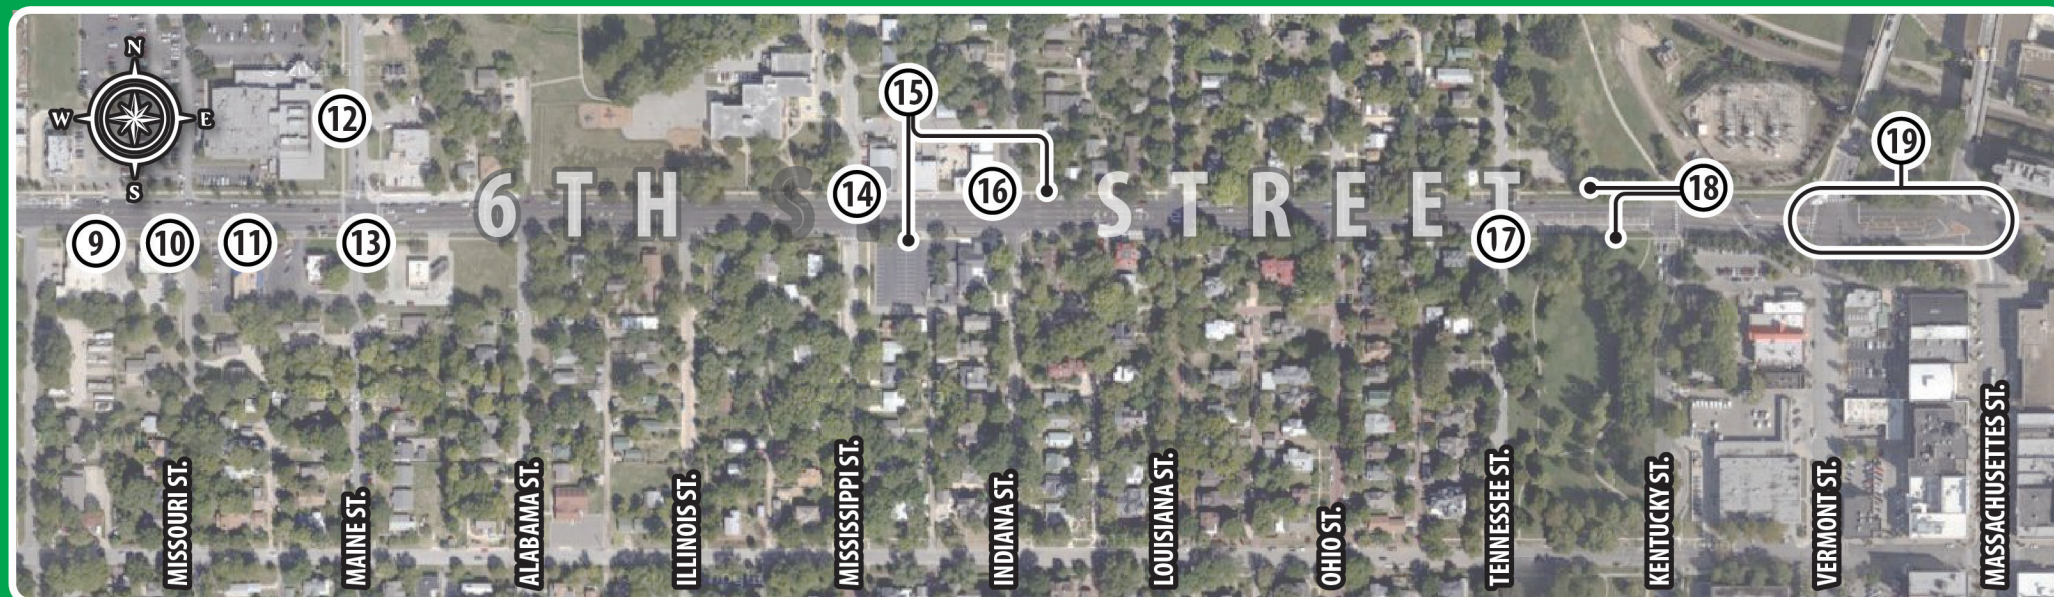
Figure 5-10: 6th Street Transit-Pedestrian Accessibility Issues

- ① ¾-miles with no north-south marked pedestrian crossings; frequent mid-block crossings by pedestrian and bicyclists.
- ② Curb ramps and pedestrian push buttons need improvement.
- ③ Bus stops with no amenities.
- ④ Missing crosswalk paint on high speed crossing.
- ⑤ Access management concern and segment of sidewalk in disrepair and steep slope.
- ⑥ Bus stops with no amenities.
- ⑦ Sidewalk in disrepair.
- ⑧ Connecting walkway on south but not north side.
- ⑨ Good example of sidewalk connection to commercial building.
- ⑩ Severe grade at curb ramp (southwest corner).
- ⑪ Sidewalk deficiencies - site presently in redevelopment.
- ⑫ Bus stop on Maine Street – currently no amenities (bus stop was recently relocated).

- ⑬ Accessibility issue at curb ramp needs improvement (southeast corner).
- ⑭ Missing crosswalk paint; priority crossing near school.
- ⑮ Bus stops with no amenities.
- ⑯ Accessibility issue at curb ramp needs improvement (northwest corner).
- ⑰ Curb ramps in severe disrepair and steep grades; heavy traffic and priority crossing near park grades.
- ⑱ Bus stops with no amenities.
- ⑲ No north-south crosswalks to Robinson Park.

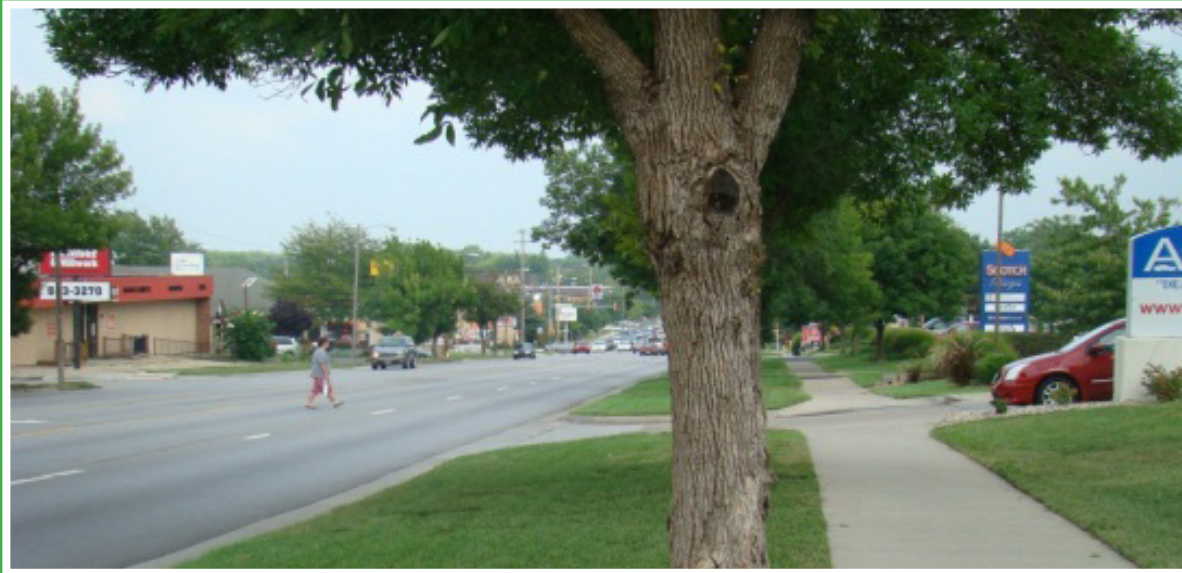
Mid-block crossings were frequently observed along the corridor.

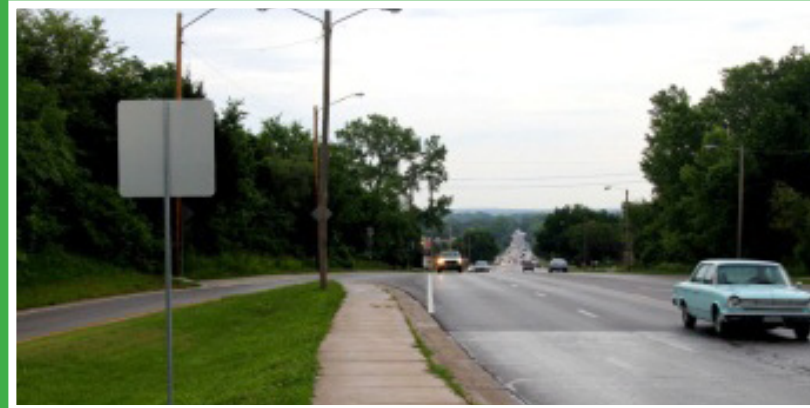
A high speed pedestrian crossing on 6th near the ramp to northbound McDonald Drive heading to I-70.

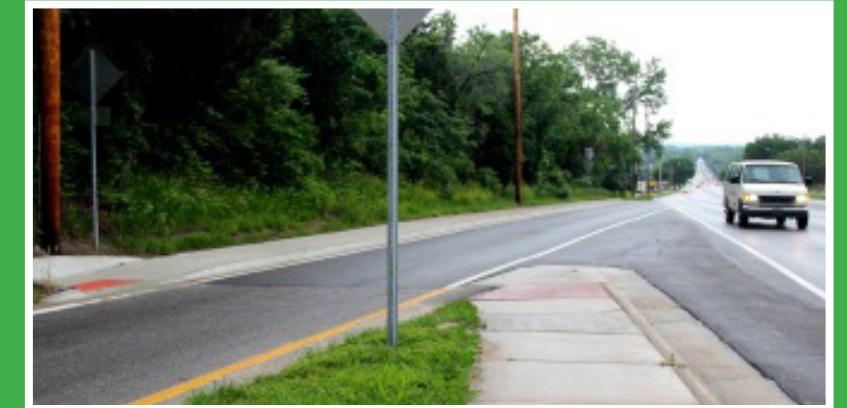
Steep slopes on some sidewalk segments, and poor drainage, make pedestrian travel difficult.

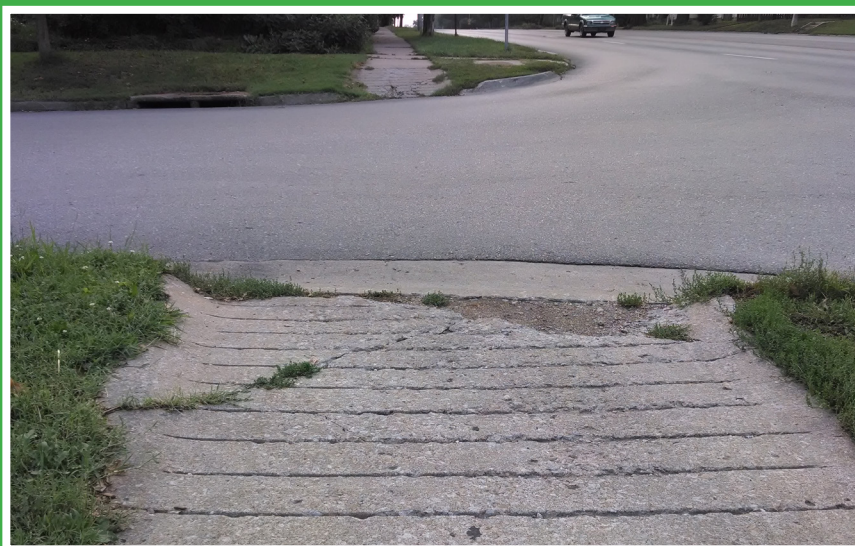
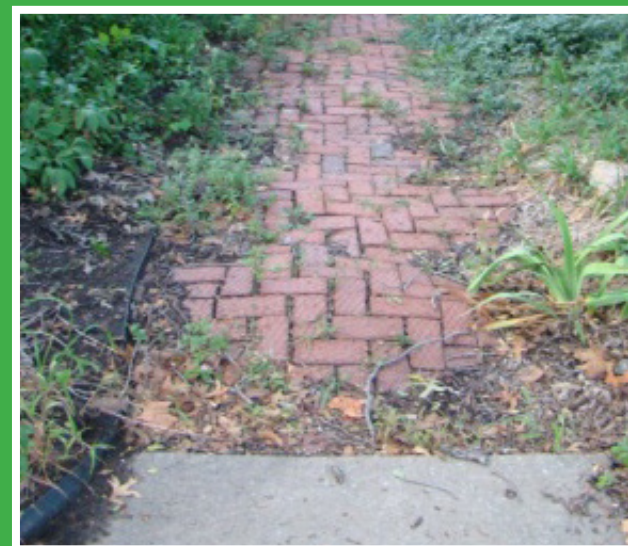
Sidewalks in disrepair, and brick sidewalks connecting to the corridor, make pedestrian accessibility difficult.

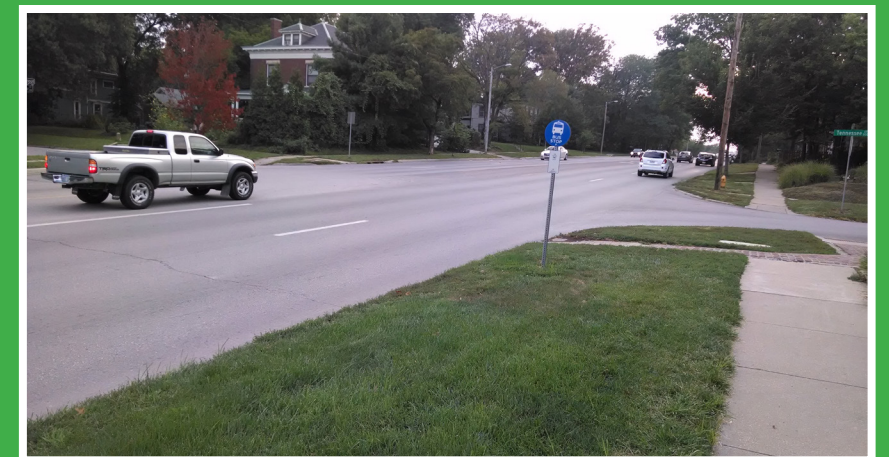
Typical bus stops along 6th Street do not have concrete pads or other amenities.

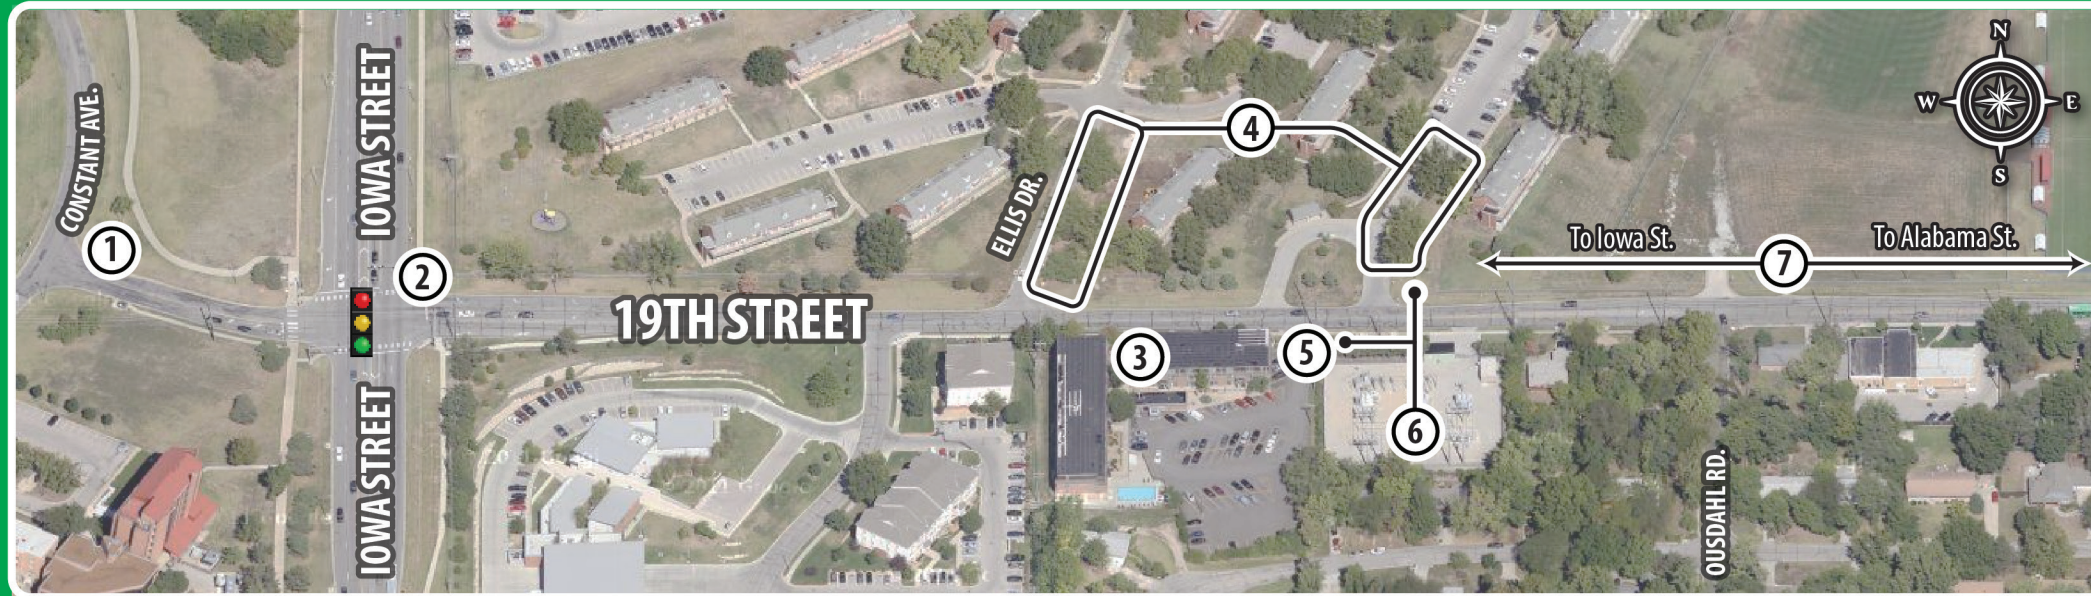
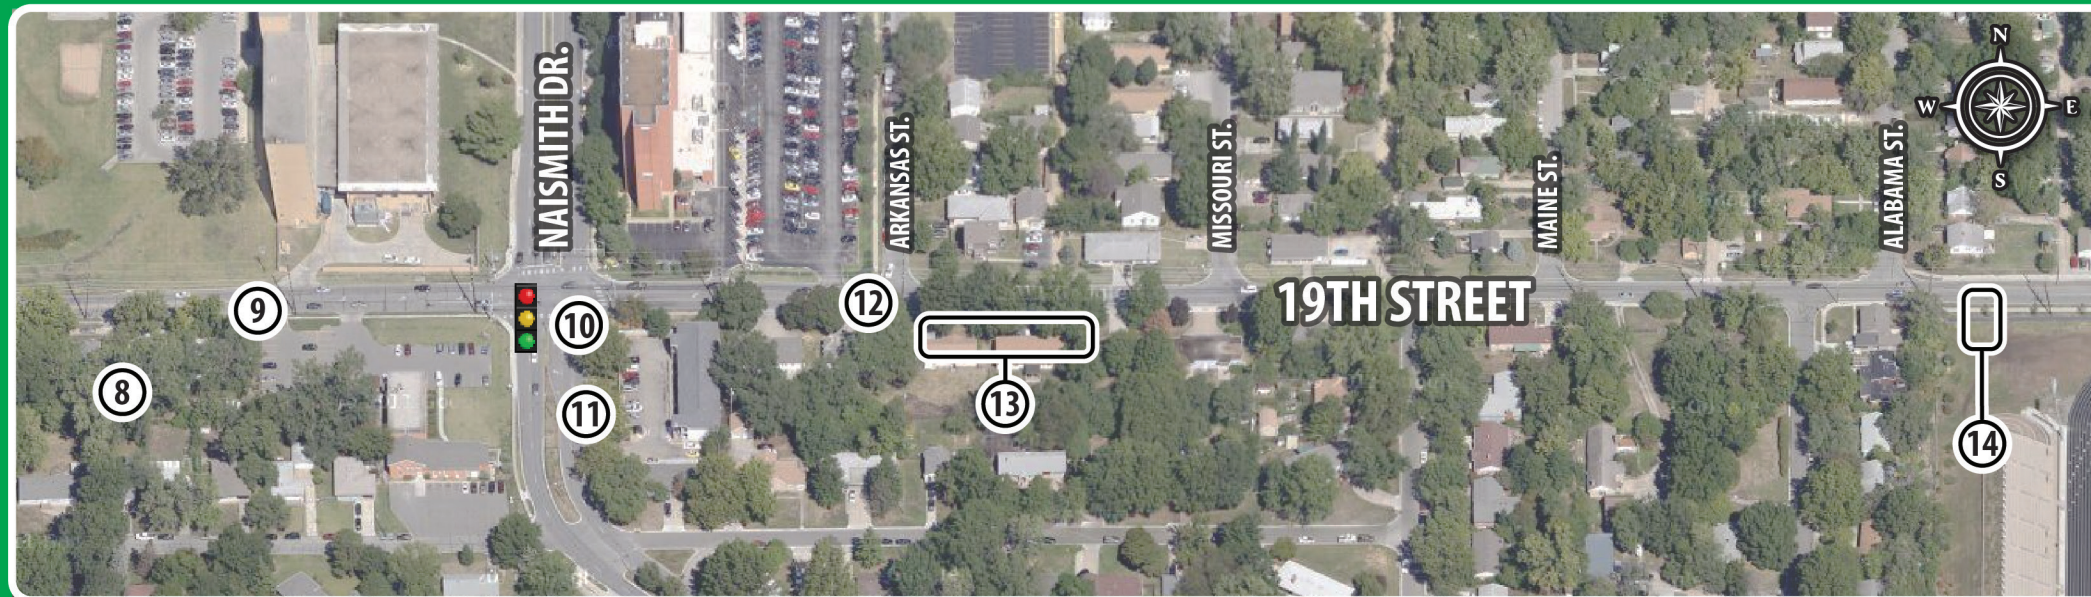
- ① Bus stop with no amenities; no connection to nearby sidewalk.
- ② Ped push button inaccessible - on back of pole.
- ③ 50% of sidewalk in disrepair - Ellis to Ousdahl; obstacles in sidewalk and overgrown landscaping.
- ④ No sidewalk connection to student housing.
- ⑤ No crosswalk between bus stops (East of Anna).
- ⑥ Bus stops with no amenities; steep slope on north side.
- ⑦ No sidewalk on north side of 19th (Iowa to Alabama).

- ⑧ Multiple sidewalk segments need replacement; some obstacles in sidewalk path.
- ⑨ Bus stop with no amenities; no sidewalk connection.
- ⑩ Missing crosswalk paint (included in Naismith Drive improvements).
- ⑪ Inaccessible pedestrian push buttons (included in Naismith Drive improvements).
- ⑫ Sidewalk ends 8' north of 19th Street.
- ⑬ Problem with untrimmed trees (~4' off sidewalk).
- ⑭ Possible location for a marked crossing

- 1 Provide typical bus stop amenities and sidewalk connection.
- 2 Reposition pedestrian push button.
- 3 Replace sidewalk that is in disrepair.
- 4 Install sidewalk from 19th to student housing.
- 5 Install painted crosswalk between bus stops; consider possible pedestrian crossing signs.
- 6 Provide typical bus stop amenities; improve waiting area on north side of 19th Street.
- 7 Install sidewalk on north side of 19th Street; coordinate with KU Master Plan. As part of implementing this facility, a 300' retaining wall will likely need to be constructed.

- 8 Replace sidewalk that is in disrepair.
- 9 Provide typical bus stop amenities.
- 10 Repaint crosswalk.
- 11 Upgrade curb ramp/push button accessibility.
- 12 Connect sidewalk to future 19th Street sidewalk.
- 13 Trim trees to provide adequate overhead clearance for pedestrians.
- 14 Install painted crosswalk near school; consider pedestrian crossing signage.

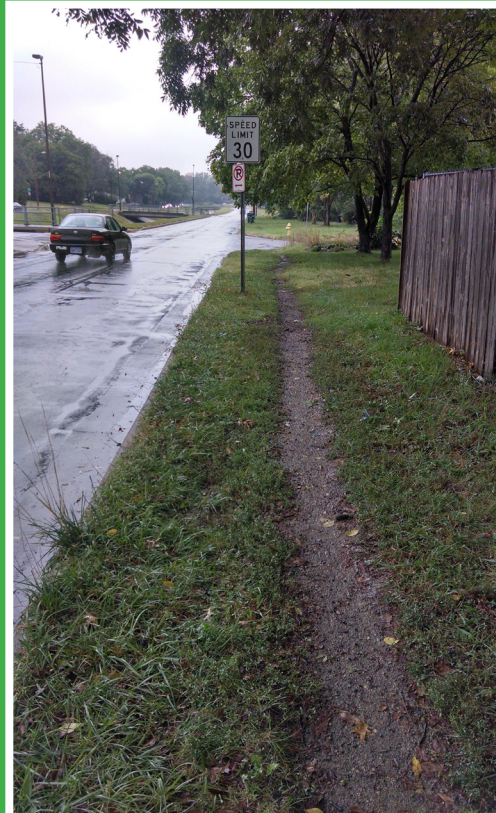
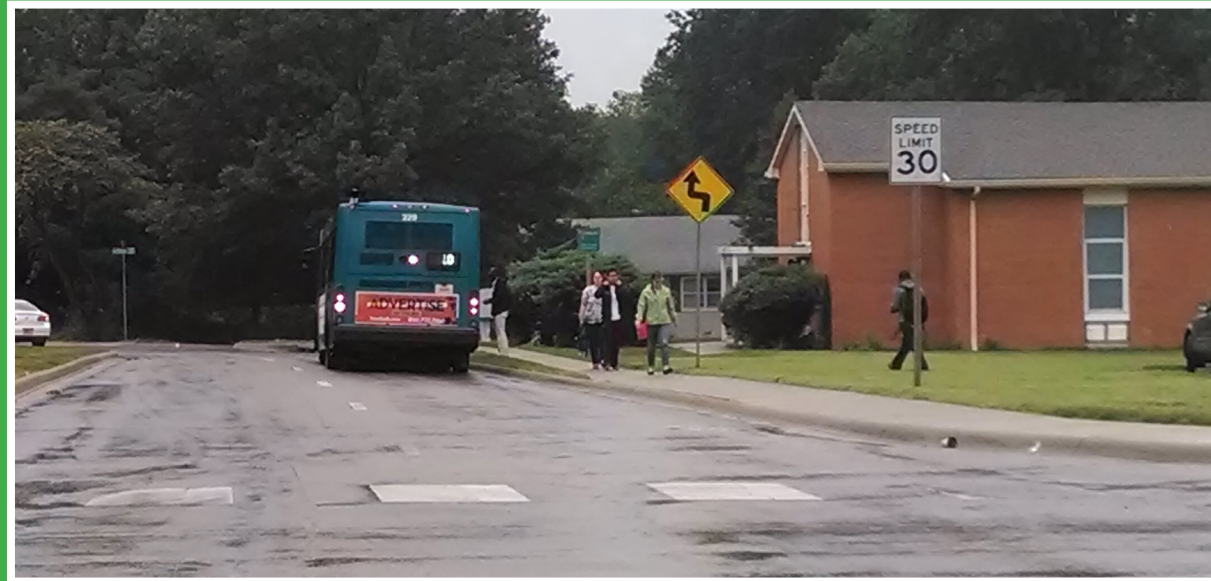
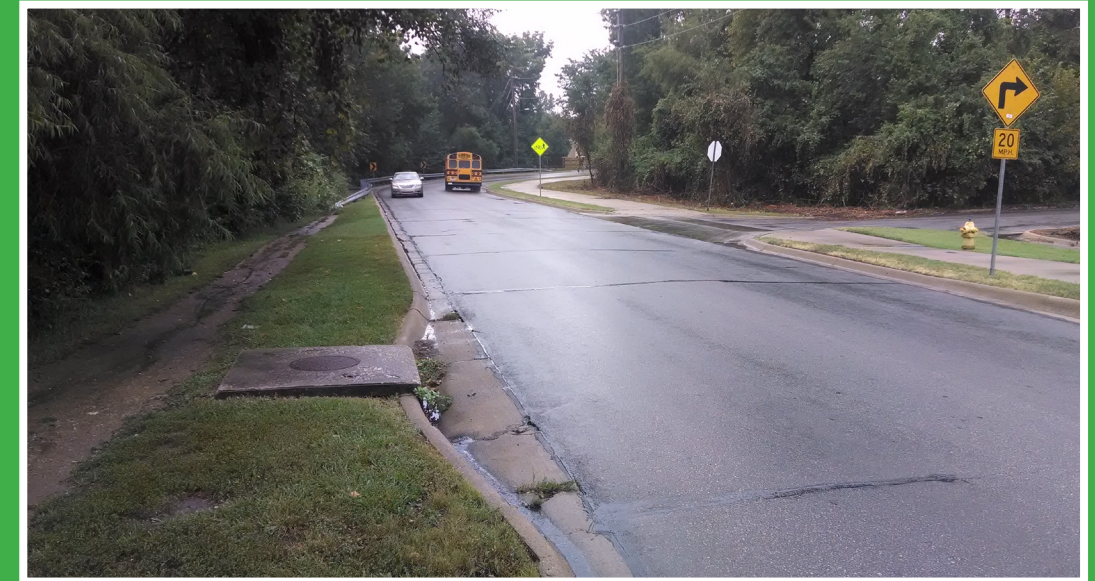
Figures 5-14 through 5-17: Naismith Drive (see sub-headings for more information)

Figure 5-14:
 (Bottom- and Top-left)
 Naismith Drive - No sidewalks on
 East Side of the Roadway.

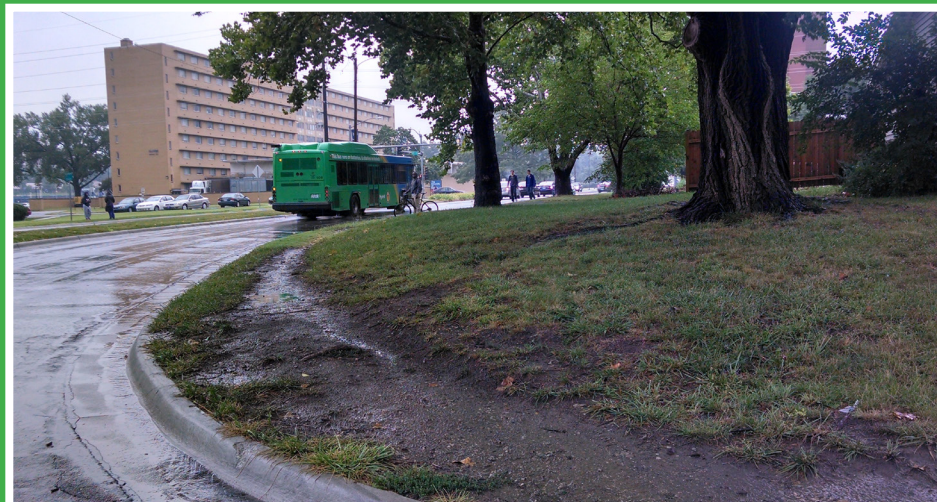
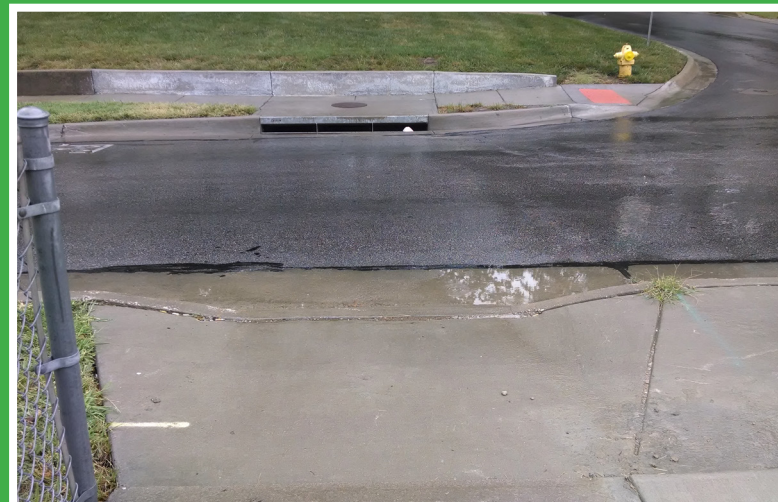
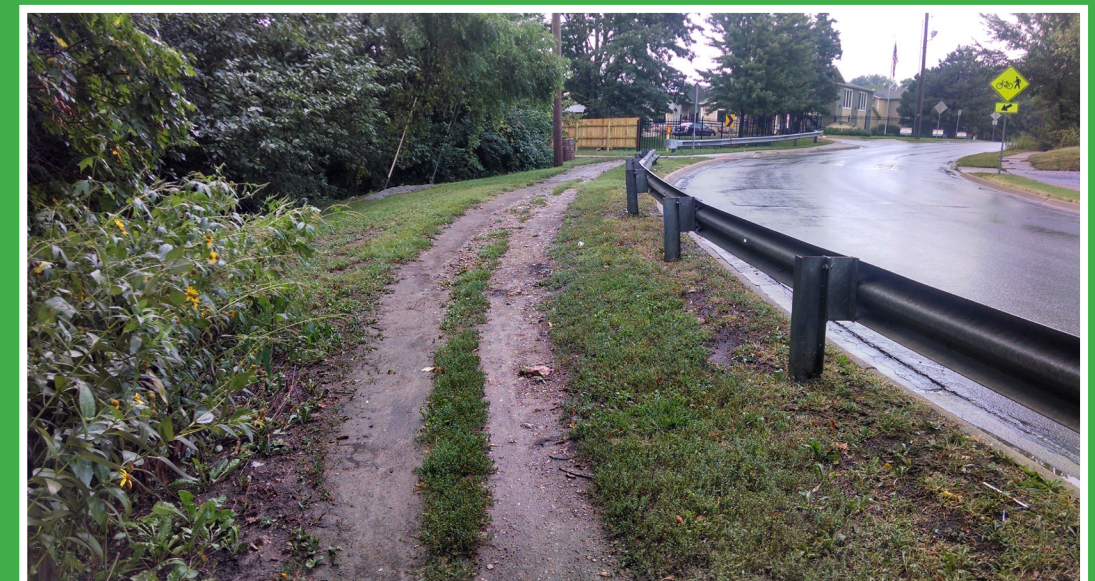
Figure 5-17:
 (Above and Below) Naismith Drive – No Sidewalks South of 23rd Street.

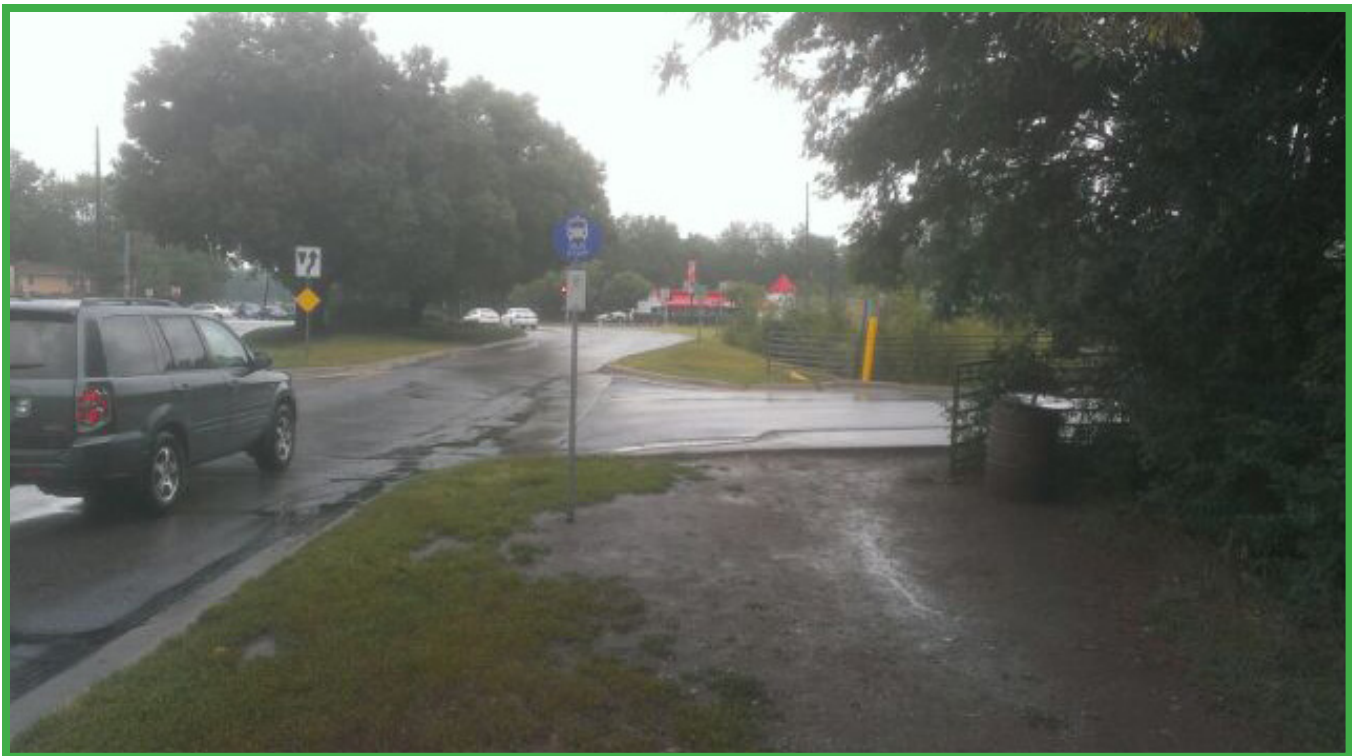
Figure 5-18: Naismith Drive – Bus Stop with No Concrete Pad.

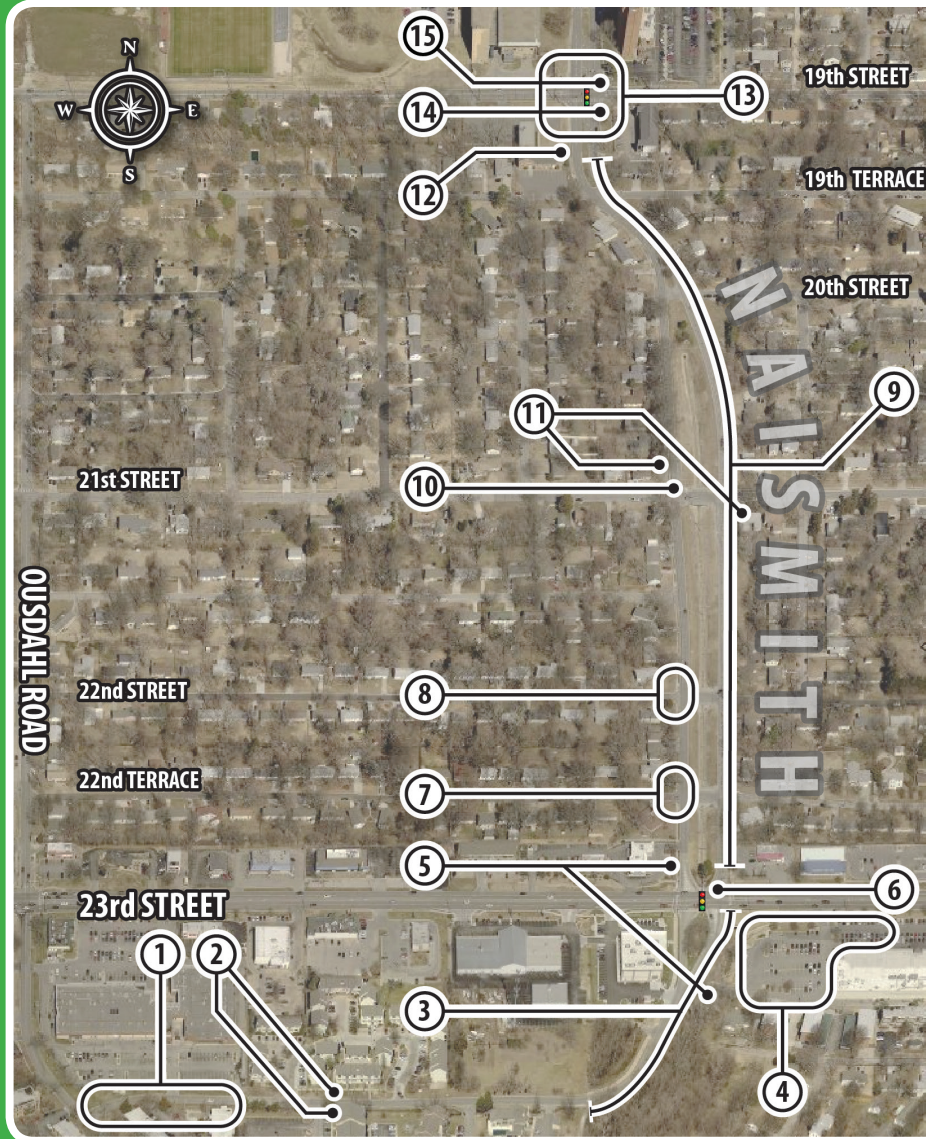
Figures 5-19: Naismith Drive Transit-Pedestrian Accessibility Issues

- 1** Missing sidewalk - dirt path.
- 2** Bus stops with no amenities / crossing; steep slope on north side of 24th Street; high transit ridership from nearby student apartments.
- 3** Missing sidewalk / connection to bus stop; also located near regional bike trail.
- 4** Poor connectivity to commercial area; sidewalk in disrepair in parking lot
- 5** Bus stops with no amenities.
- 6** Missing crosswalk paint.
- 7** Curb ramp leads to catch basin.
- 8** Curb ramp leads to catch basin.
- 9** No sidewalk present on the east side of Naismith Drive; dirt path is present along much of the corridor.
- 10** Curb ramp/crosswalk alignment skewed.
- 11** Bus stops with no amenities.
- 12** K-10 Connector bus stop; currently no amenities.
- 13** Pedestrian push button located on back side of pole.
- 14** Inaccessible pedestrian push buttons.
- 15** Missing crosswalk paint.

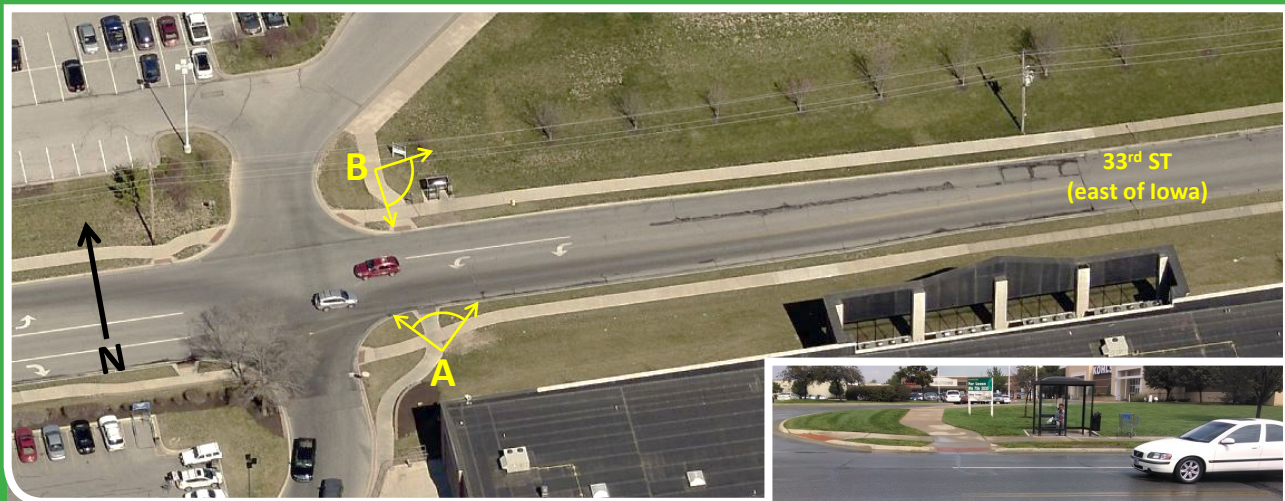
Figure 6-6: 33rd Street east of Iowa (between Walmart and Kohl's)

- ▶ Heavily used bus stop
- ▶ Carts often left scattered
- ▶ Shelter provides room for at most two riders; a larger shelter would be useful
- ▶ Muddy area where bus boarding occurs; bus stop needs a concrete pad
- ▶ Stopped bus blocks through and right turning traffic; construct bus pull-out space
- ▶ Many riders and pedestrians use this crossing; a marked crosswalk would be beneficial

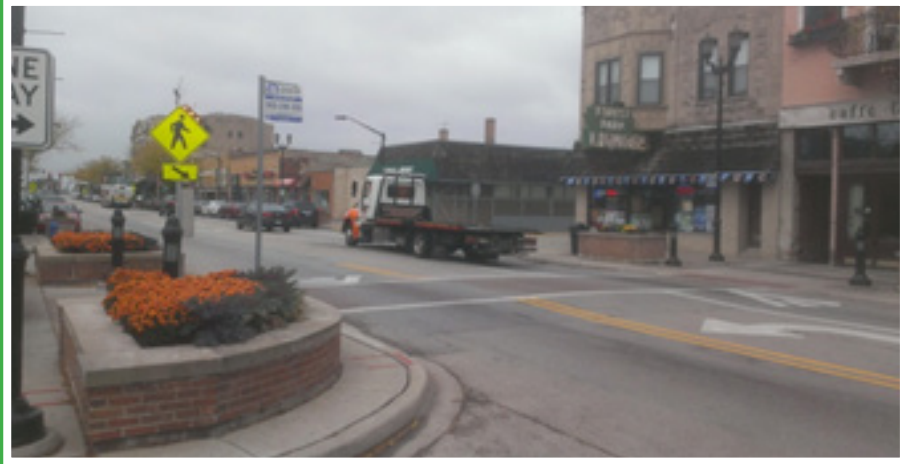
Figure 6-9: Examples of Sidewalk Enhancements

(Above) This pedestrian crosswalk includes a slightly raised crossing to enhance accessibility. There is also a pedestrian button that activates a flashing pedestrian sign to alert motorists.
