DGM Consultants, P.A.

FIELD REPORT #01

Project	Carnegie Library	Date	5/15/2012 DGM Project # 2012014
Location	9 th and Vermont Lawrence, Kansas 66044	Contractor	The Garland Company, Inc
To	Mr. Lynn Applegate , Bldg & Aquatics Sup City Of Lawrence 6 East 6th Street Lawrence, Kansas 66044	Owner	City of Lawrence
FAX		Weather	Sunny, 60-84°F
		Present	Greg Leslie Lynn Applegate
		PN	PO 005556

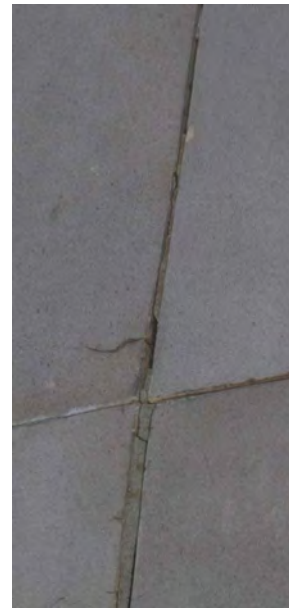
- ii) The south wall was looked at next. Back side is covered with a weathered asphalt coating above the termination bar to “seal” the exposed brick. The joints above in the back of the terra cotta finial are displaced and open. One crack was noted along the vertical joint.

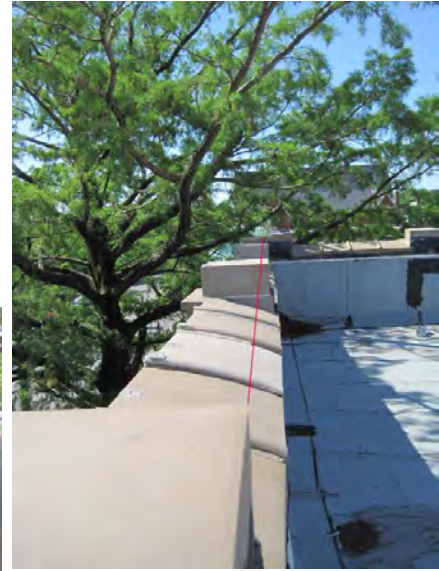
- (d) East parapet wall (31'-4")
 - i) Starting at the north end of this wall we noted a slight inward lean (bow) in this wall.
 - ii) The north end of the wall has similar covered brick issues and gaps above the

termination bar.

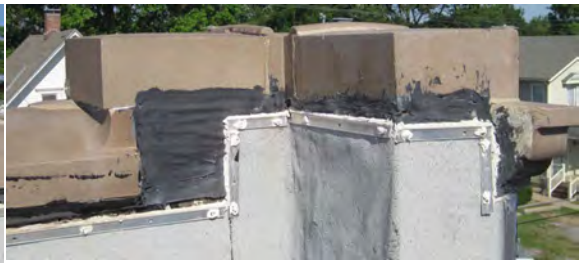
- (3) West parapet wall (31'-4"): The deteriorated conditions along this wall are

similar to the other walls.

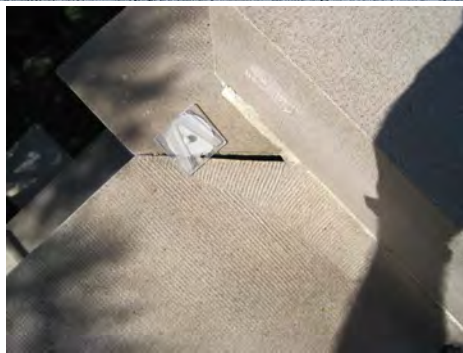
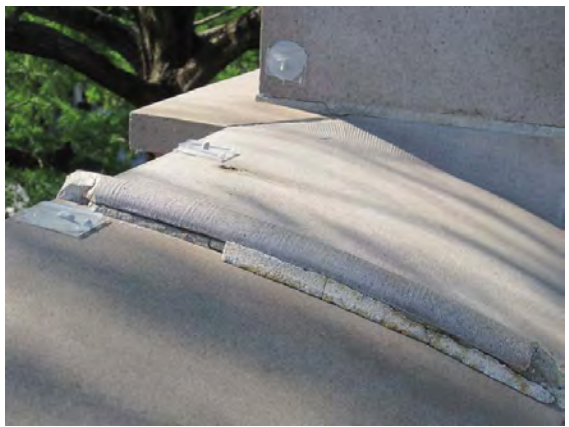
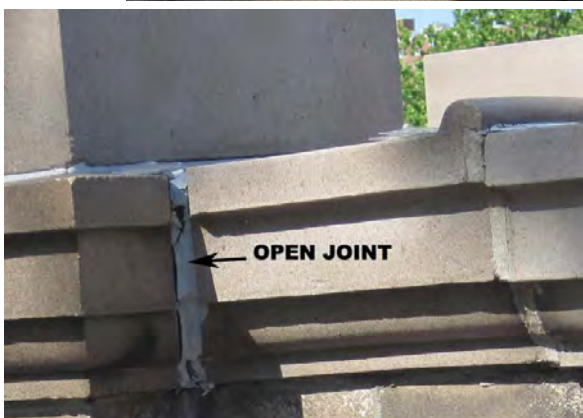
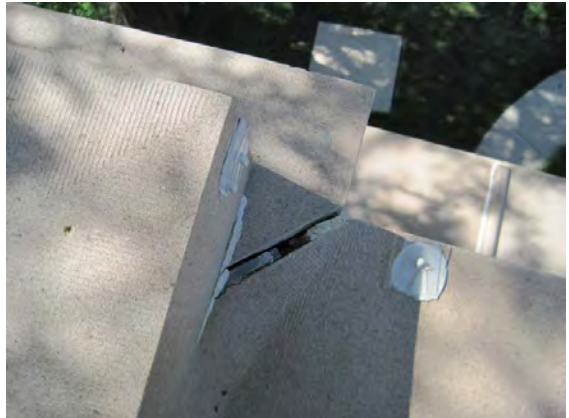
- (4) Terra cotta coping: Copings appear to be a very durable material, based on the noted condition in most locations. We noted several chips, open joints, and gaps under the coping. Several of the open joints noted were a direct result of the leaning walls. Refer to pictures on next page.

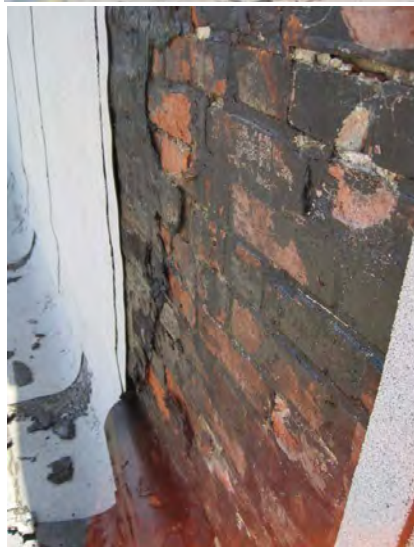
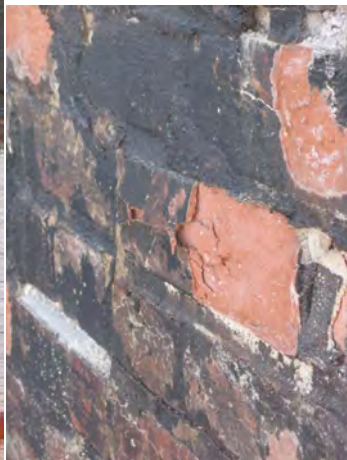
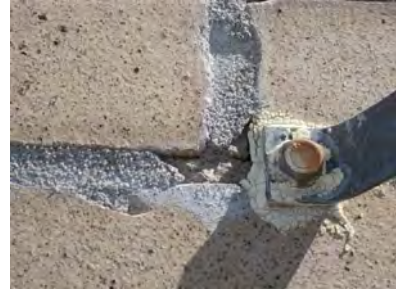
- (1) The first was at the center section. After folding the roofing down we noted the wall to be visibly wet from the glistening surface moisture. The brick backup wall had been coated with an asphalt coating subsequent to some pointing and the bricks were spalling.

1. Remaining parapet walls also need to be exposed on the back sides to allow the walls to dry out to reduce further damage. Based on the condition of the two south areas opened up, we assume that the backs of all walls are deteriorated and should be pointed. The tops of walls are also deteriorated based on the exposed portions and need to be rebuilt so that the top of wall can be flashed and the copings be reinstalled. The slight curvature of these walls is similar to that of the south walls, but is not expected to be as deteriorated. All walls should be reviewed to establish the full extent of the required repairs.
2. Repair options: The two options presented for the severely leaning walls could also be applied to all original building walls to produce the best solution for these severely exposed walls.

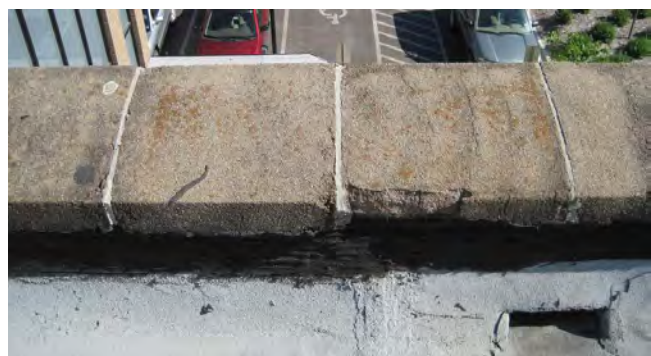
(1) The copings on the north wall are cast stone units that are of a similar cross section as the original, but 24 of the 47 units are severely deteriorated and joints are cracked.

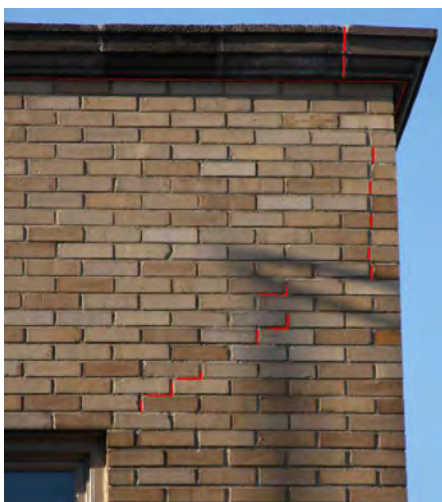
- (3) At the northwest corner (from the ground), we noted that the coping was being pushed off the wall in both direction but more toward the west since the north wall is twice as long. The expansion toward the west has also cracked the brick wall below.

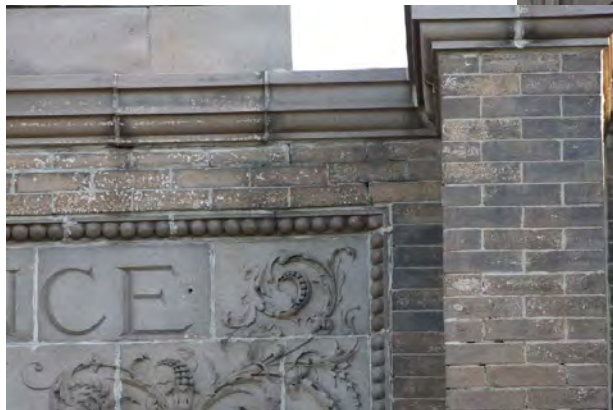
- (c) Center section: Masonry appears to be in good condition, except for some open joints between the bricks and the inlaid panels and mortar joints.

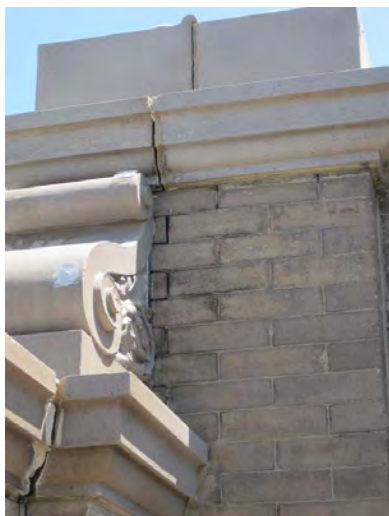
- iv) At top of wall (west central portion), open joints were noted from ladder (photo left).

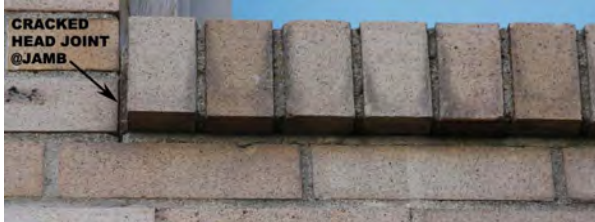
- (c) Open mortar joints were noted in brick wall near original building's northwest corner. The mortar joint, at the lintel bearing, is cracked.
- (d) Deteriorated

rowlock window sill and cracked joint at jamb were noted.

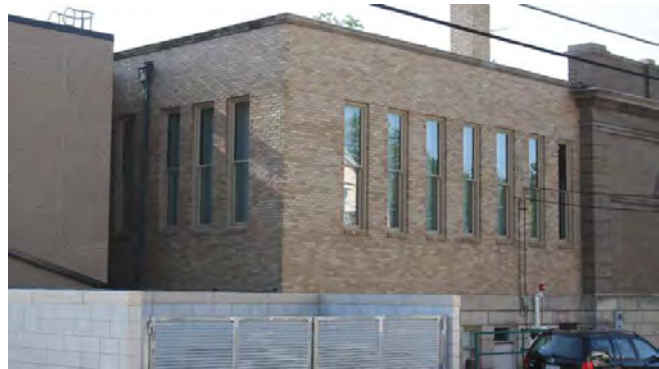
- d. North elevation
 - (1) 1937 Addition
 - (a) Western portion of elevation is partially visible from the northwest. Noted concerns were previously discussed.
 - (b) Eastern portion of north elevation is more visible from the northeast. Lintels were noted to be rusted along this elevation.

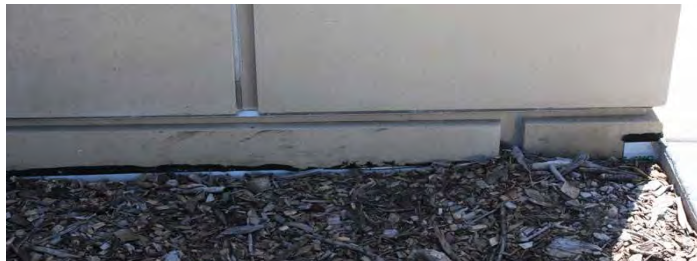
- (2) 2011 Addition: The foundation waterproofing has been improperly terminated above grade. This material will degrade with UV exposure.

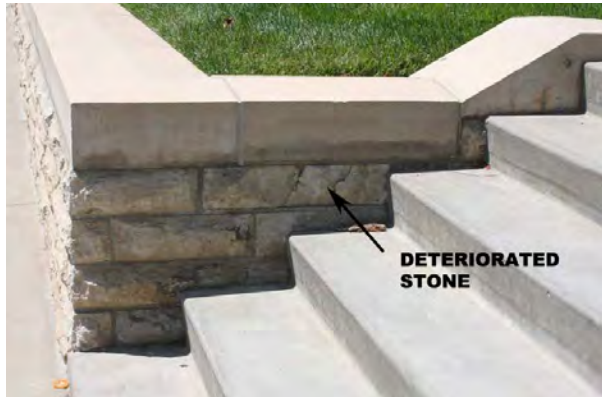
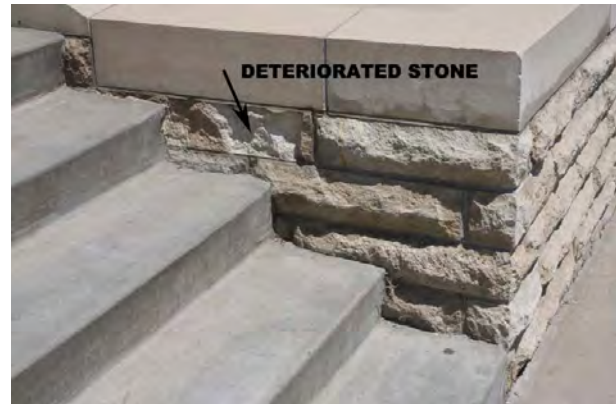
- (2) South entrance stair walls: Some stones are deteriorated.
