DGM Consultants, P.A.

FIELD REPORT #01

Project	Carnegie Library	Date	5/15/2012 DGM Project # 2012014
Location	9 th and Vermont Lawrence, Kansas 66044	Contractor	The Garland Company, Inc
To	Mr. Lynn Applegate , Bldg & Aquatics Sup City Of Lawrence 6 East 6th Street Lawrence, Kansas 66044	Owner	City of Lawrence
FAX		Weather	Sunny, 60-84°F
		Present	Greg Leslie Lynn Applegate
		PN	PO 005556

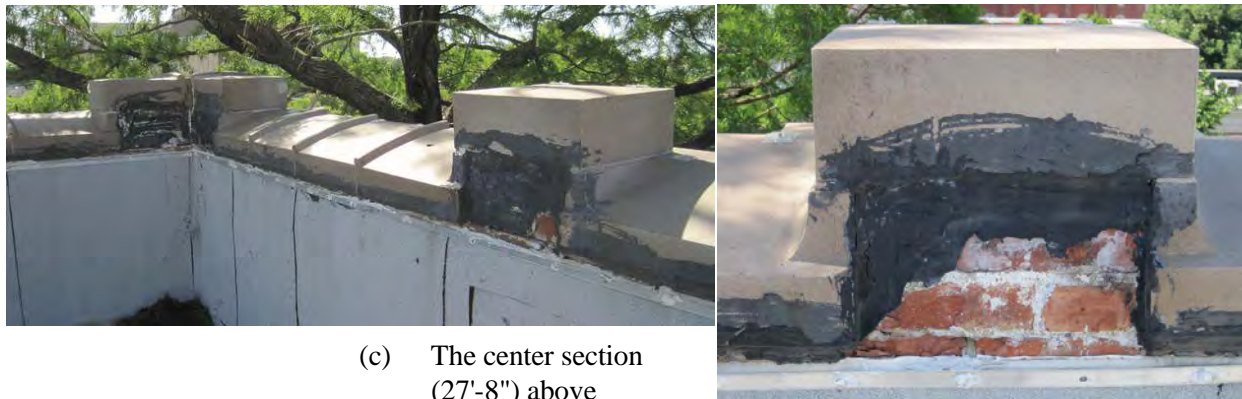
Eastern parapet's series of pilaster caps shown below.

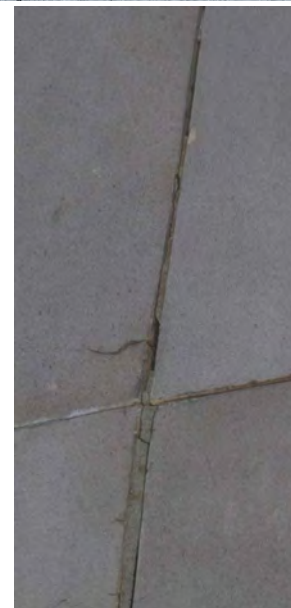
- ii) The south wall was looked at next. Back side is covered with a weathered asphalt coating above the termination bar to “seal” the exposed brick. The joints above in the back of the terra cotta finial are displaced and open. One crack was noted along the vertical joint.

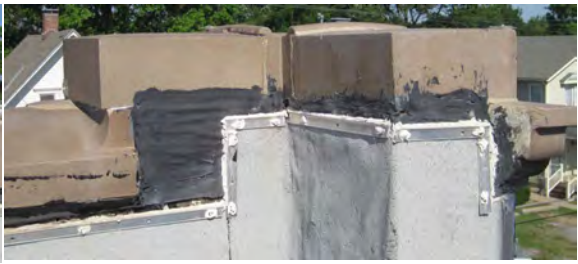
- (3) West parapet wall (31'-4"): The deteriorated conditions along this wall are

similar to the other walls.

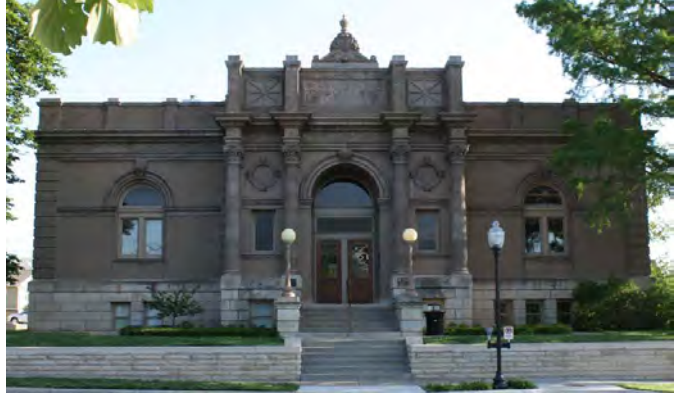
- (1) General: This elevation is the front of the original building. Discussions will include the east and west portions of the entrance.

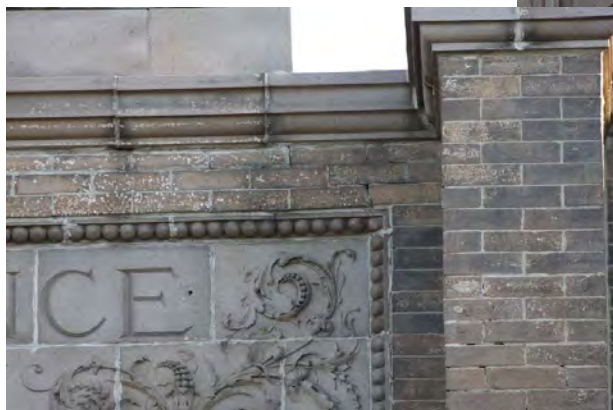
- (c) Center section: Masonry appears to be in good condition, except for some open joints between the bricks and the inlaid panels and mortar joints.

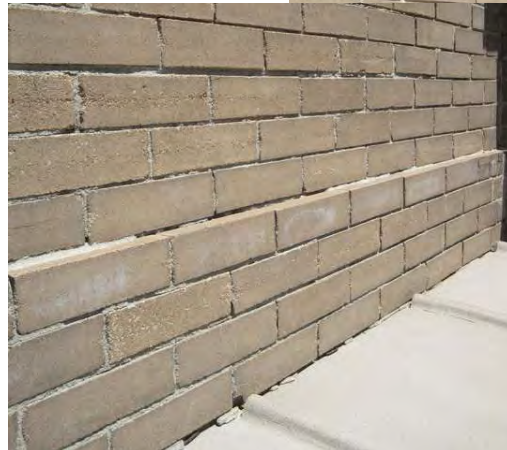
- iii) Displaced units were noted near the top of wall (photo right).

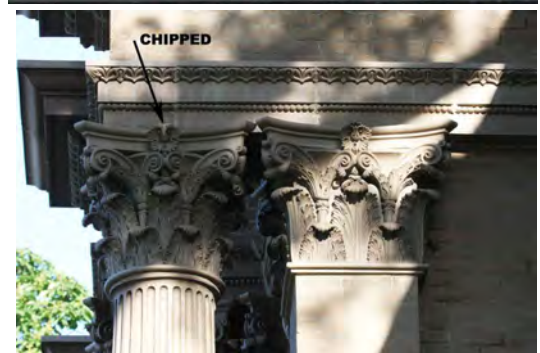
- (4) South Entrance
 - (a) The right terra cotta column capitals appear to be in excellent condition. One slightly chipped detail was noted.
 - (b) The base of the left wall corner is cracked on the west and south faces. Previous repairs have addressed the older cracks, but some cracks appear to be newer than the last repairs.

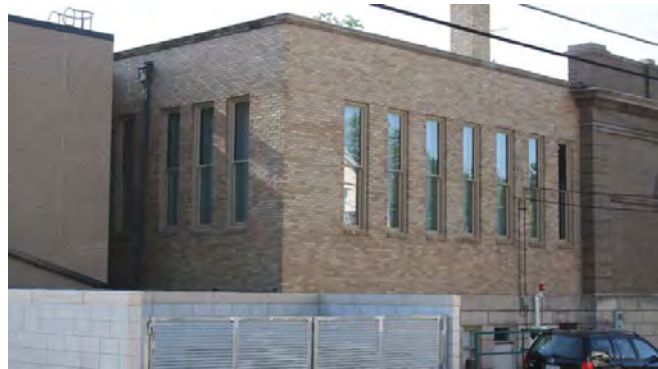
- d. North elevation
 - (1) 1937 Addition
 - (a) Western portion of elevation is partially visible from the northwest. Noted concerns were previously discussed.
 - (b) Eastern portion of north elevation is more visible from the northeast. Lintels were noted to be rusted along this elevation.

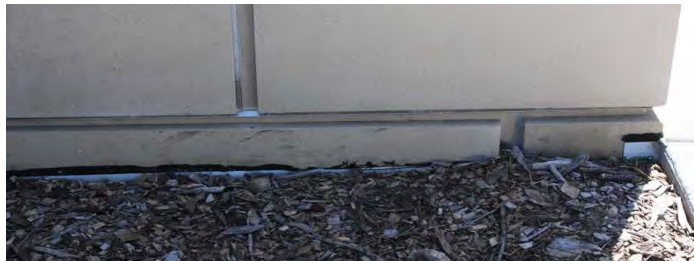
- (2) 2011 Addition: The foundation waterproofing has been improperly terminated above grade. This material will degrade with UV exposure.

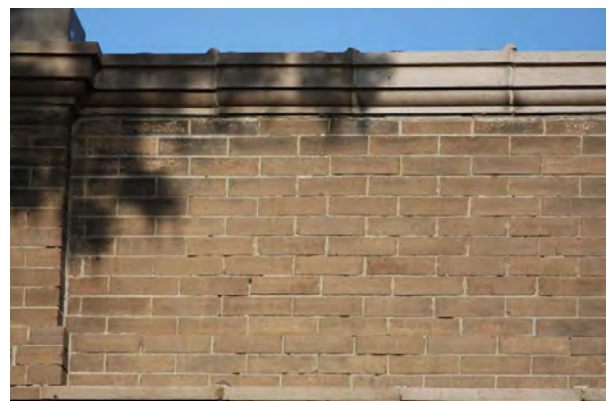
- (b) Repaired jamb conditions were reviewed and previous repairs are cracked.
 - (c) Parapet wall is like the others, except only open mortar joints were noted.

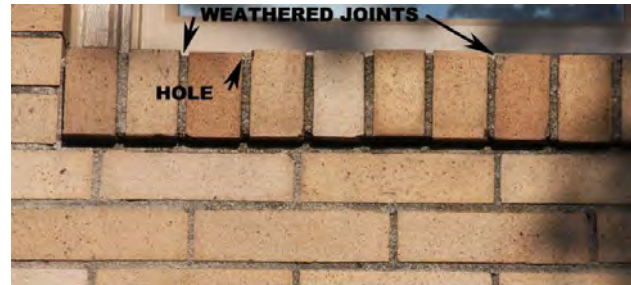
- (d) Signs of moisture coming through terra cotta joints were noted at the inside corner below the watertable. Joints above need to be reviewed and repaired.

- (3) 1937 Addition: Deteriorated mortar joints at rowlock window sills and a cracked joint next to jamb were noted.

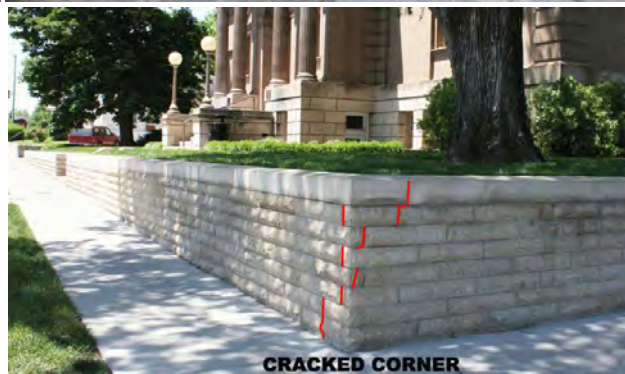
- b. Stone wall along walk at southeast corner.
 (1) The wall extends a long ways to the corners beyond. No movement joints were noted, except for a resulting crack at the southeast corner.
