DGM Consultants, P.A.

FIELD REPORT #01

Project	Carnegie Library	Date	5/15/2012 DGM Project # 2012014
Location	9 th and Vermont Lawrence, Kansas 66044	Contractor	The Garland Company, Inc
To	Mr. Lynn Applegate , Bldg & AquaticsSup City Of Lawrence 6 East 6th Street Lawrence, Kansas 66044	Owner	City of Lawrence
FAX		Weather	Sunny, 60-84°F
		Present	Greg Leslie Lynn Applegate
		PN	PO 005556

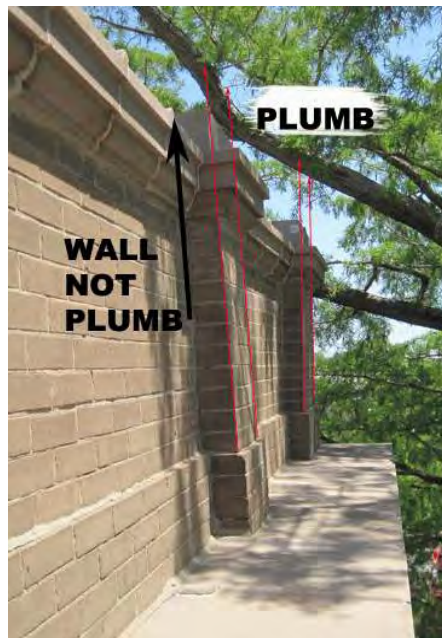
- (3) We later accessed the exterior south face of the south parapet walls, that flank each side of the area above the south porch. Both sections were noticeably out of plumb. (Portion of original drawing #5 below).

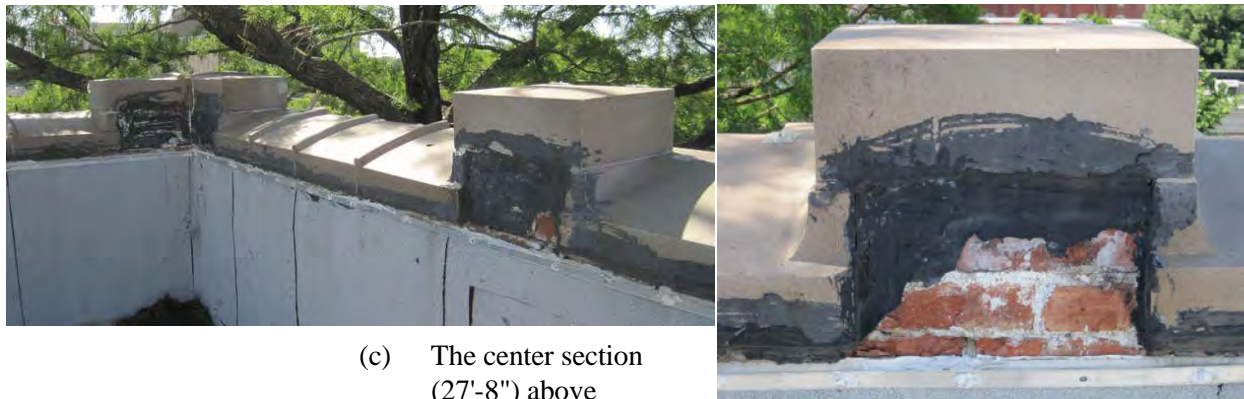
above the rest of the cap stones. The back of the pilasters are brick between the upturned terra cotta cap stone edges. The brick is partially exposed from behind an asphalt coating that was applied over the masonry. The bricks are deteriorated to varying degrees. West parapet series of pilaster caps shown below.

Eastern parapet's series of pilaster caps shown below.

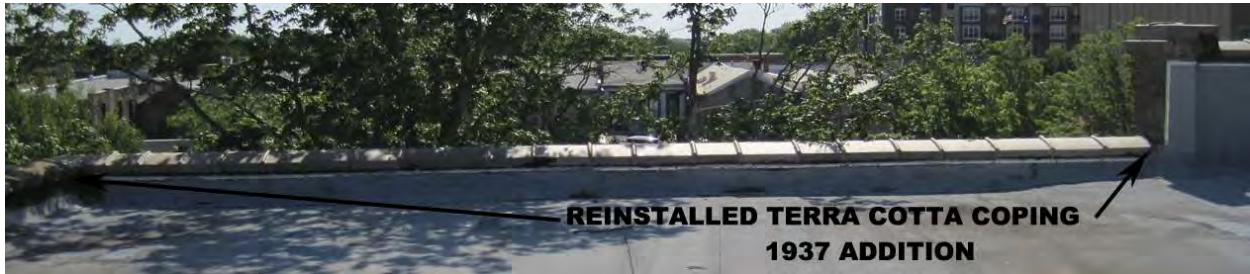
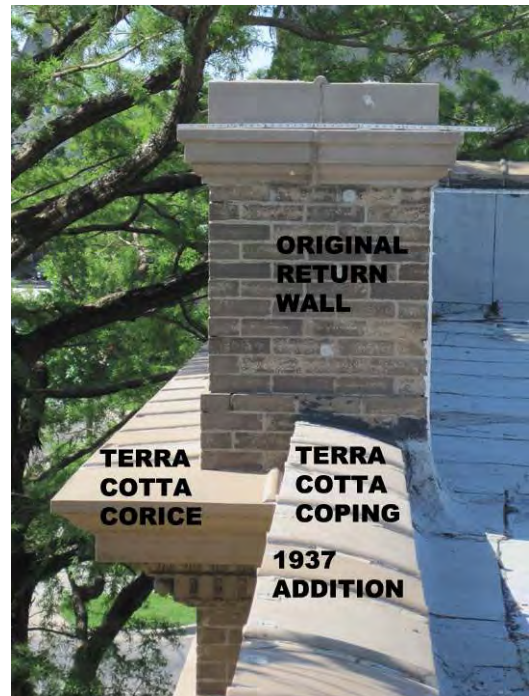
3. 1937 Addition's parapet walls (from north roof)
 - a. This addition has three sides and is centered along the north remaining portion of the original building. The parapet walls are much shorter than the original building.
 - b. East wall (36'-5"): Wall is capped with 24 terra cotta coping units salvaged from the original building, that was replaced by this addition. These terra cotta coping units are in good condition.

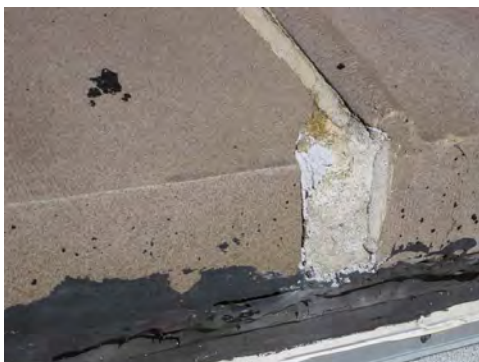
- c. West wall (36'-5"): Wall is capped with 25 terra cotta coping units, plus three pieces at the corner, from the original building that was replaced by this addition. These terra cotta coping units are in good condition, except for several chipped units and open joints.

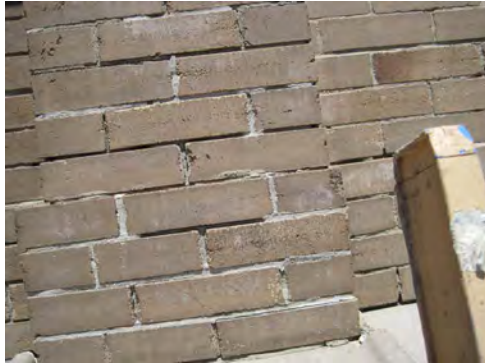
- (d) Western parapet
 - i) Accessed with a ladder
 - ii) Narrow mortar joints are weathered.

Some pointing has failed. Watertable is in good condition, but some open joints were noted. Pointing at base of parapet wall (at watertable) appears to be installed improperly and holes were noted in mortar joints.

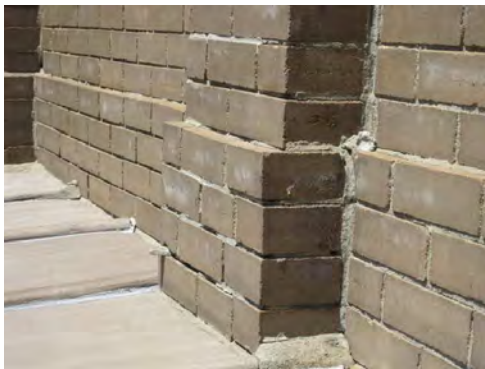
- iii) Displaced units were noted near the top of wall (photo right).

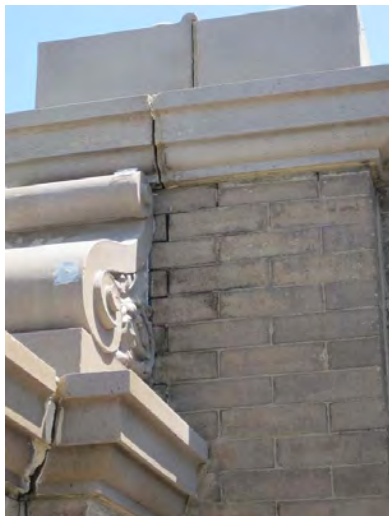
- iv) At top of wall (west central portion), open joints were noted from ladder (photo left).

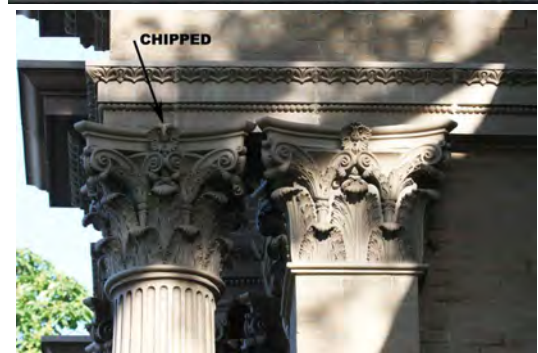
- (4) South Entrance
 - (a) The right terra cotta column capitals appear to be in excellent condition. One slightly chipped detail was noted.
 - (b) The base of the left wall corner is cracked on the west and south faces. Previous repairs have addressed the older cracks, but some cracks appear to be newer than the last repairs.

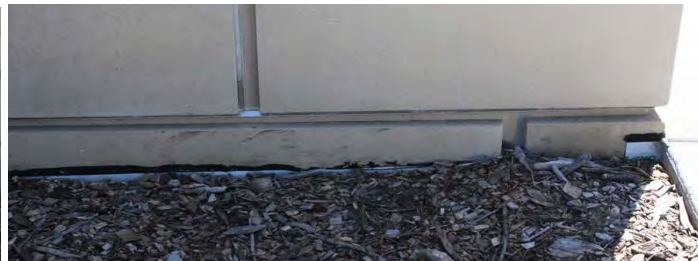
- (2) 2011 Addition: The foundation waterproofing has been improperly terminated above grade. This material will degrade with UV exposure.

I. Exposed Foundation Waterproofing
