ARCHITECTURAL/ENGINEERING  
**EVALUATION & STUDY**  
— FOR —

**FIRE STATION**  
**# 1**

LAWRENCE, KANSAS

NOVEMBER 22, 2010

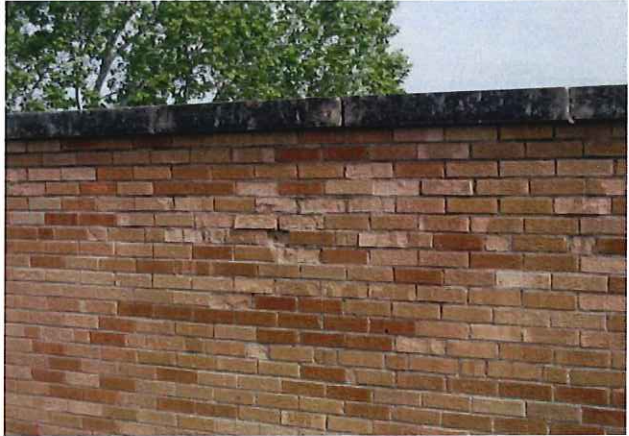
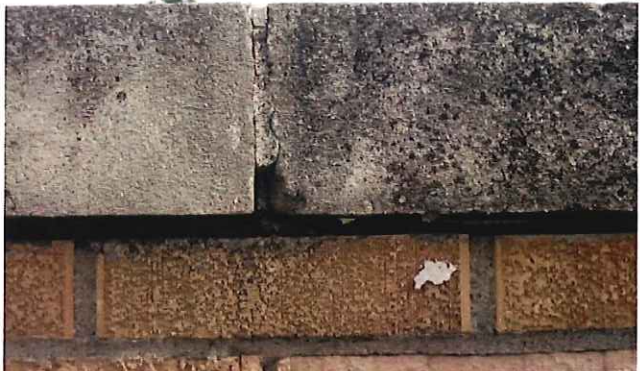
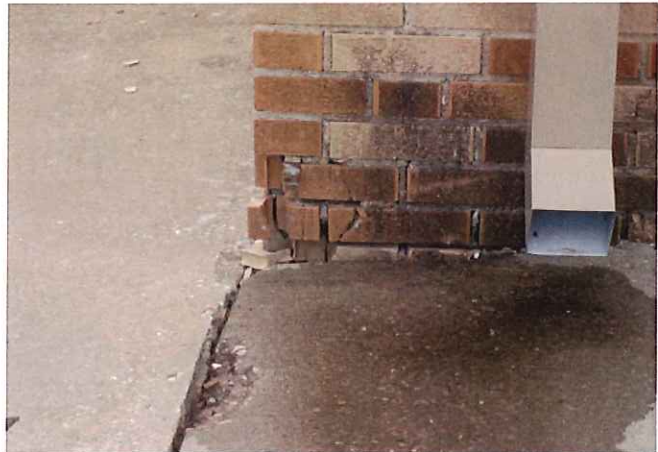
- 1 Exterior character is consistent with 1950's era blond brick masonry building. Masonry veneer is deteriorating due to water infiltration at stone wall cap locations
- 2 Stone coping wall caps have mildew growth, deteriorated head joints, and no through wall flashing below cap. This condition should be corrected at entire building perimeter.
- 3 Limited brick veneer repair is required. This area is likely a result of freeze thaw cycle brought on by moisture from the adjacent downspout.

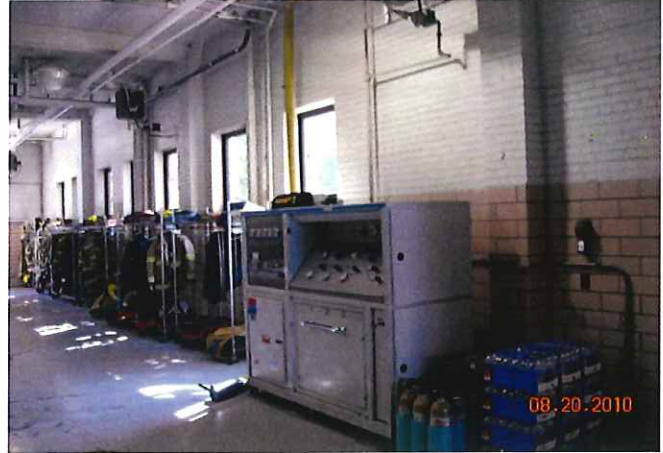
- 15 Bunker gear, SCBA units and other equipment reduce the available space in an existing apparatus bay. Natural light level is good and structural components of the bay appear to be functioning well.

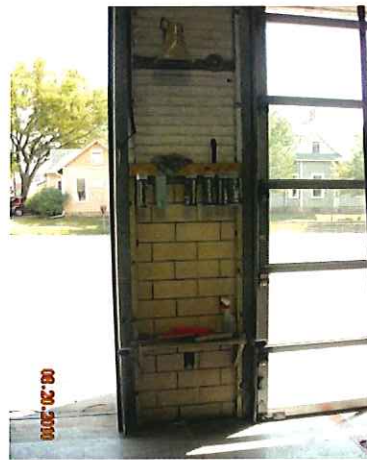
- 16 Existing bays are limited in width reducing storage options and door type options at bay front.

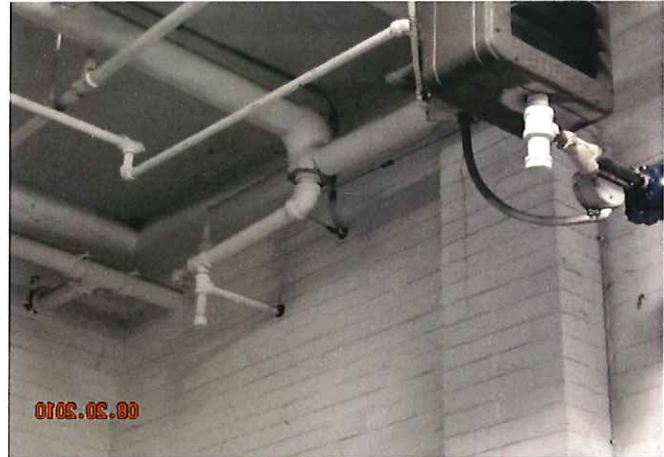
- 18 Mechanical system in facility is reaching its servicable life. Refer to attached mechanical engineers report. Current department standard for heating bay areas is radiant gas fired heaters. These would be retrofitted as part of a full mechanical system upgrade.

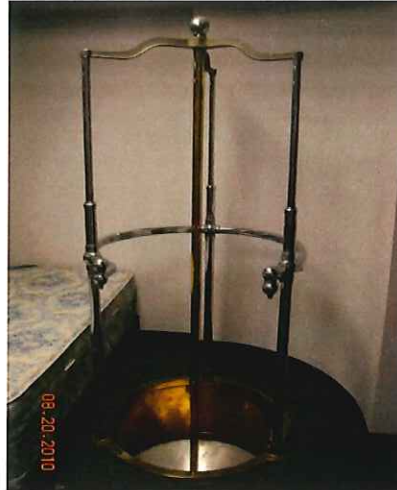
- 27 Existing poles provide access from sleeping quarters on the second floor to the apparatus bay below.

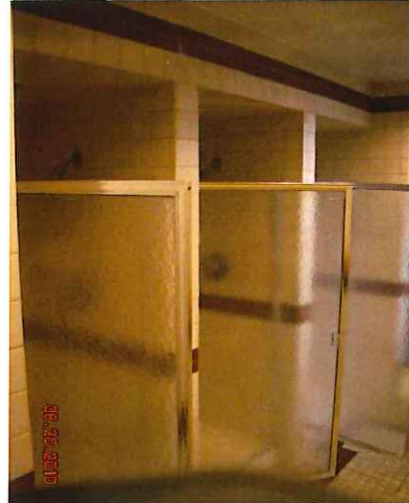
- 30 Existing tile shower compartments are in good repair. It is the design teams understanding that these showers were constructed by fire fighters as part of the renovation work performed in 1984.

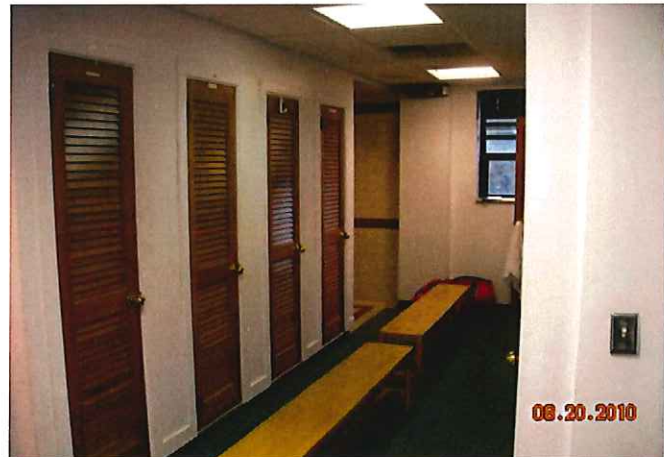
- 31 Existing locker room is in good repair. It is the design teams understanding that these lockers were constructed by fire fighters as part of the renovation work performed in 1984.

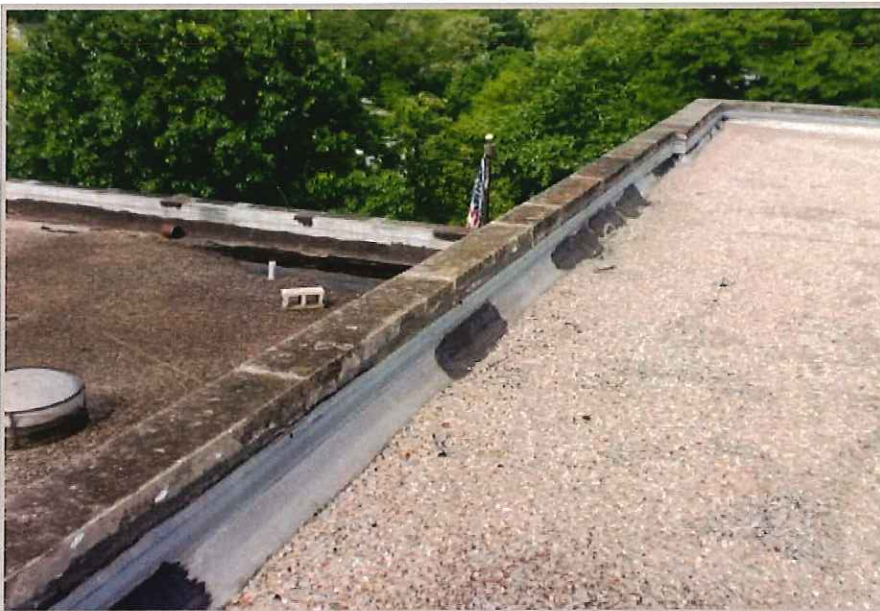
Area between the parapet wall and coping caps needs to be sealed to keep water from penetrating behind the flashings. This area shows where water is getting in behind the termination bar and under the roofing system.

View of coping cap and flashing along Southwest corner of upper roof.

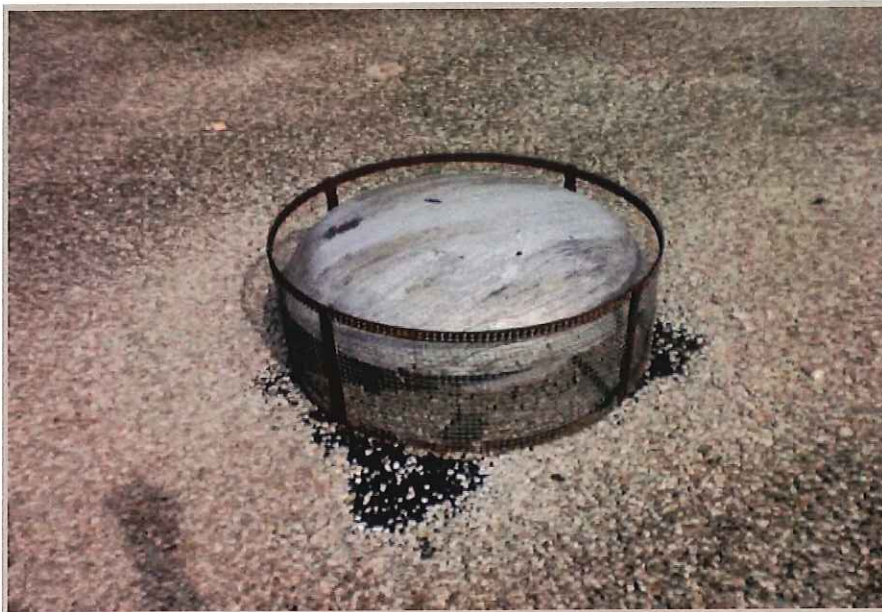
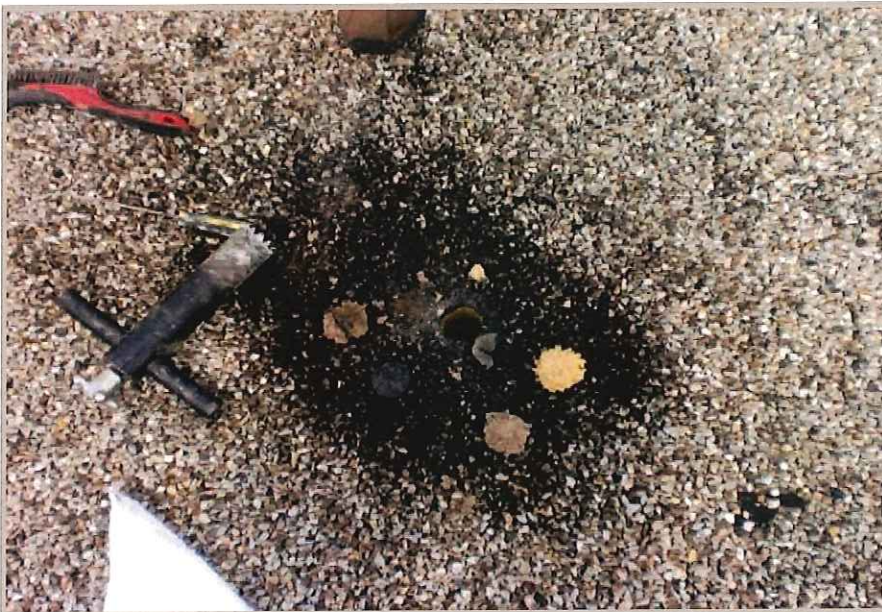
Flashings under the vents are in bad shape.

Core cut identifying the roofing elements.
