City Hall Executive Summary 2009 6 East 6th Street

Lawrence Arts Center Executive Summary 2009 940 New Hampshire Street

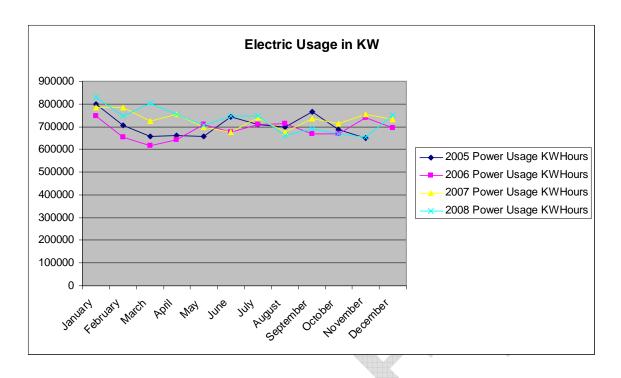
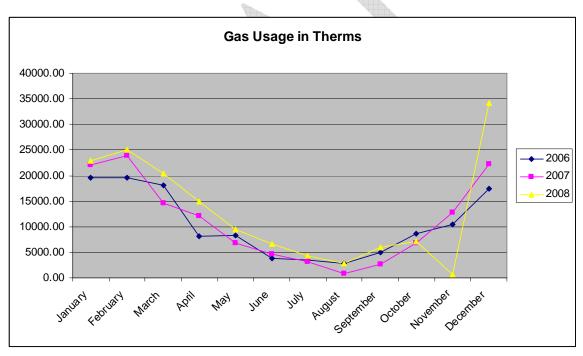
January	February	March Ap	ril Ma	/ June	July	August	September	October	November	December
2007	22086	23968	14688 12	045 677	4 4599	3232	895	2634	6802	12841	22208
2008	22879	25034	20496 148	870 951	8 6583	4292	2828	5918	7146	604	34175

January	February	March	April	May	June	July	August	September	October	November	December
2007	782400	784800	724800	753600	699600	676800	739200	676800	736800	712800	753600	732000
2008	830400	747600	804000	754800	704400	746400	747600	661200	692400	668400	655200	748800

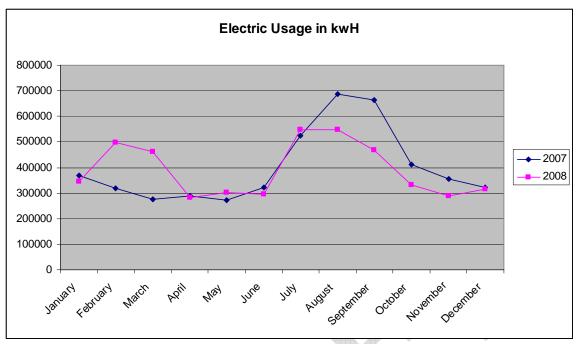
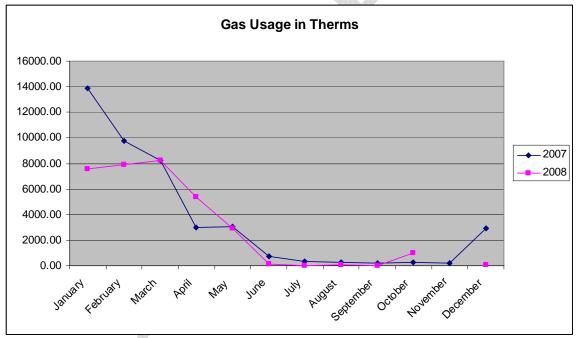
January	February	March	April	May	June	July	August	September	October	November	December
2007	13862	9789	8202	2969	3085	756	360	255	209	238	223	2936
2008	7577	7895	8222	5353	2935	127	22	39	24	970		99

January	February	March	April	Мау	June	July	August	September	October	November	December
2007	346601	497424	460230	281990	302693	294014	548731	547132	468548	331746	289132	315949
2008	346601	497424	460230	281990	302693	294014	548731	547132	468548	331746	289132	315949

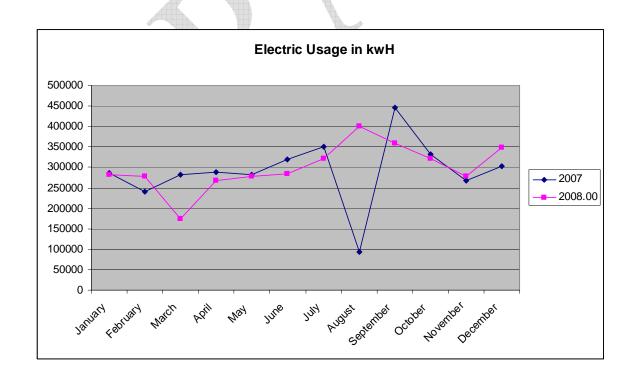
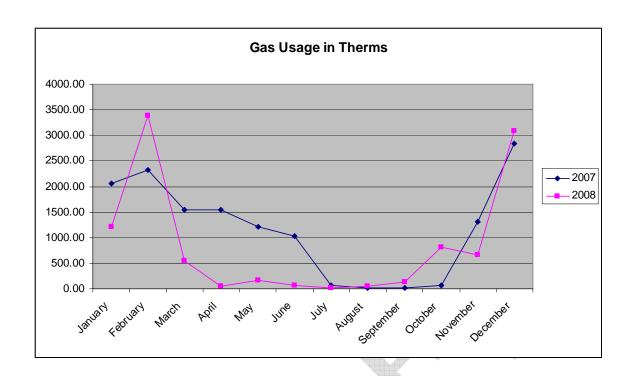
January	February	March	April	May	June	July	August	September	October	November	December
2007	2061	2327	1549	1537	1220	1032	69	11	12	66	1306	2845
2008	1211	3391	543	58	166	63	13	47	137	821	656	3082

January	February	March	April	May	June	July	August	September	October	November	December
2007	281280	278112	173416	268504	277036	283844	321800	401020	359056	322024	278860	347660
2008	286072	241216	281976	288694	281280	318984	350632	392448	446560	332680	267920	302712

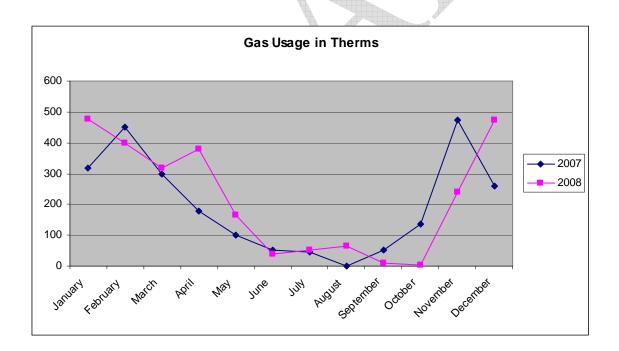
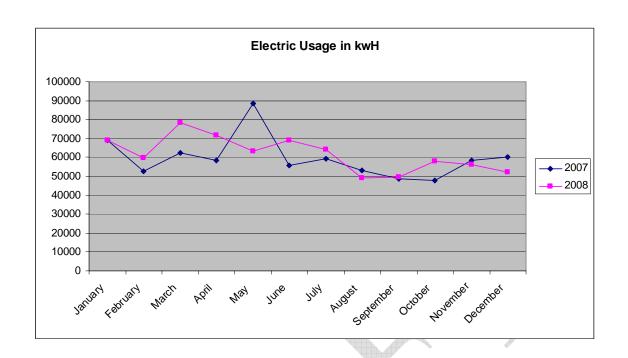
December	November	eptember October	August	July	June	May	April	March	February	January	
258	475	51 137	0	46	53	101	180	297	451	319	2007
474	239	10 2	66	51	38	166	381	319	398	477	2008

January	February	March	April	May	June	July August	September	October	November	December
2007	69180	52540	62460	58300	88380	55740	59380 53180	48700	47740	58300	60220
2008	69180	59580	78140	71740	63100	69180	64380 49020	49340	57980	56380	52220

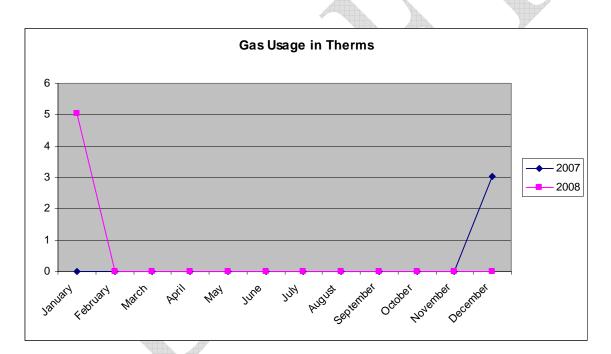
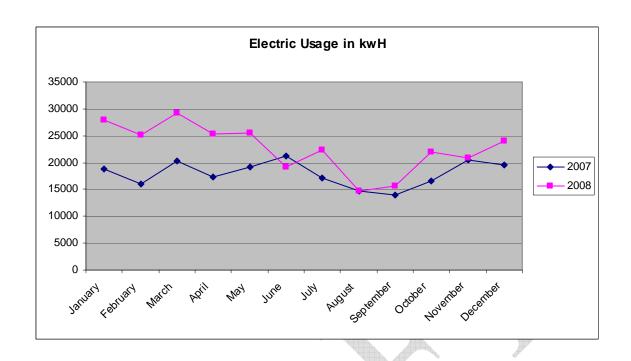
Janu	uary	February	March	April	May	June	July	August	September	October	November	December
2	007	0	C	0	0	0	0	0	0	0	0	0	3.04
2	800	5.04	C) 0	0	0	0	0	0	0	0	0	0

January	February	March	April	May	June	July	August	September	October	November	December
2	2007	18890	16090	20290	17290	19090	21290	17090	14690	13890	16490	20490	19490
2	2008	27890	25090	29290	25290	25490	19090	22290	14690	15690	21890	20890	24090

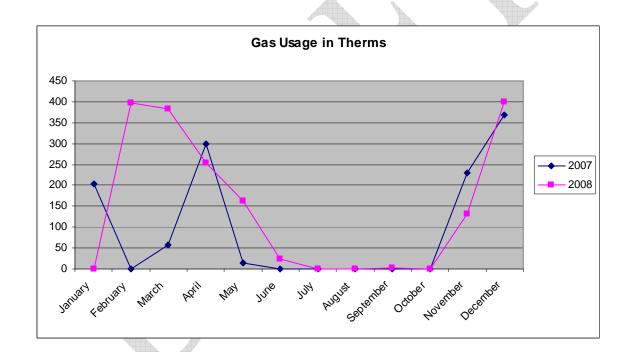
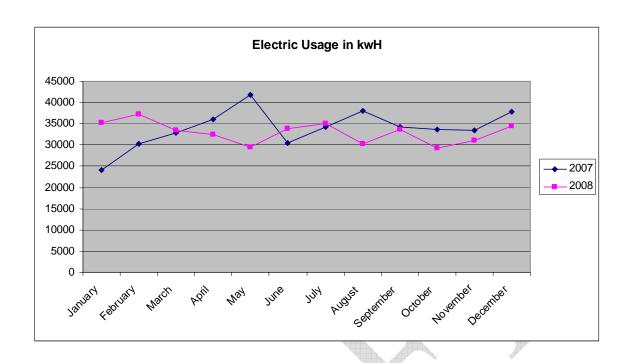
January	February	March	April	May	June	July	August	September	October	November	December
2007	203	0	58	299	15	0	0	0	0	0	229	369
2008	0	397	383	253	163	25	0	0	3	0	132	399

January	February	March	April	May	June	July	August	September	October	November	December
2007	24180	30280	32880	36080	41880	30480	34280	37980	34280	33580	33480	37880
2008	35180	37180	33380	32480	29480	33780	35080	30280	33580	29180	31080	34480

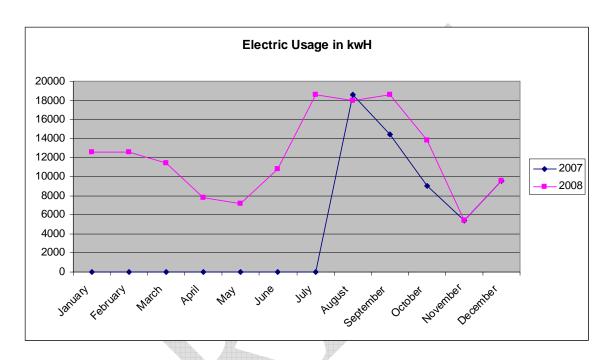
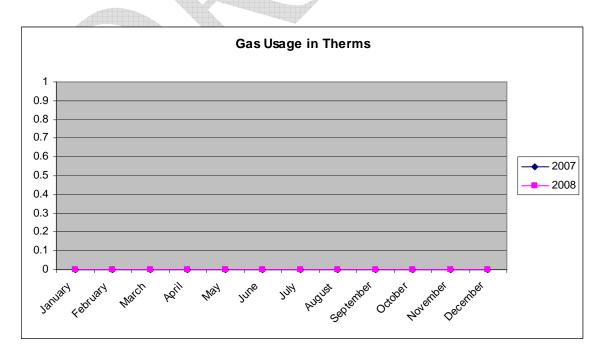
January	February	March	April	May	June	July	August	September	October	November	December
2007	0	0	0	0	0	0	0	0	0	0	0	0
2008	0	0	0	0	0	0	0	0	0	0	0	0

January	February	March	April	May	June	July	August	September	October	November	December
2007	0	0	0	0	0	0	0	18600	14400	9000	5400	9600
2008	12600	12600	11400	7800	7200	10800	18600	18000	18600	13800	5400	9600
